Hermits Peak-Calf Canyon Burned Area Emergency Response Phase 1 Assessment Report Summary

Phase 1 Soil Burn Severity - Headwaters Gallinas River and Tecolote Creek Watersheds

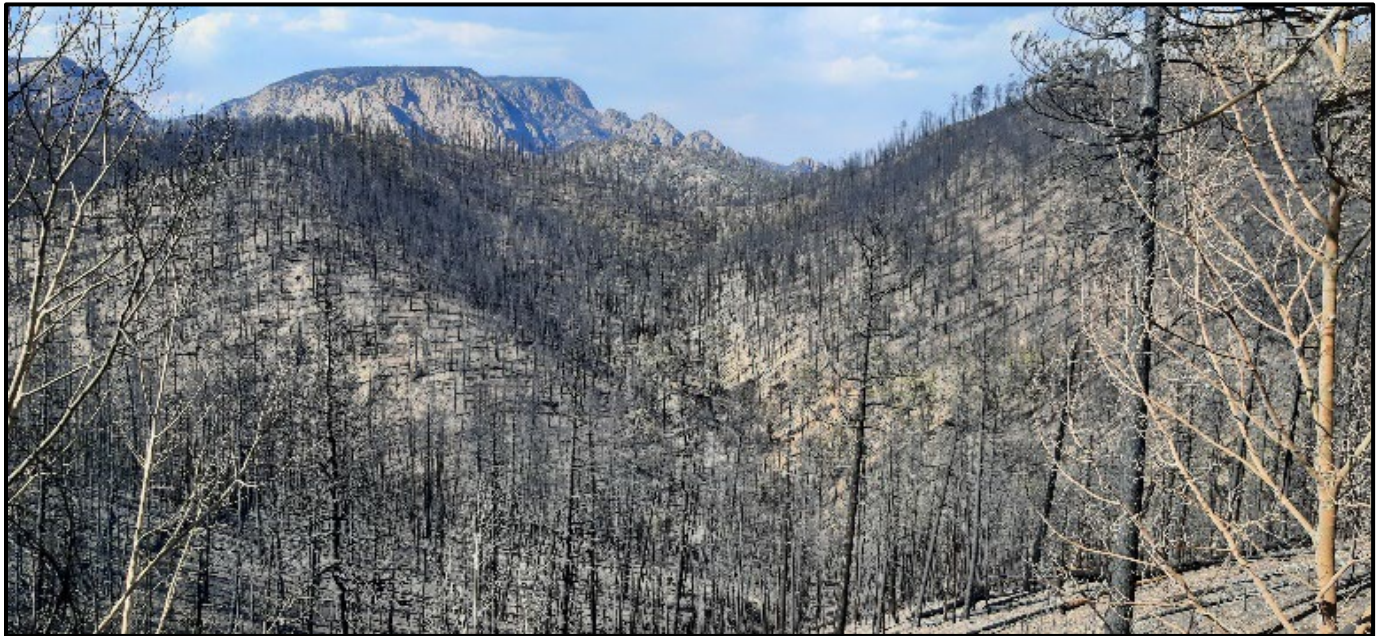
Figure 1. High soil burn severity with Hermit Peak in the background.

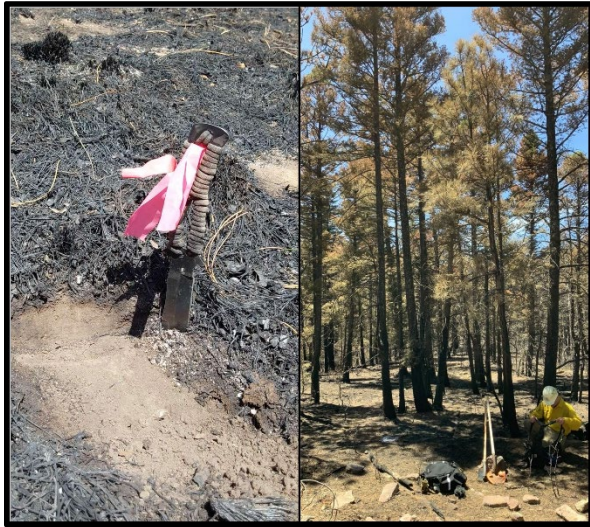
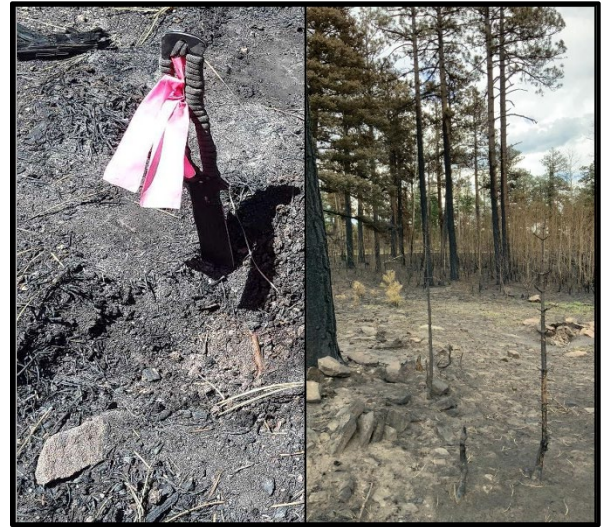
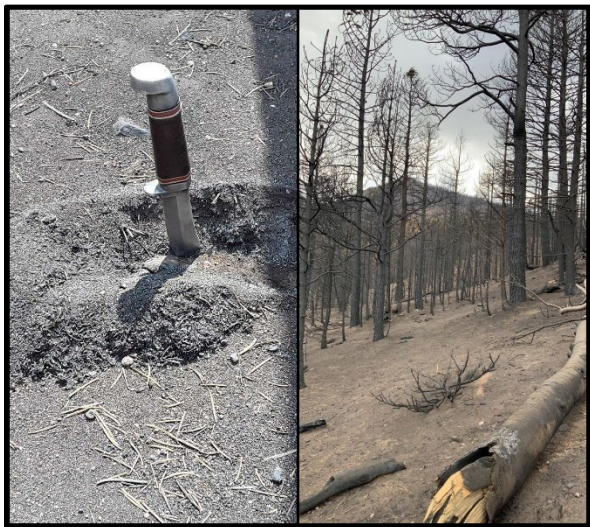
Figure 2. Examples of low (top left), moderate (top right), and high (lower left) soil burn severity in the Phase 1 analysis area. These burn conditions, including remaining ground cover, soil integrity, hydrophobicity, remaining root structure, and surviving vegetation, assist to estimate the likelihood and intensity of future flooding, erosion, and debris flows.

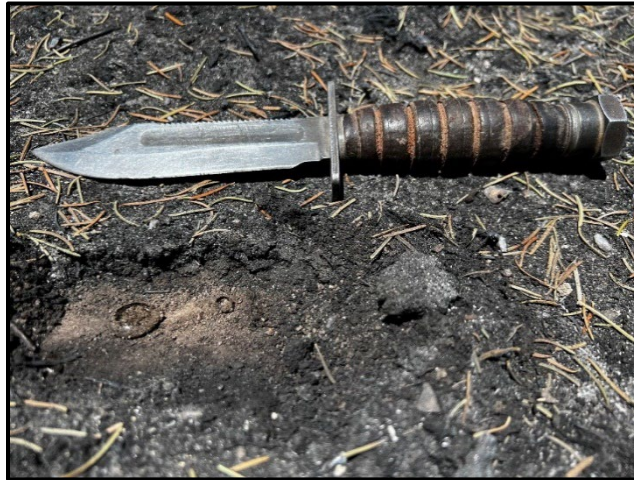
Figure 3. Strong hydrophobicity at a depth of 2 cm in a moderate soil burn severity field plot.

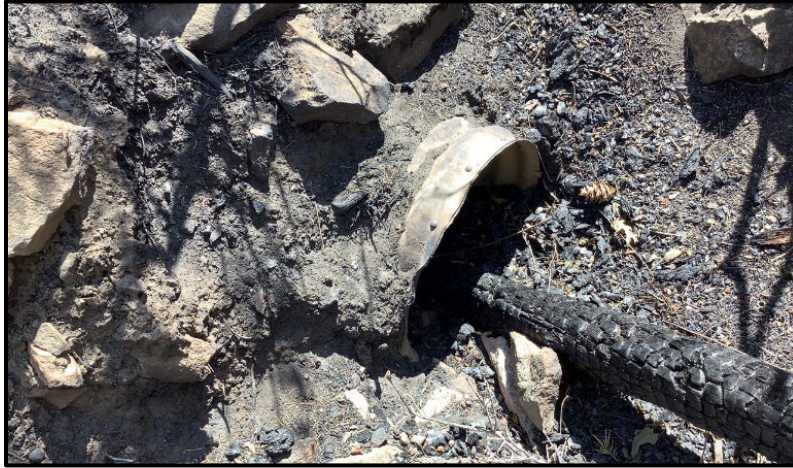
Figure 5. Plugged culverts can lead to a road being overtopped by flood waters.

The road prism may become impassible to vehicles and in extreme cases may be completely washed out due to fill slope failure. Road prisms may also be damaged due to falling rock and debris making the road impassible. Public safety hazards are significantly increased due to flash flooding, where road segments lie within the floodplain, fallen trees, destabilized rock slopes, damage to traffic safety structures and signs.

Common BAER emergency treatments could include signs warning travelers of the increased danger, closures of maintenance level 2 roads during monsoon season, storm inspection and response, creating armored dips, clean ditches to handle increased flows, and removing debris from stream channel.

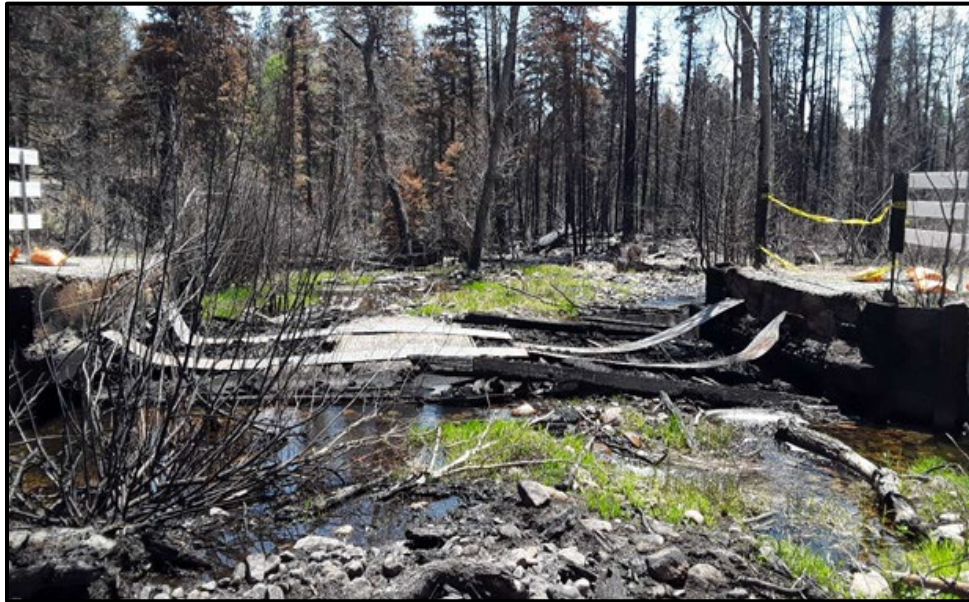
potential for structural failure of roads within the affected watersheds. There are 14 bridges on NFSR 263, all intact with only minor damage at one wingwall support. There is one bridge on NFSR 156 that received no damage from the fire and one bridge on NFSR 261 that was destroyed by the fire (Figure 6).

Figure 6. Burned infrastructure that may mobilize during a storm.

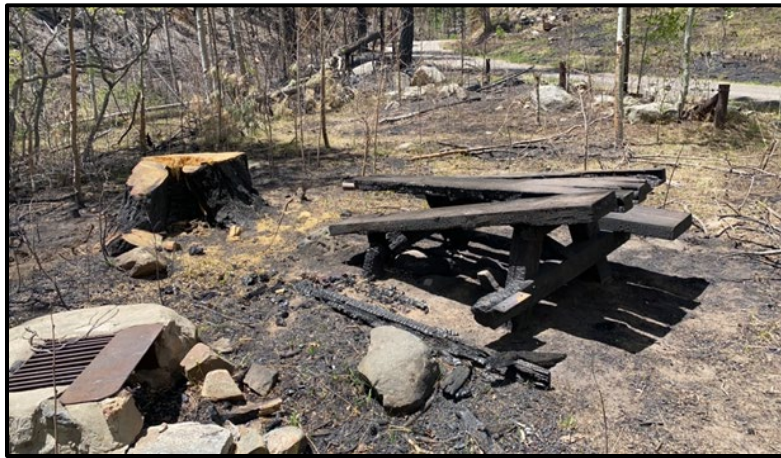
Facilities such as campgrounds and picnic sites (Figure 7), particularly those in moderate and high burn severity, are affected by numerous hazard trees throughout the sites. Facilities that are within the floodplain or are immediately downhill from moderate and high severity burn areas could experience downhill debris flow. The road bridge to El Porvenir was burned and unusable so alternate access will need to be established before any treatments can occur. Trails situated along ridges are less likely to experience damaging erosion from flooding, but trails located next to streams, within narrow canyons, or on hillsides are likely to sustain damage. Fire effects to trail recreation include impeded trail access due to downed trees, damage to trail treads, debris rolling onto trails, and flooding from streams next to trails.

Figure 7. Burned recreation infrastructure at Big Pine Day use site.

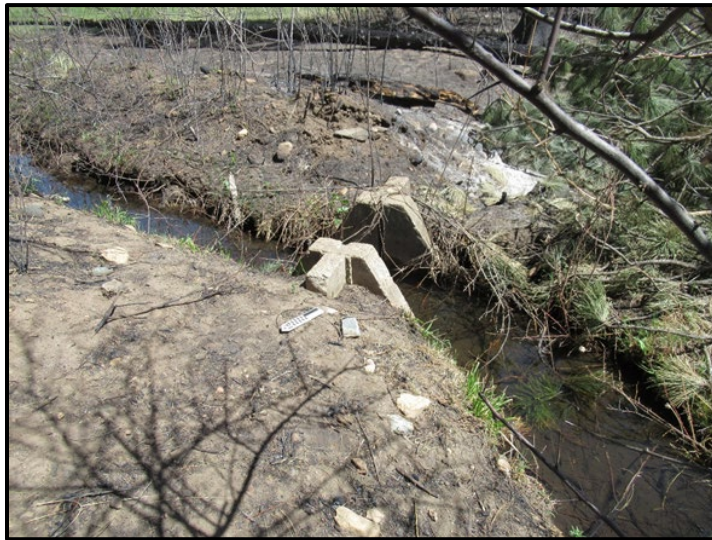
Figure 9. Historic concrete acequia headgate.
