Forest Service  
U.S. DEPARTMENT OF AGRICULTURE

Santa Fe National Forest | June 2022

# Cerro Pelado Burned Area Emergency Response (BAER) Assessment Report

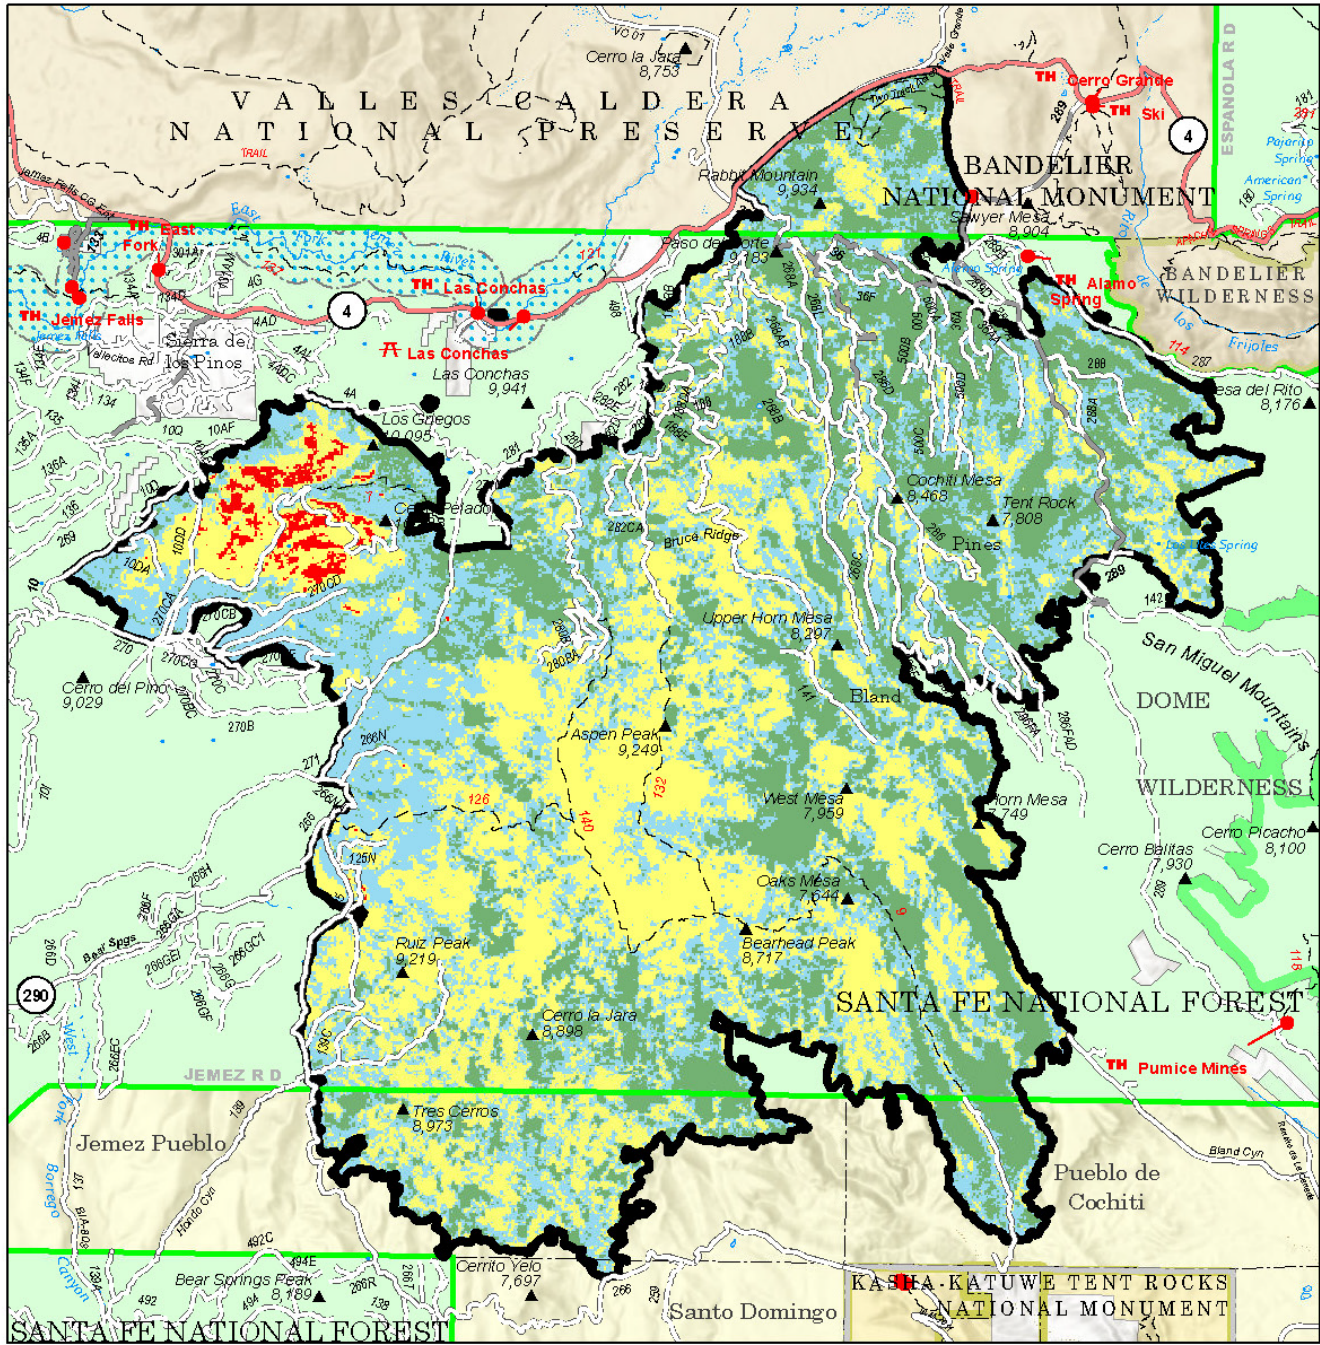
Figure 2: Soil Burn Severity Map for the Cerro Pelado Fire

The Cerro Pelado SBS map analyzes approximately 45,605 acres of the burned area. Approximately 67% of the acres are either very low or low SBS, while 32% sustained a moderate SBS and only 1% identified as high SBS. The SBS map also shows the burned acreage for land ownership to be:

- High Severity - 382 acres - 1%
- Moderate Severity - 14,737 - 32%
- Low Severity - 16,512 - 36%
- Unburned - 13,974 - 31%
- Cerro Pelado Fire Perimeter

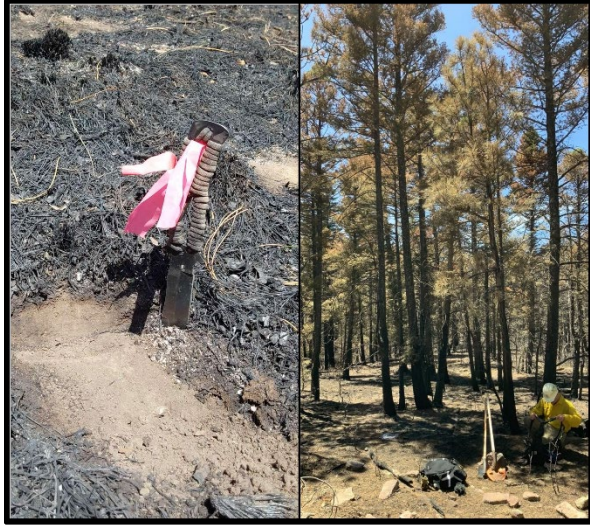
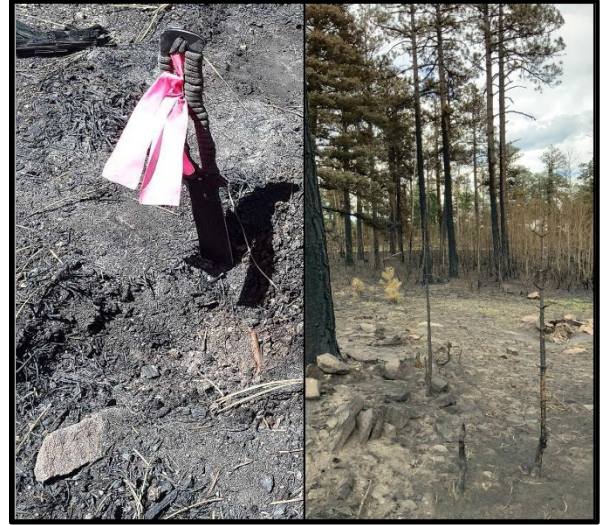
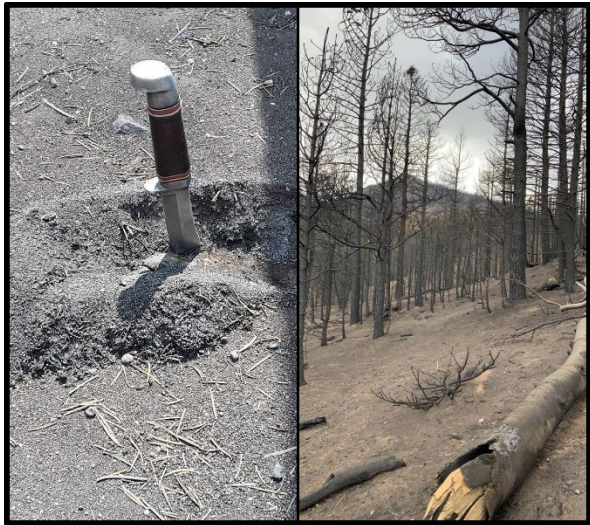
Figure 3: Examples of low (top left), moderate (top right), and high (lower left) soil burn severity in the burned area. These burn conditions, including remaining ground cover, soil integrity, hydrophobicity, remaining root structure, and surviving vegetation, assist to estimate the likelihood and intensity of future flooding, erosion, and debris- flows.

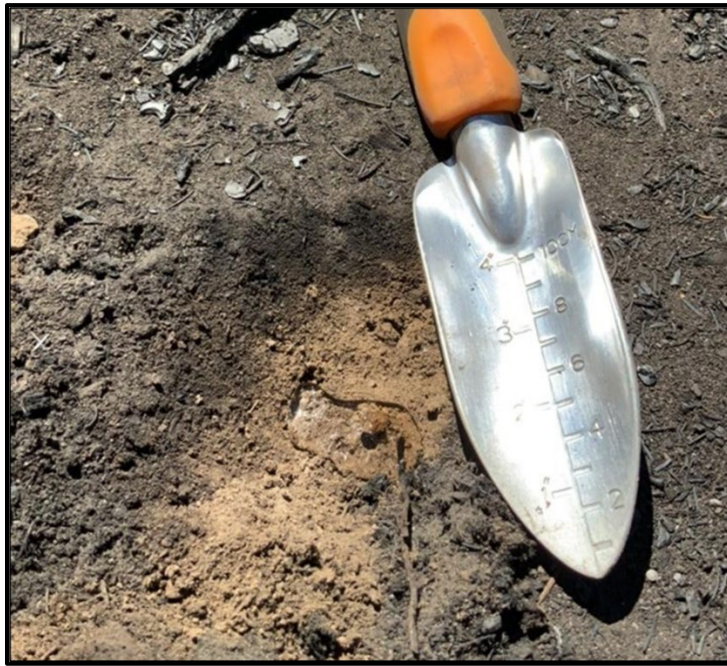
Figure 4: Strong hydrophobic soil conditions caused by moderate soil burn severity in mixed conifer forest. Note 2 cm diameter water drop that persists on soil surface.

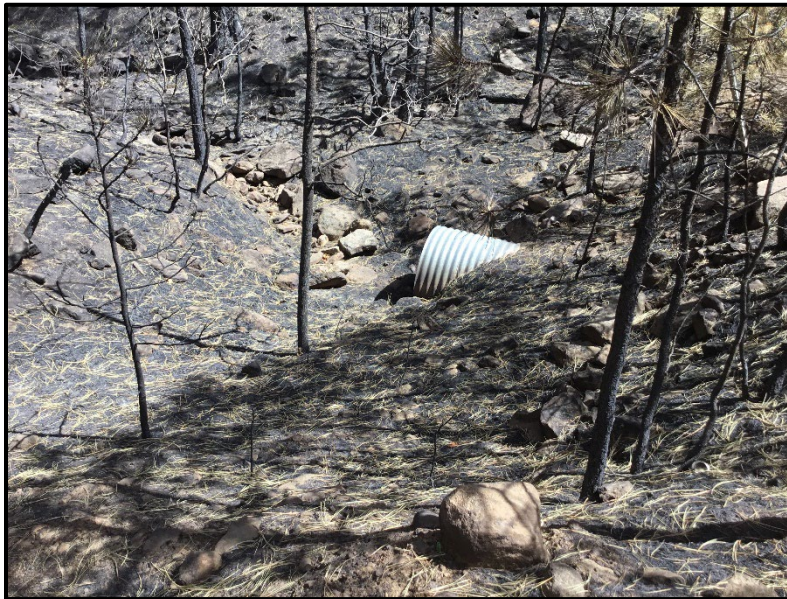
Figure 5. Burned area above culvert where increased erosion and sedimentation can plug culverts leading to a road being overtopped by flood waters.

The road prism may become impassible to vehicles and in extreme cases may be completely washed out due to fill slope failure. Road prisms may also be damaged due to falling rock and debris making the road impassible. Public safety hazards are significantly increased due to flash flooding, where road segments lie within the floodplain, fallen trees, destabilized rock slopes, damage to traffic safety structures and signs.

Common BAER emergency treatments could include signs warning travelers of the increased danger, closures of some FS roads during monsoon season, storm inspection and response, creating armored dips, clean ditches to handle increased flows, and removing debris from stream channel.
