BAER Scientists and Specialists Assess the Oak Fire for Flooding and Debris Flow Risks

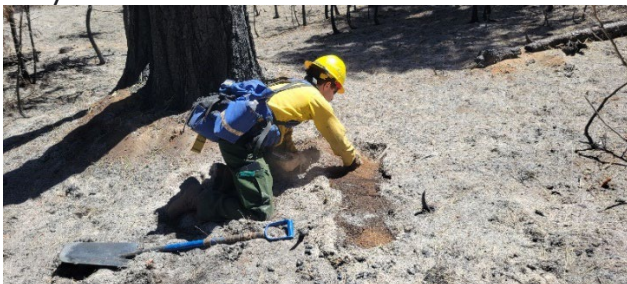
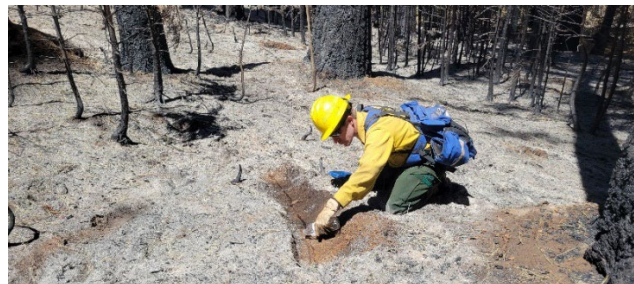
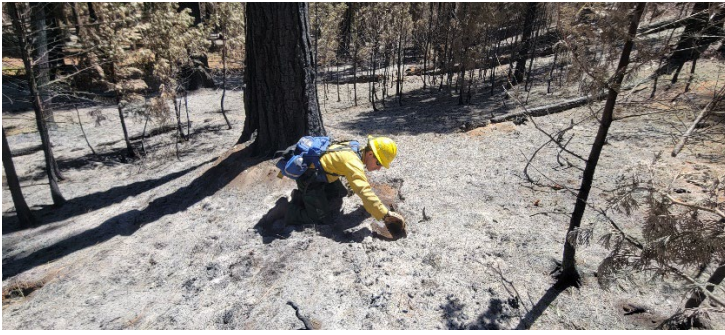
Below, these three photos show Forest Service soil scientist Curtis Kvamme assessing soil hydrophobicity (water repellency) and changes to soil structure in a high soil burn severity (SBS) area of the Oak burned area. Curtis digs a trench and drops water on the soil at multiple depths to determine how deep and how strong the layer of water-repellant soil may be.

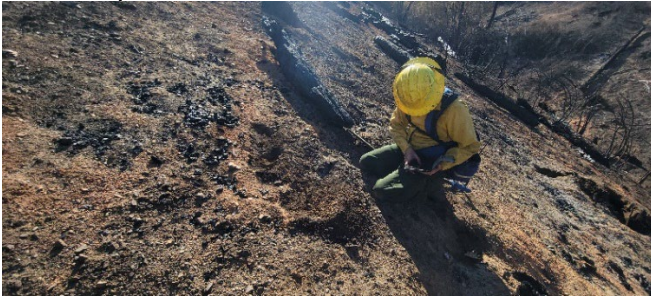
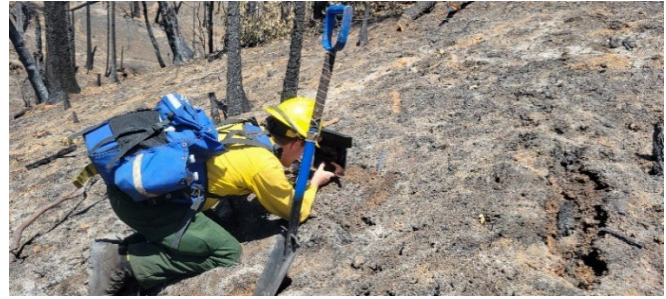
In the next two photos, Curtis captures high soil burn severity data in the Oak burned area using Survey 123 data collection program to evaluate and map the level of severity for this part of the fire.

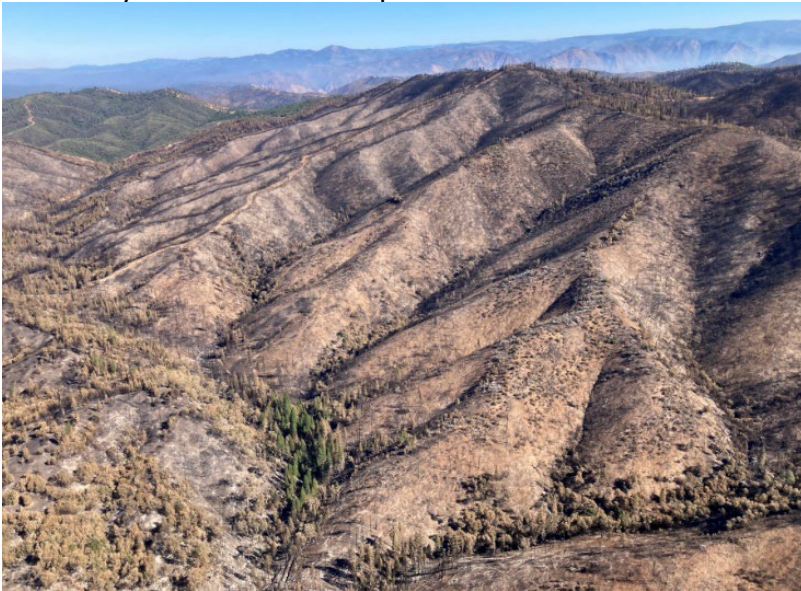
The photo below is an aerial view of a portion of the Oak burned area that was taken by Forest Service Geologist Yonni Schwartz during an air reconnaissance flight. The photo shows gentle valleys and ridges formed by fluvial erosion processes which shaped a relatively smooth landscape that is devoid of instable geological features.

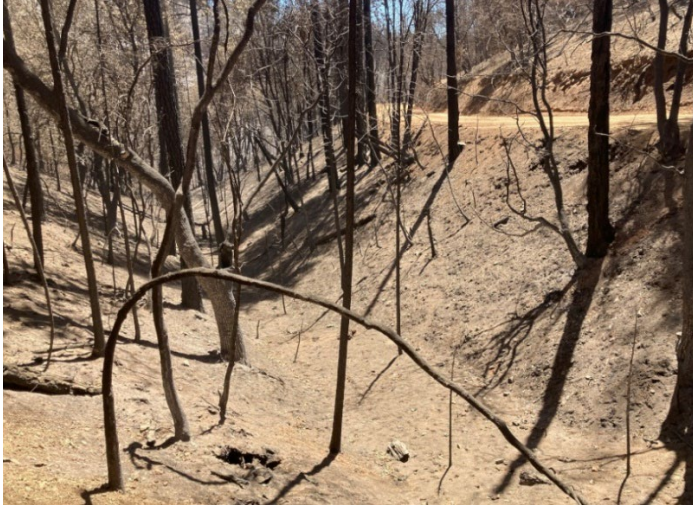
Yonni's photo below shows a channel that is loaded with a thick layer of mostly fine sediments, that are lacking any surface rocky materials that could produce a hyper-concentrated sediment flow during a major rainstorm event.

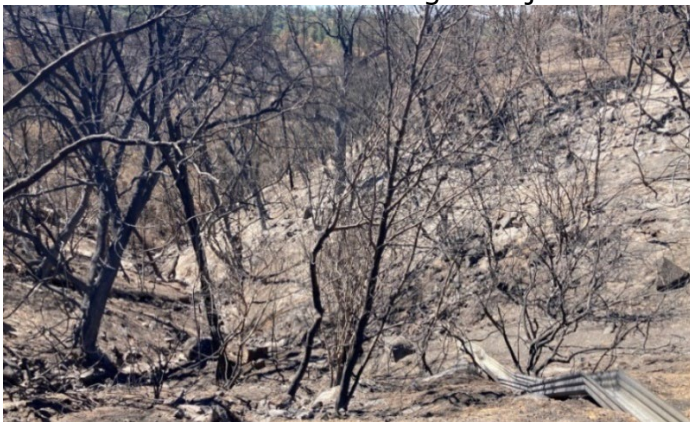
This photo below is of the lower end of Snow Creek that is loaded with unsorted, unconsolidated rocky materials that is available to be transported downstream as a destructive debris flow during a major rainstorm event.

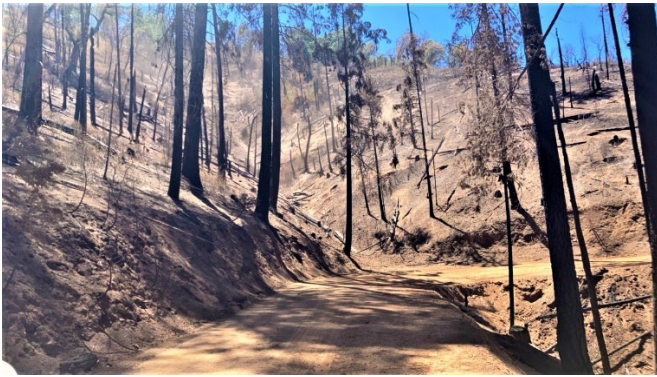
The photo below is an example of several critical drainage crossings identified by BAER assessment team road engineers, hydrologist and geologist. They inspected these crossings to prescribe the most effective BAER treatment to protect the road prisms from washing away during major storm events.

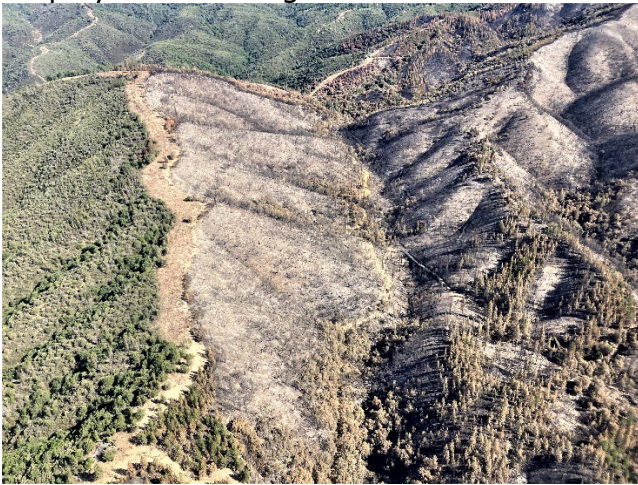
This photo below is an aerial view above Forest Service roads 5S24 and 4S33. Both roads are below a high soil burn severity area of the Oak Fire that is expected to have a potential significant increase in water run-off. Consequently, predicted debris flows could exceed the capacity of current road drainage features. BAER stabilization treatments will be recommended and implemented to protect these roads for Forest visitors and employees traveling in the Sierra NF.

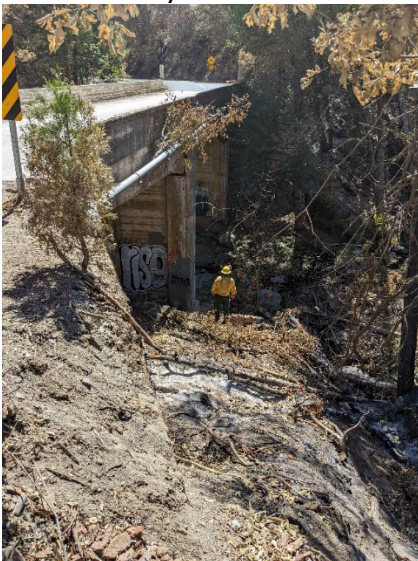
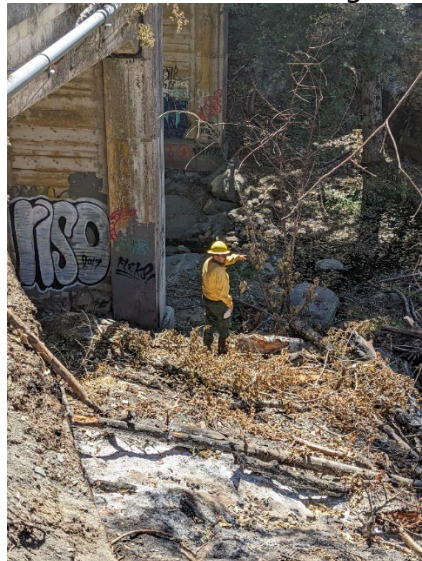
In the next two photos below, Forest Service Transportation Engineer Marcos Rios is inspecting and evaluating risk at a Triangle Road bridge on Snow Creek. Marcos assessed the bridge to determine if it had capacity for potential increased stream and debris flows that is likely to come down the burned watershed during rainstorm events.

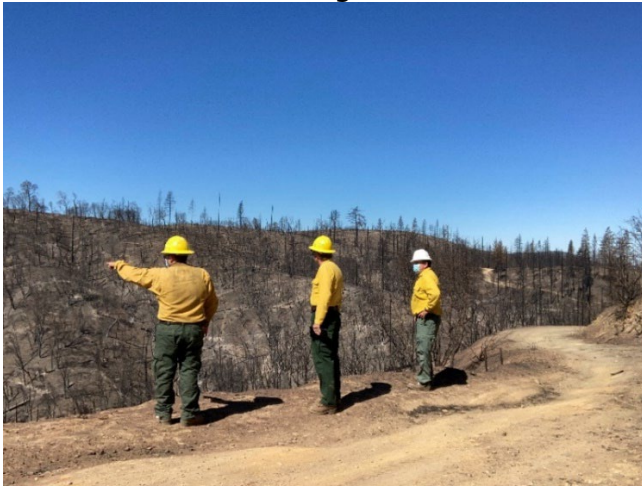
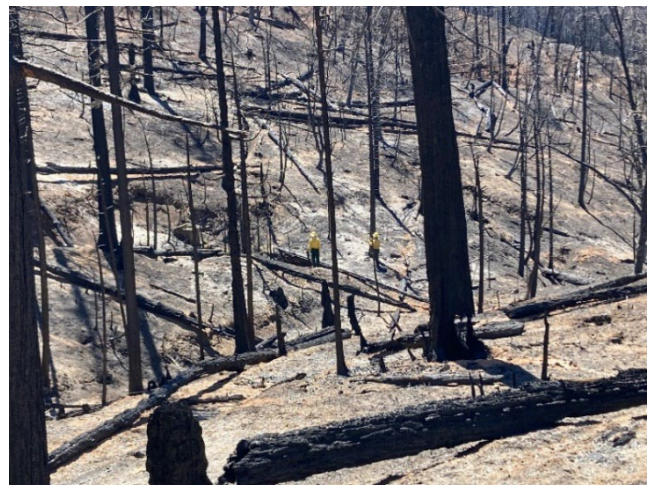
In the next two photos, Marcos Rios, BAER Team Leader Kendal Young, and Sierra NF Roads Manager Pablo Gonzalez, evaluate soil burn severity conditions along roads within the Oak burned area. The second photo shows Kendal and Marcos looking to determine if there is a BAER stabilization treatment that would prevent hazmat from a burned structure from reaching a creek.

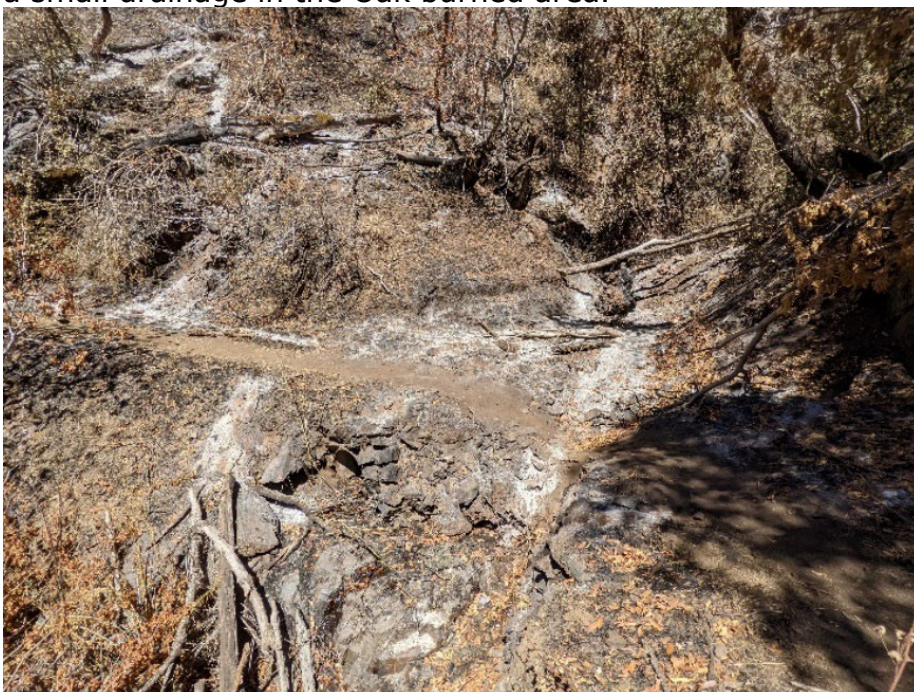
This photo is of a rock wall and culvert built on the Skelton Creek hiking trail crossing over a small drainage in the Oak burned area.

The two photos below show portions of two trails Cori evaluated for the BAER team report and provided BAER emergency stabilization treatment recommendations to minimize threats from potential rainstorm threats.

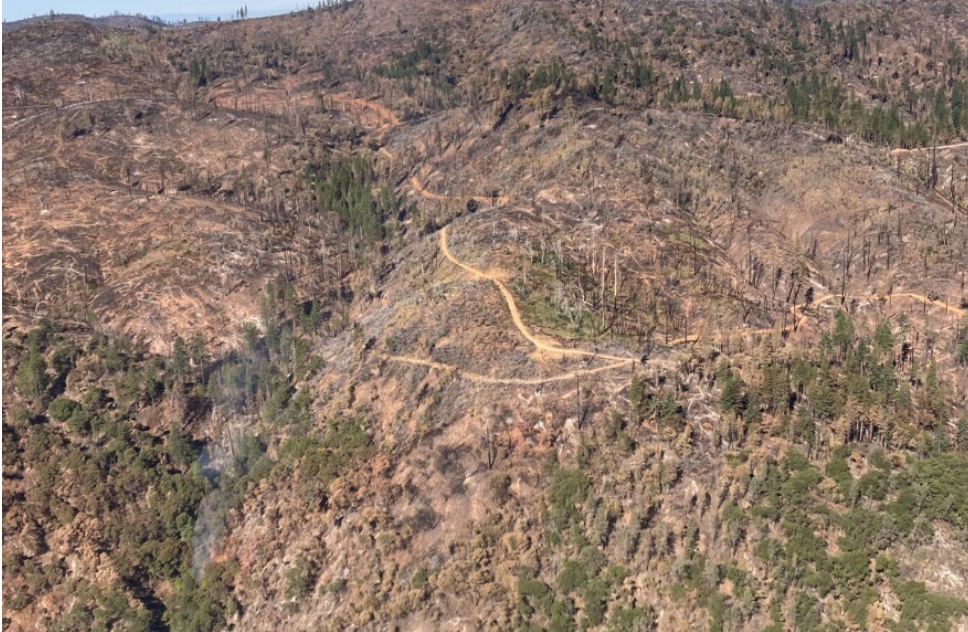
This photo is an aerial overview of Windlass Ridge OHV trail that is within the Oak burned area.
