OAK FIRE

Burned Area Emergency Response Assessment

August
2022

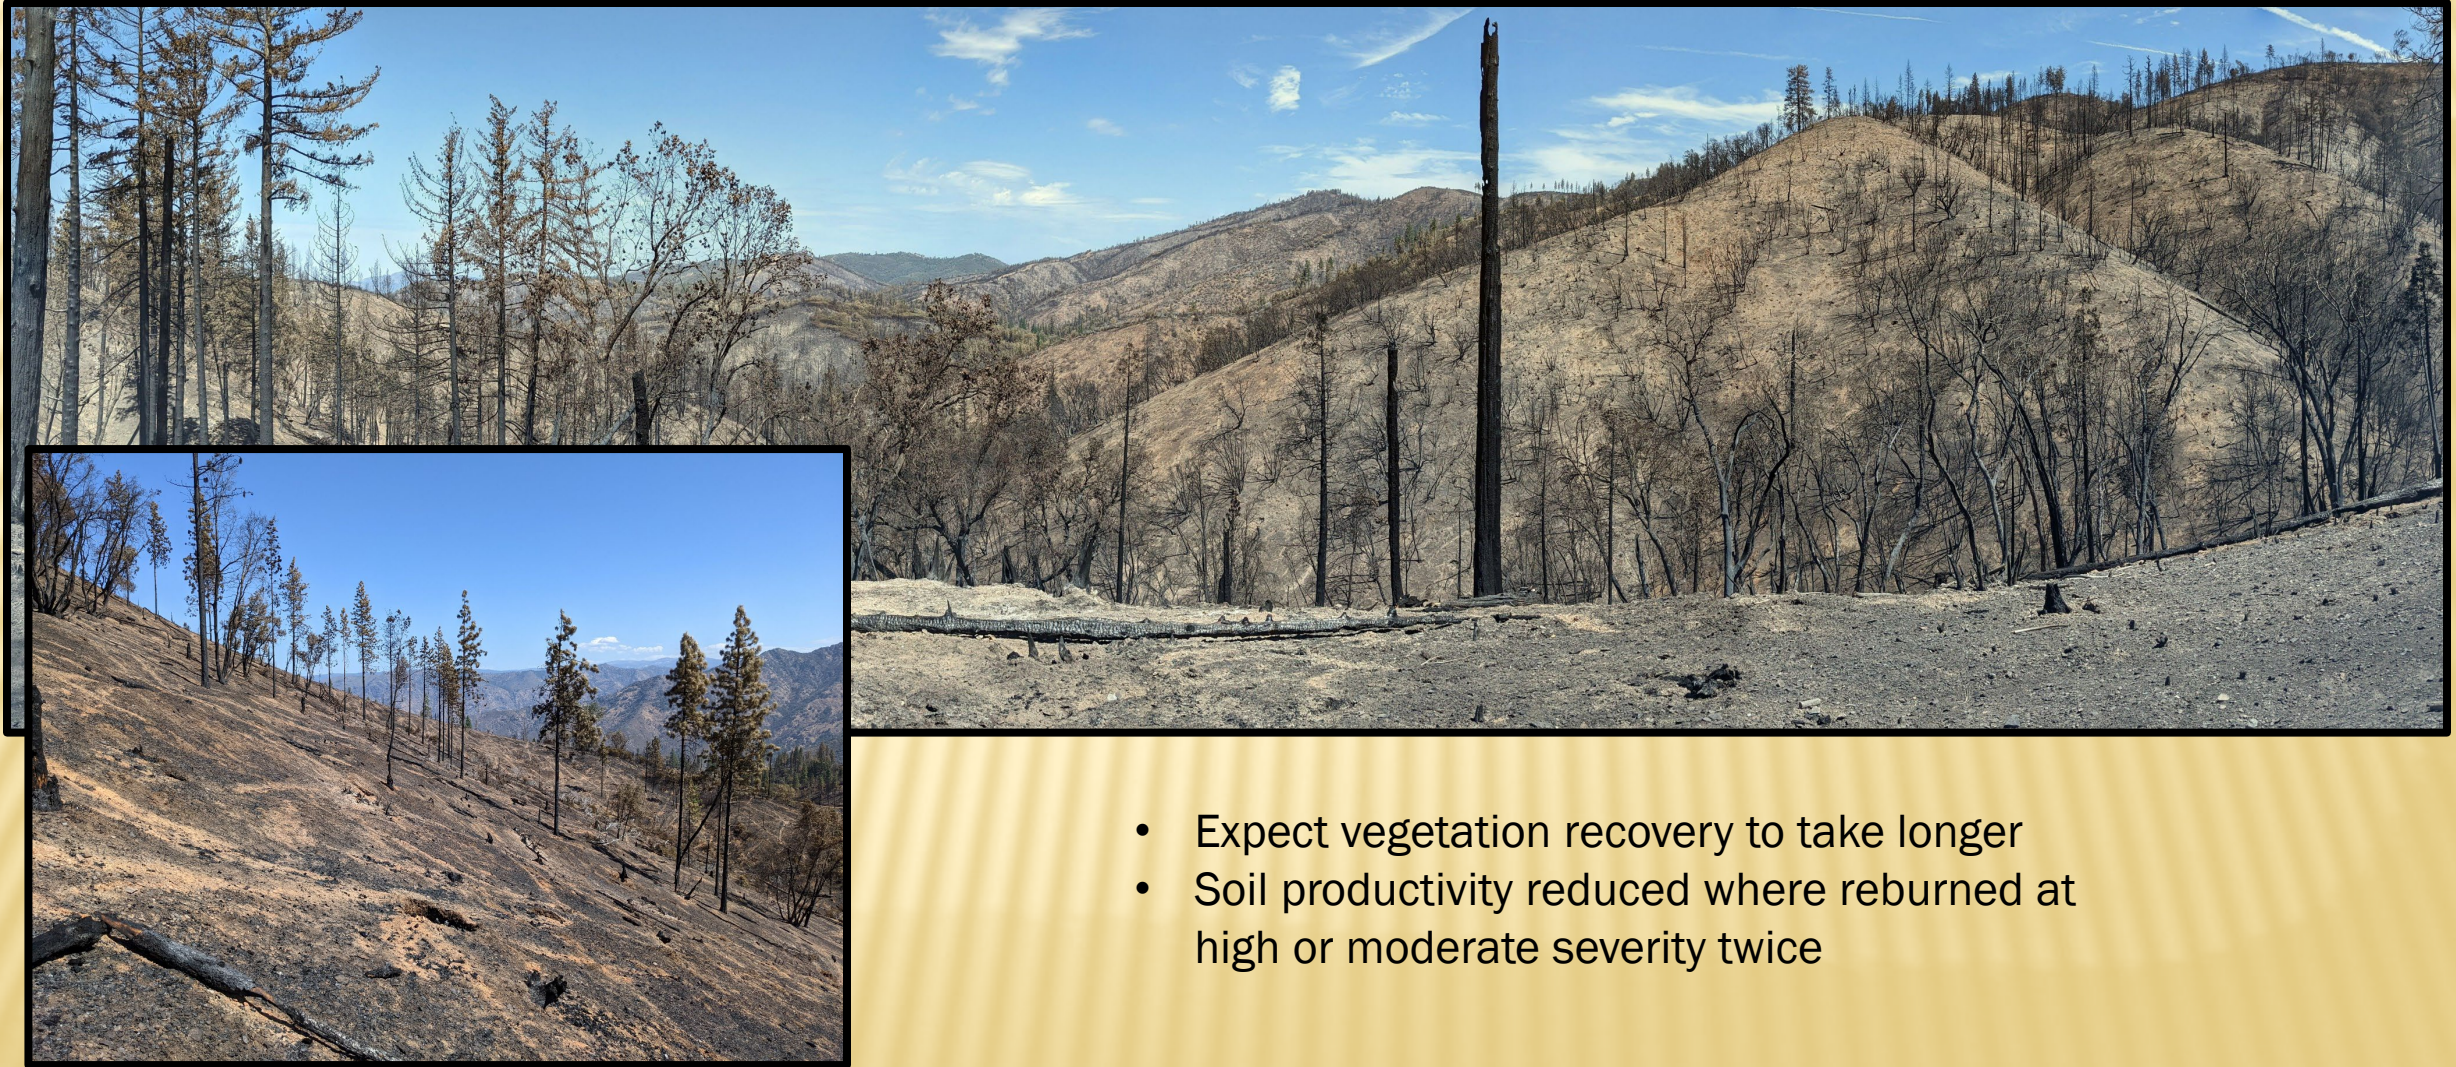
REBURN – CARSTENS AND FERGUSON FIRES

- Expect vegetation recovery to take longer
- Soil productivity reduced where reburned at high or moderate severity twice

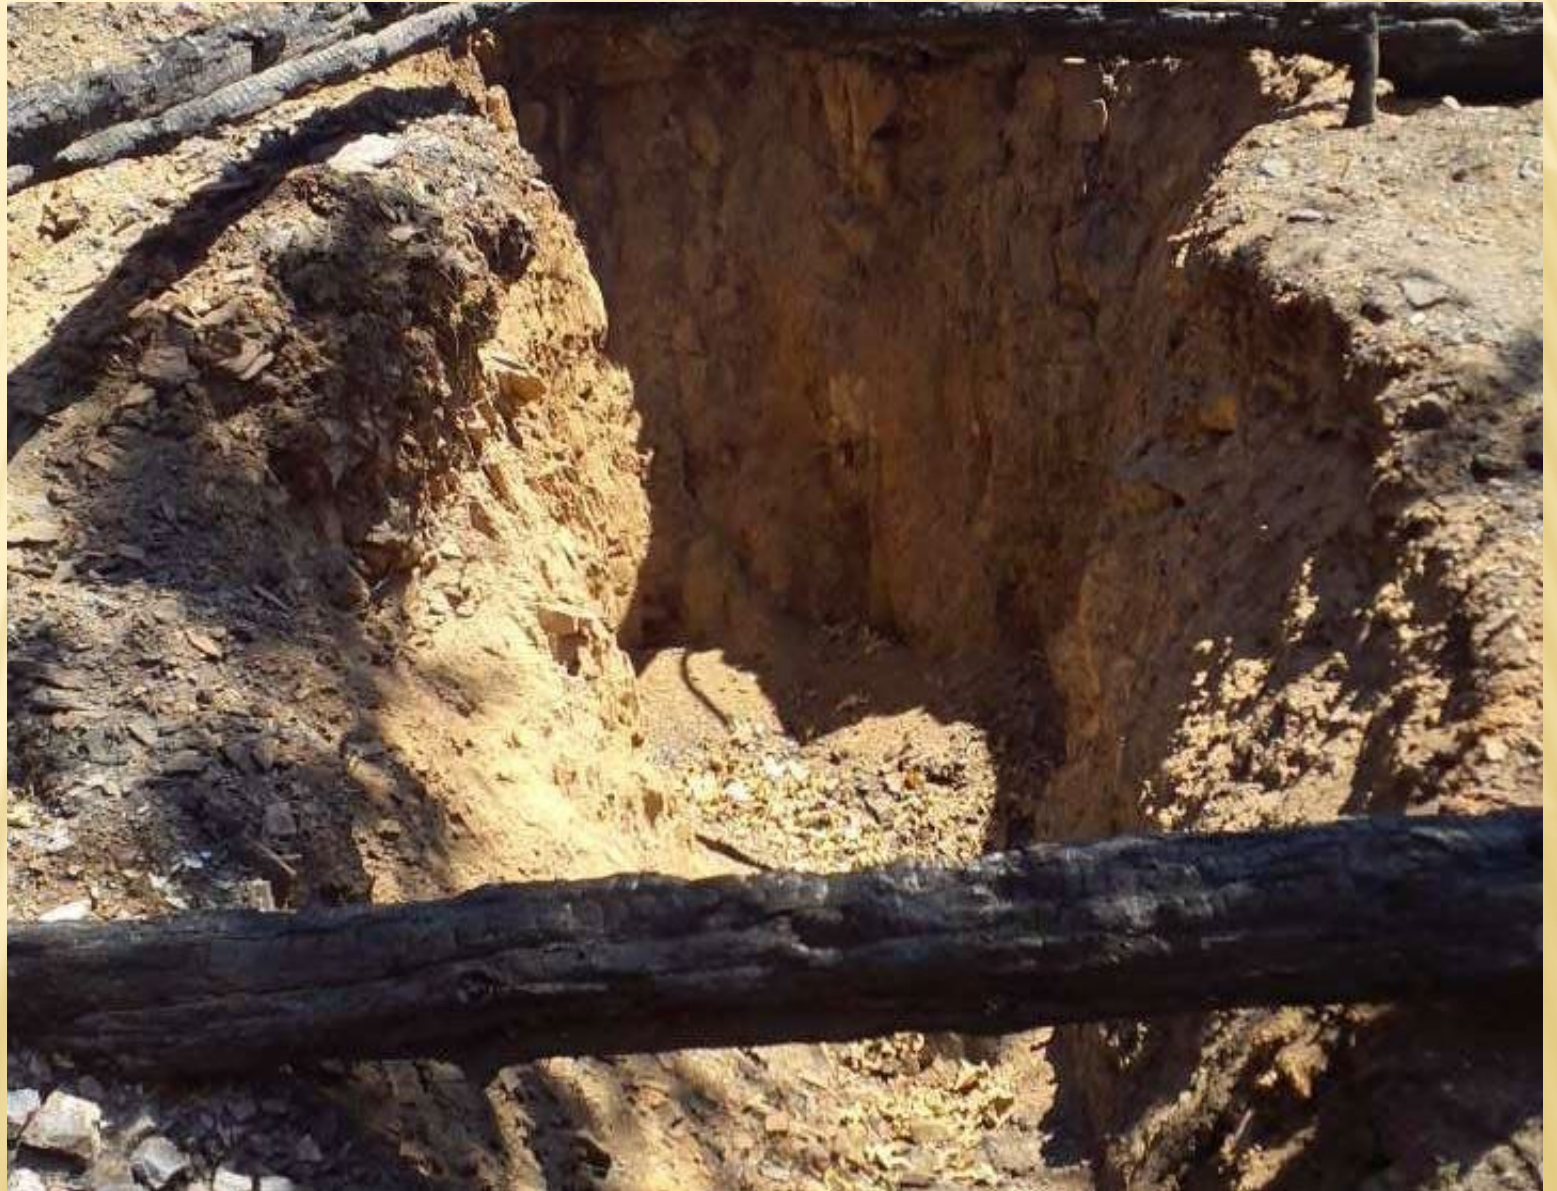
Six adits and shafts at Early and Sweetwater Abandoned Mine sites have been exposed by the fire. Thus presents a threat to Life and Safety to the public visiting the site. Propose fencing around the openings with hazard warning signs to protect the public from accidental injury.

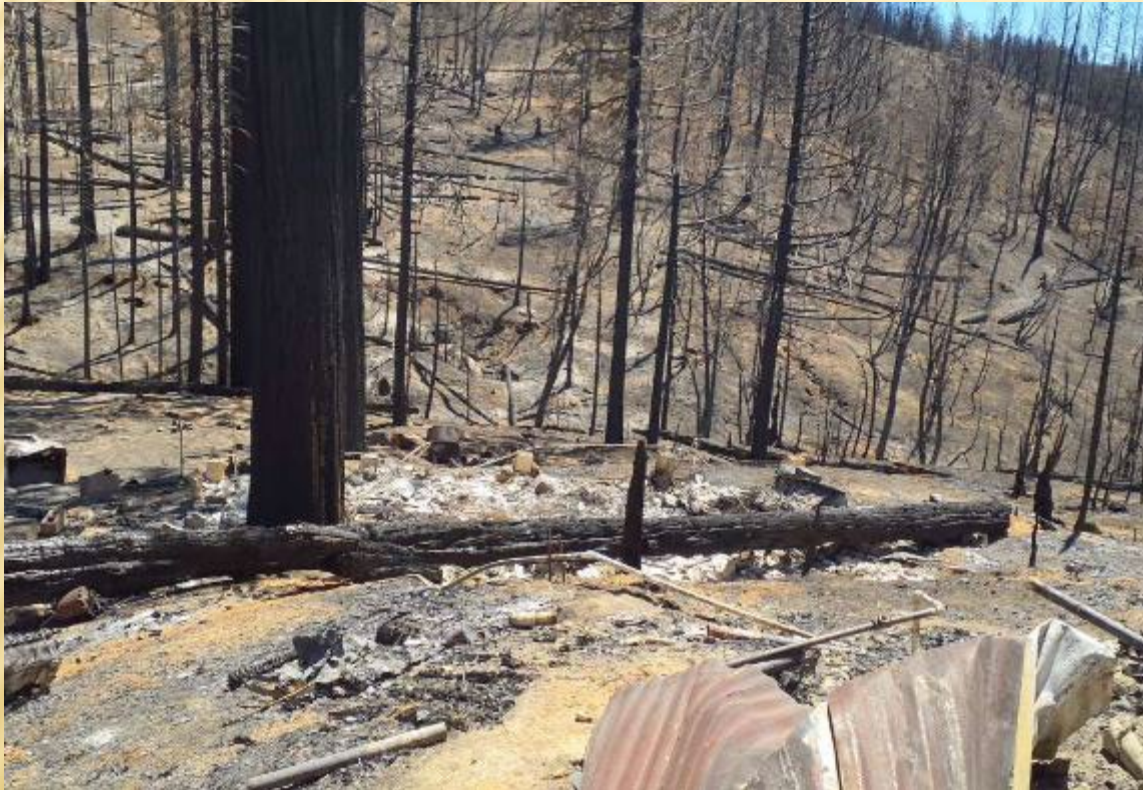
Burned Mine Site - Early Mine threat of hazmat refuse release to Forest Service lands

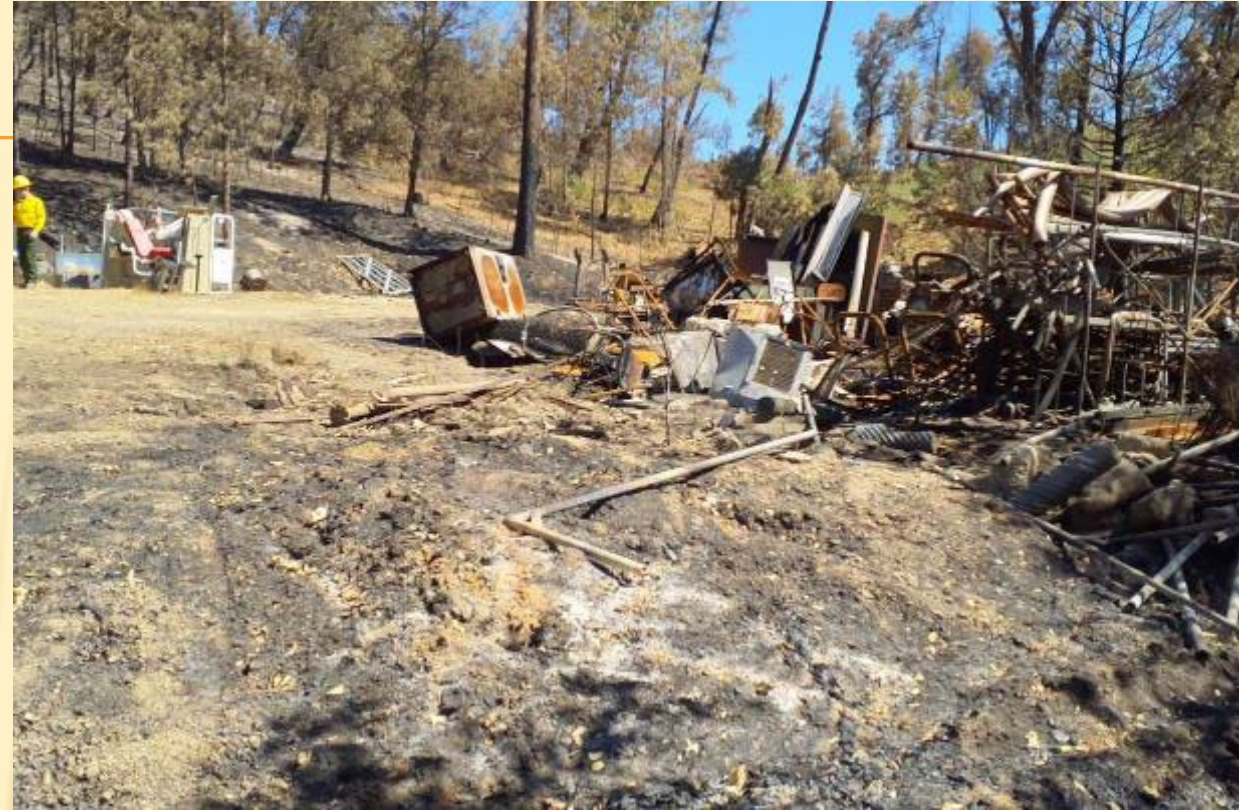
Jerseydale Work Center burned buildings with hazmat refuse

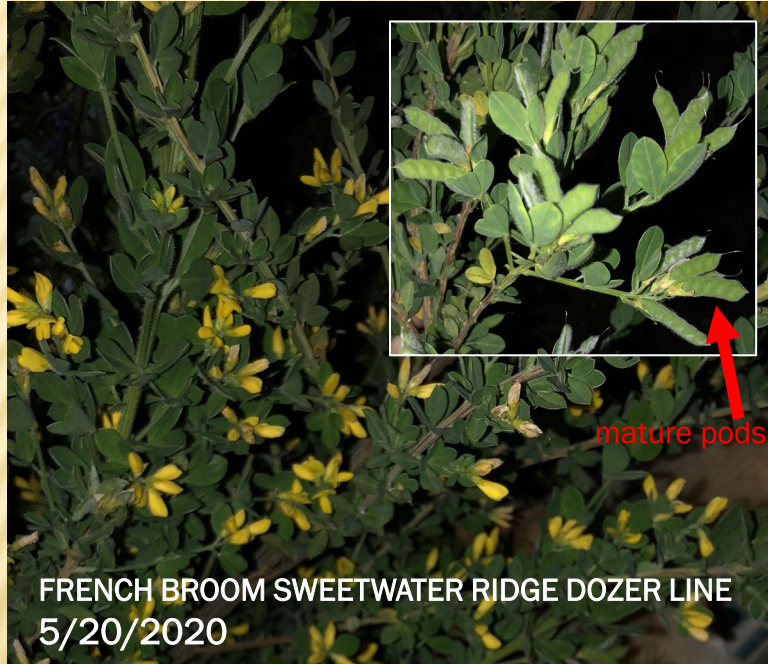
Repeatedly dozed since 2018 (Ferguson, Briceburg, Oak). Seeds were likely transported to new sites, firelines, and other suppression features.

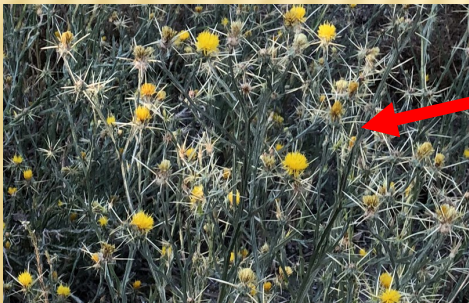
Yellow starthistle at Jerseydale helipad was dozed through

- Hire a contractor to spray the yellow starthistle at the dozer line by Jerseydale helipad (and new infestations that arise as a result at admin site).
