Pacific Southwest Region, San Bernardino National Forest | September 2022

**Burned Area Emergency Response (BAER)
Watershed Response Report Summary**

**Fairview Fire
(CA- RRU-129712)
Riverside County, California**

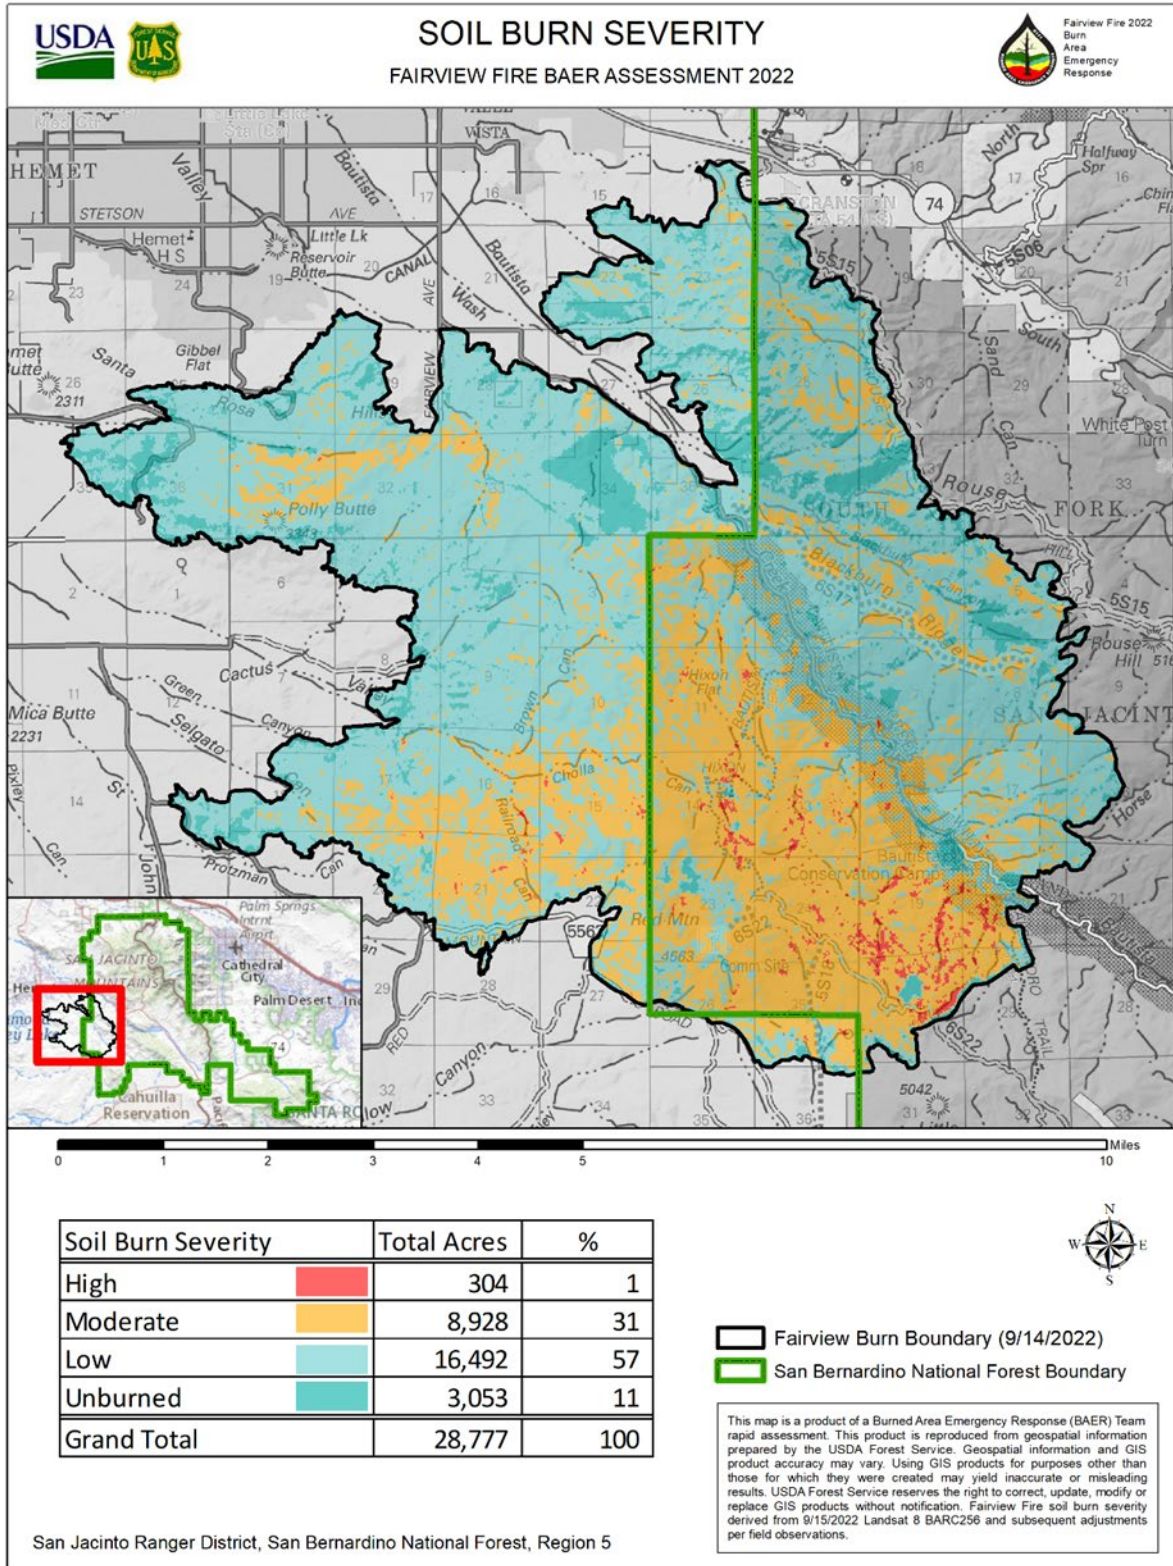
Map 1- Soil Burn Severity

Low soil burn severity makes up most of the burned area at 57%. In areas with low soil burn severity effective ground cover is mostly consumed, however pre-fire ground cover was very low. Litter may still be recognizable. Ash color is black, and the ash depth is no deeper than 2 centimeters. Ash is very patchy and discontinuous across the burned area. Roots and soil structure are unchanged. Strong hydrophobicity was observed in low soil burn severity areas. Vegetation mortality is approximately 75-100%.

Moderate and high burn severity areas showed 20% or less remaining effective vegetative ground cover. Vegetation mortality in the moderate and high soil burn severity ranged from 40 – 100% across both the Forest and Chaparral vegetation types. Moderate to strong hydrophobicity was encountered in these areas. Other soil characteristics common to areas with moderate high burn severity is charring and consumption of roots from approximately 0 – 3 inches and weakening of soil structure in the surface.

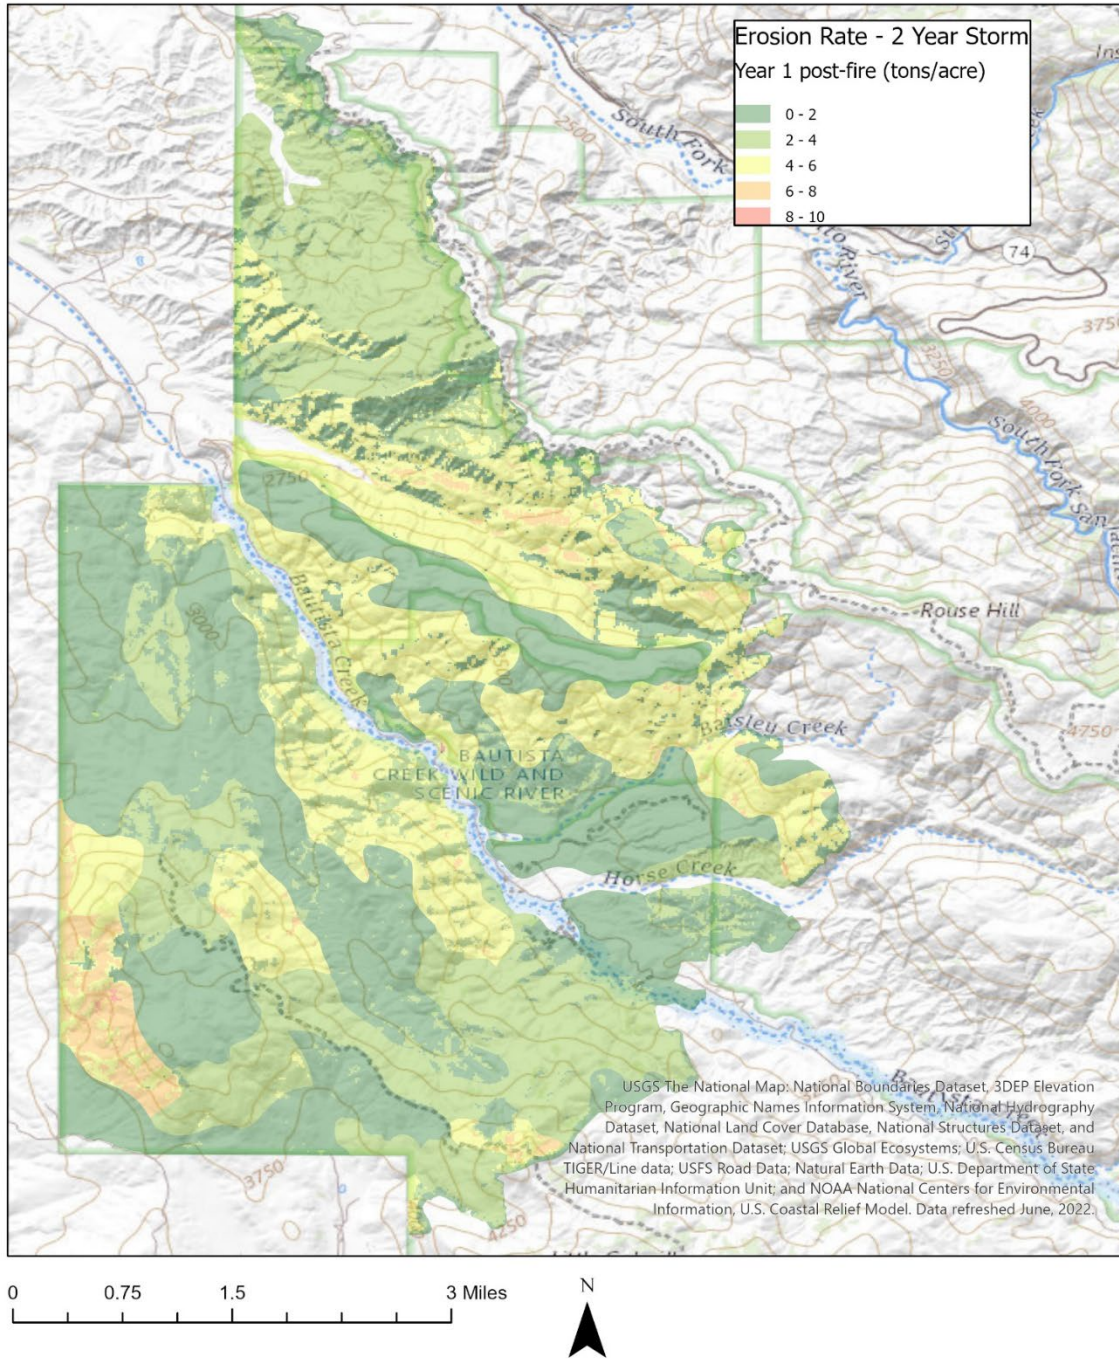
Map 2- Fairview Fire Erosion Potential. Erosion rates displayed in the map are associated with the 2-year storm in year 1 post-fire. Units are tons per acre.

Erosion rates are for a 2-year storm modeled across soil map units on NFS lands. Reported erosion rates (ERMiT) are associated with the 2-year storm (50% probability). An approximately 2.87" storm total precipitation with 4-hour duration. Riparian (alluvial) map units were not modeled in ERMiT. See Table 4 below that displays estimated soil erosion /hazard rates.

Table 4. Soil Erosion Hazard Rating		
Rating	Acres	Percent of Fire Area
Severe	12,200	88
Moderate	1,193	9
Low	8	<1
Not Rated (Rock Outcrop)	447	3
<i>¹Acres are an estimate based on soil survey coverage and area assessed by soil burn severity. ²Soil Erosion Hazard (Road, Trail) ratings are shown in table. Map units do not have a rating for Soil Erosion Hazard (Off-road, Off-trail).</i>

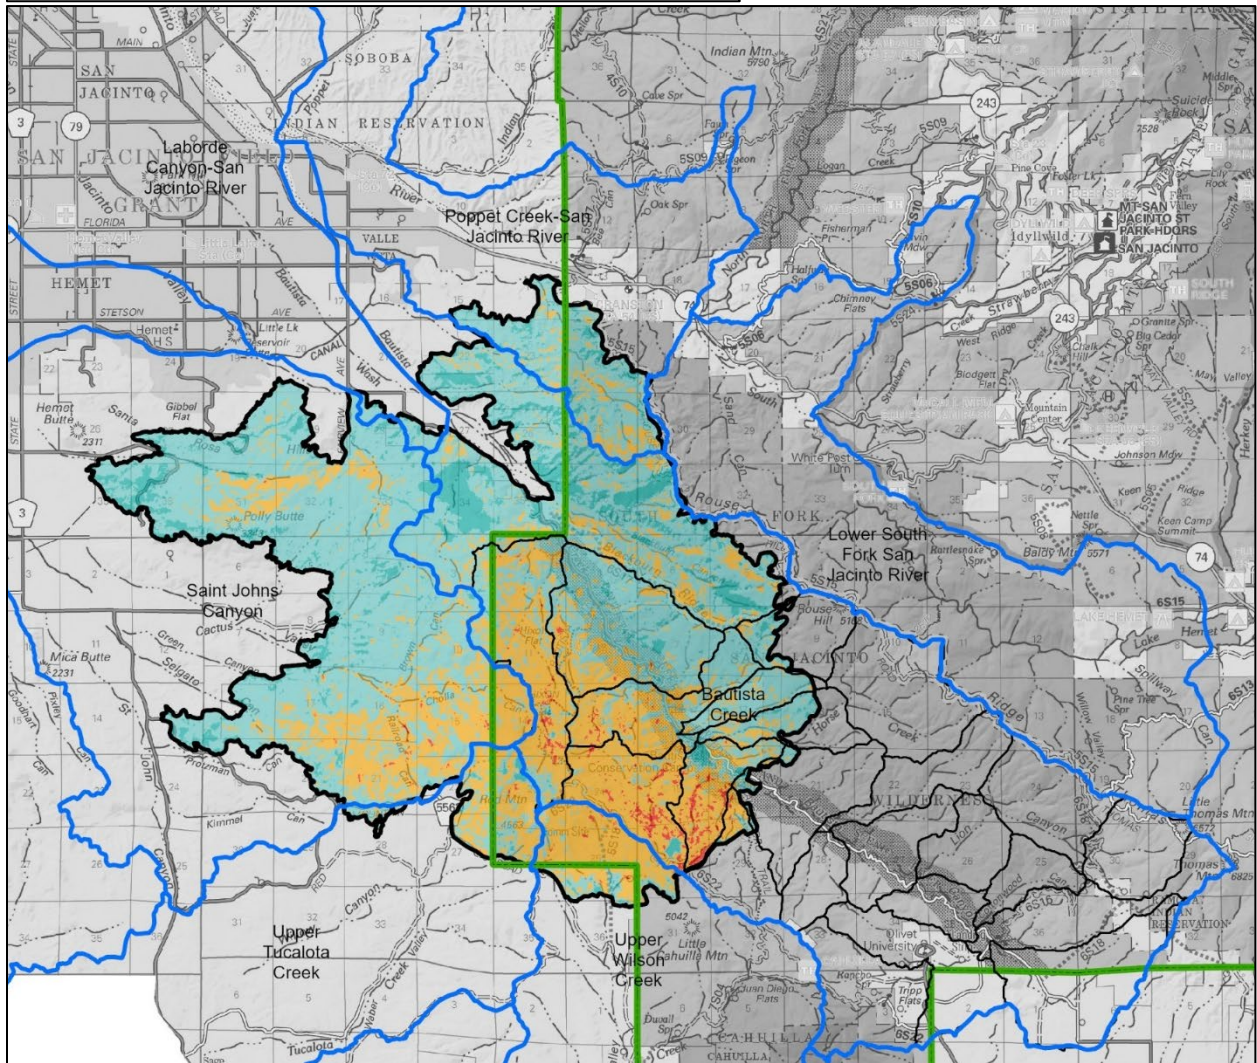
Map 3- Watersheds on National Forest

Runoff from the 2-year, 6-hour frontal storm (~1.40") was modeled to result in approximately 3 times greater flow than unburned conditions as a function of burn severity distribution throughout the watersheds.

Runoff from the 5-year frontal storm (~1.85”) was modeled to result in approximately 1.3 times greater flow from unburned conditions. The decrease in percent change as recurrence intervals lower in probability is due to increased precipitation depths resulting in higher peak flows instead of curve numbers dictating the model outputs.

Overall, moderate severity burn within the chaparral vegetation type throughout the watershed will result in significant increase in hydrologic response. However, the lack of a deep litter layer present in chaparral vegetation types lowers pre to post fire response. Although hydrologic response will increase, there will likely not be any long-term changes to stream morphology or departure from the watershed’s historical natural hydrograph.

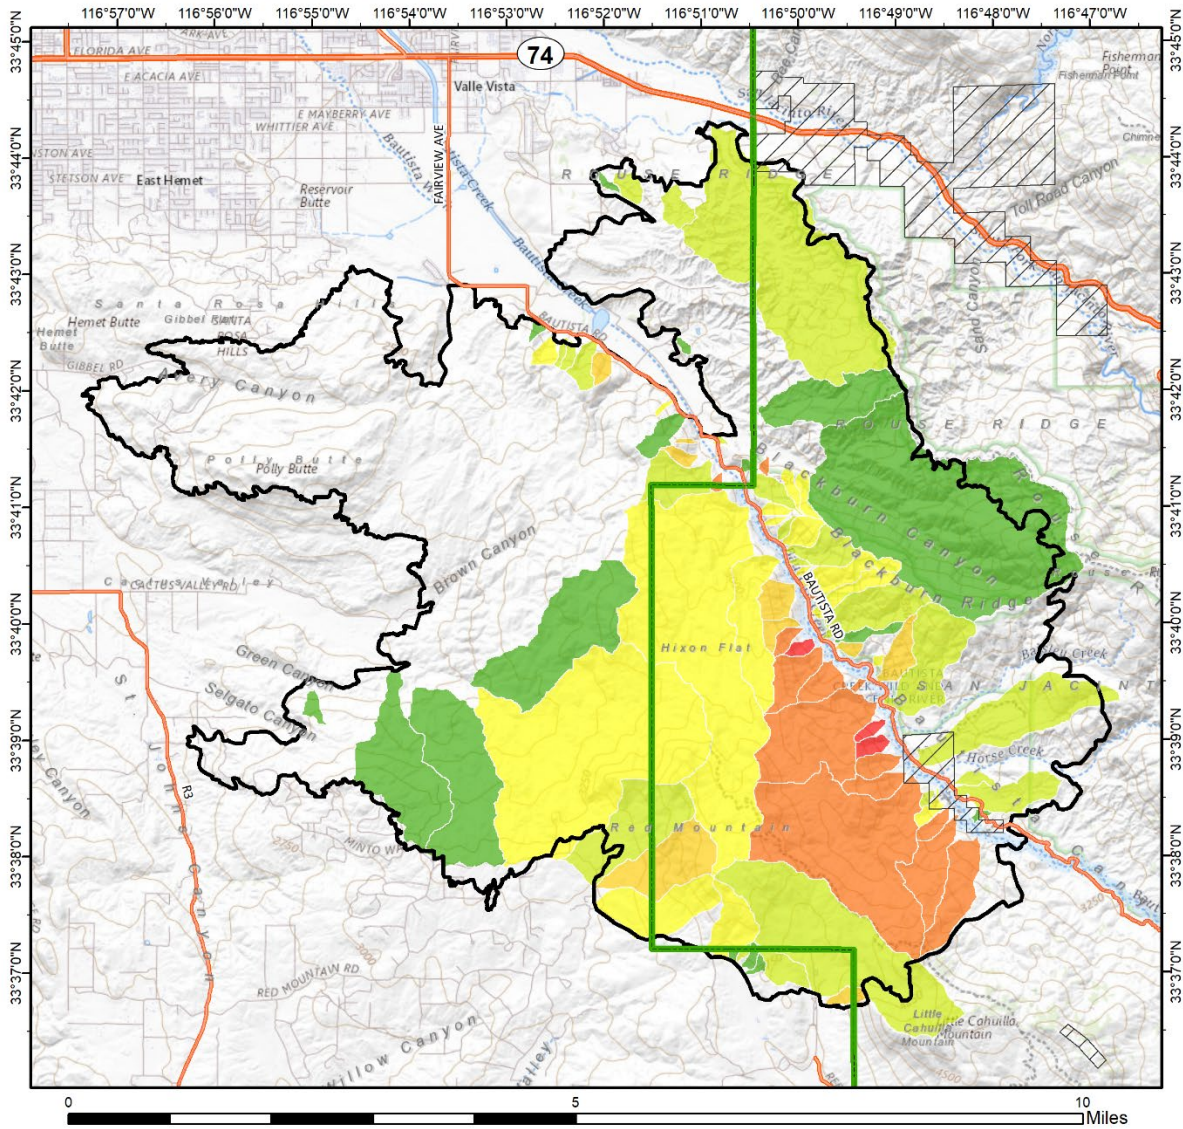
Map 5-1-Year Estimated Rainfall Threshold - 50% Probability, 15-Min storm intensity

Most of those drainages located in the southeast corner of the fire (which are represent a high combined hazard) require rainfall rates of 20-24 mm/hour (0.78-0.94 inches/hour) to exceed a 50% likelihood of debris-flow initiation. A few smaller drainages in that area require a smaller amount of rain, 16-20mm/hour (0.63-0.78 inches/hour) to exceed a 50% likelihood of debris-flow initiation. Most other areas impacted by the fire require high rainfall intensities (28mm/hour (0.94 inches/hour) or higher) to exceed a 50% likelihood of debris-flow initiation.

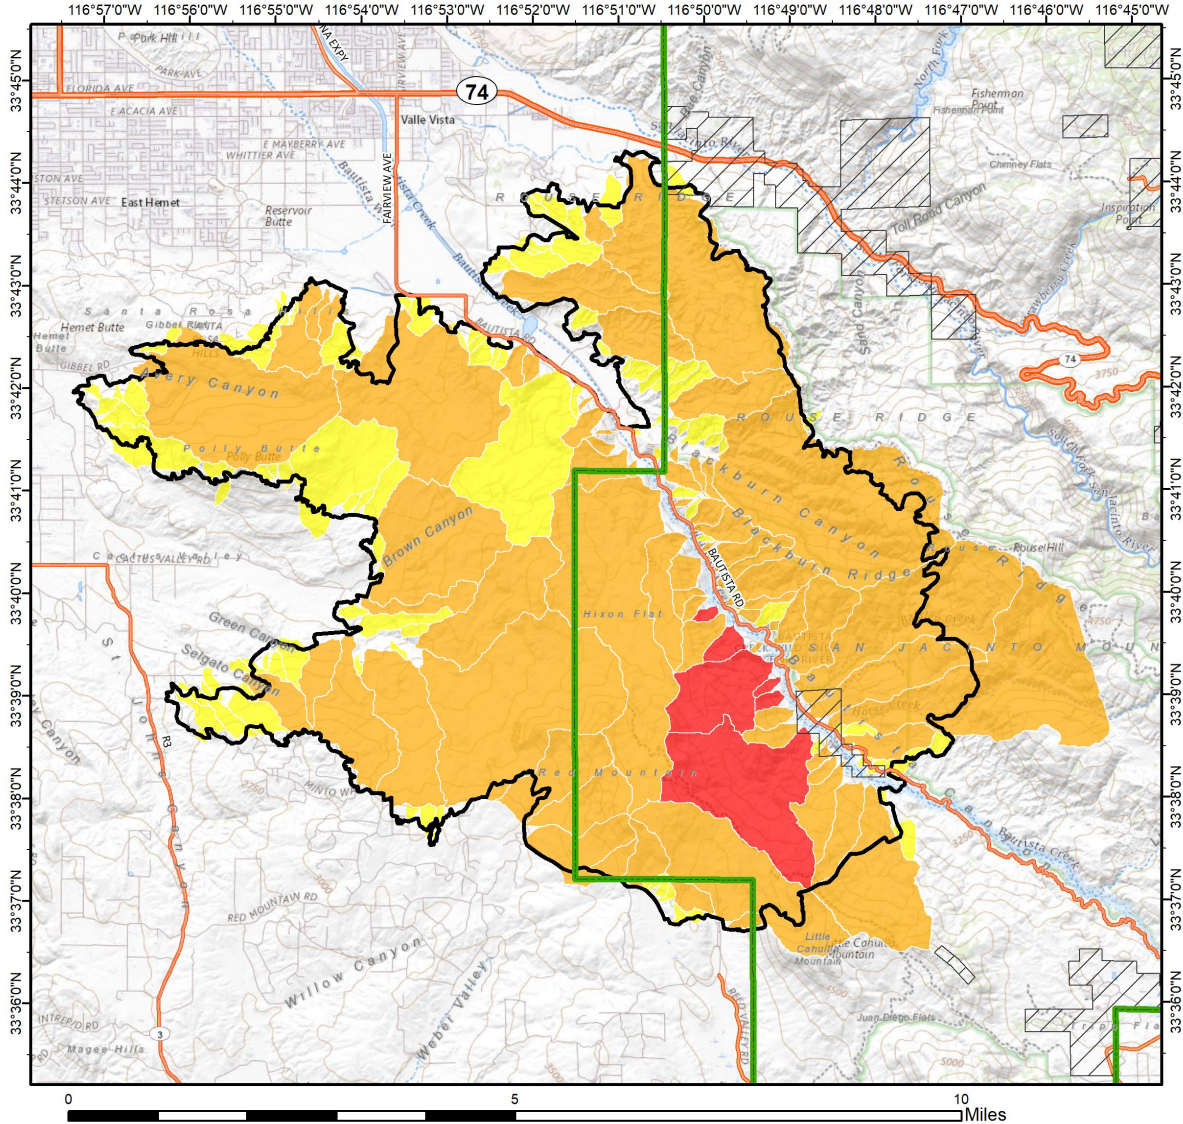
Map 6- Debris flow combined hazard

Based on USGS debris flow modeling it appears that under conditions of a peak 15-minute rainfall intensity storm of 28 millimeters per hour (1.1 inches/hour) corresponding to a 1-year storm, most of the drainages in the southeast corner of the burn scar (Between Bautista Canyon, Red Mountain and the southeast boundary of the fire) are predicted to initiate debris flows with moderate (40-60%) to high (60-80%) probability, including a few drainages with very high (80-100%) probabilities. These drainages for the most case are un-named drainages flowing to the north and northeast into Bautista Canyon. Most other drainages in the burn scar are predicted to initiate debris flows with relatively low probabilities of 0-20% or 20-40%. Under this same magnitude of storm, predicted volumes in most of the main channels impacted by the Fairview Fire range from 1K-10K cubic meters. Most of the side channels feeding into these main channels are predicted to produce volumes of less than 1K (<1K) cubic meters. Just a few drainages in the burn scar are predicted to produce volumes of 10K-100K cubic meters.

Regarding combined hazard, the USGS debris flow model estimates most of the area burned by the Fairview Fire to be under a moderate combined hazard, with exceptions of areas in the west end of the fire presenting a low combined hazard, and some drainages in the southeast corner of the fire, flowing into Bautista Canyon, presenting a high combined hazard.
