MOSQUITO FIRE

Burned Area Emergency Response Assessment

October
2022

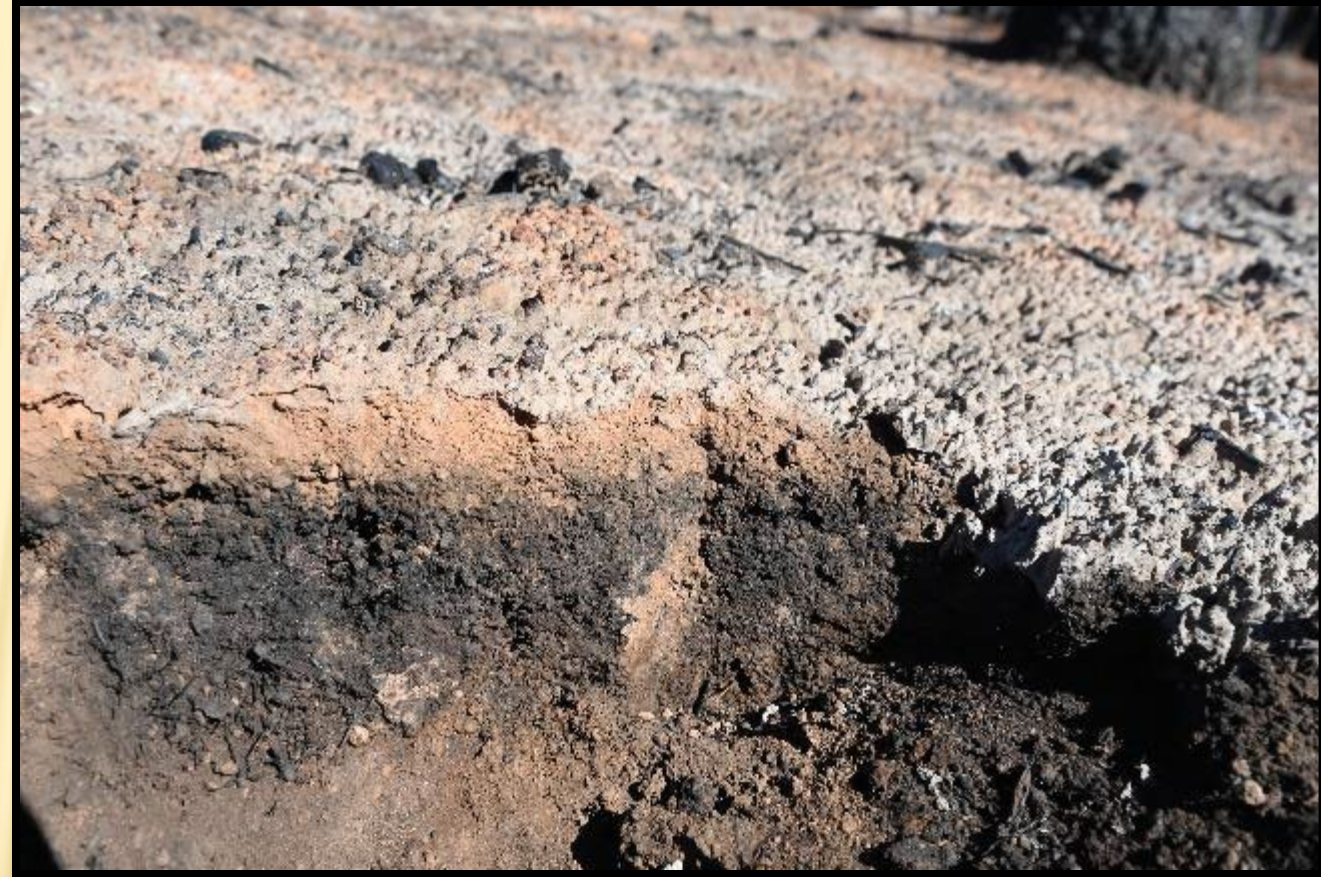
- Loss of soil productivity
 - Loss of topsoil and ecological function.
 - Soils are deep so long-term soil productivity loss is not expected.
- Majority of the fire area was a healthy understory burn.
- Oddly, the highest burn severity occurred in an 8-year-old plantation (photo right). The soil scientist speculates the overstory removal facilitated increased drying of the highly decomposed soil organic material allowing for higher soil temperatures.

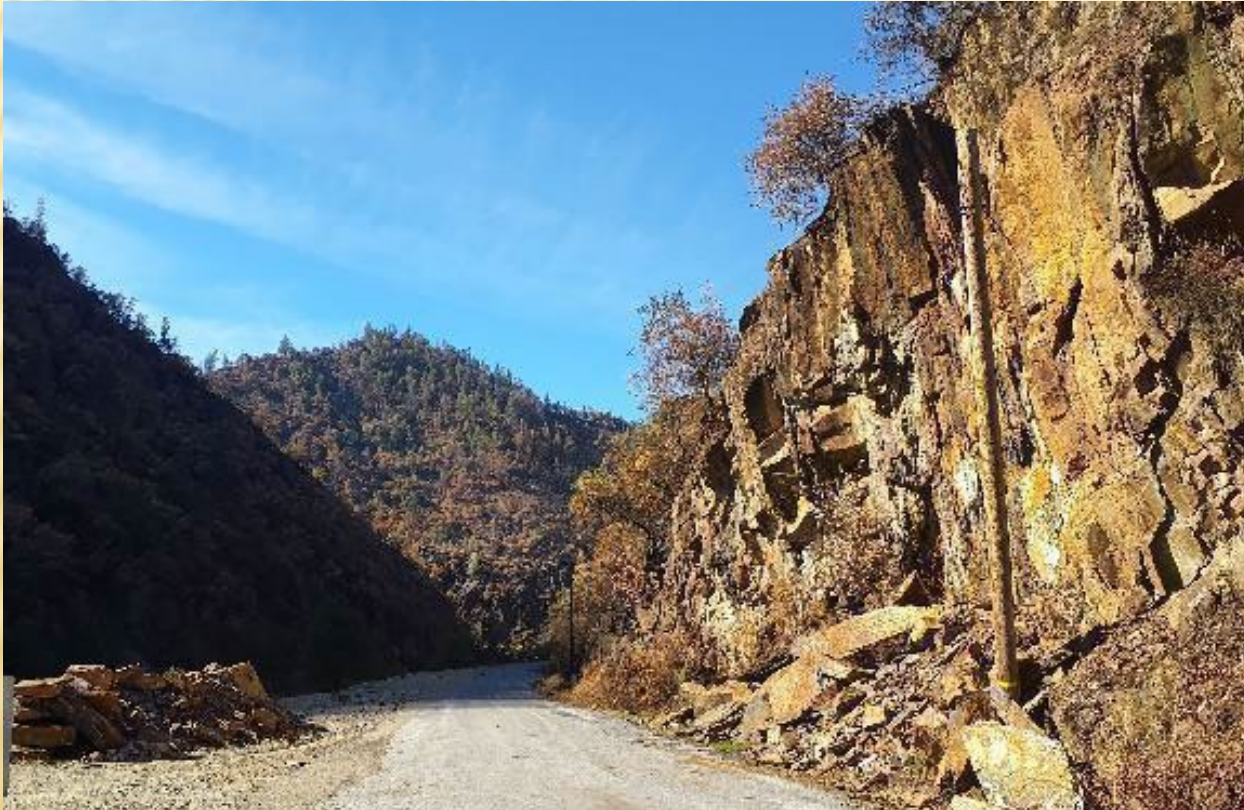
Rockfall on Blacksmith Flats Road from Mosquito Ridge Road to Ralston Reservoir

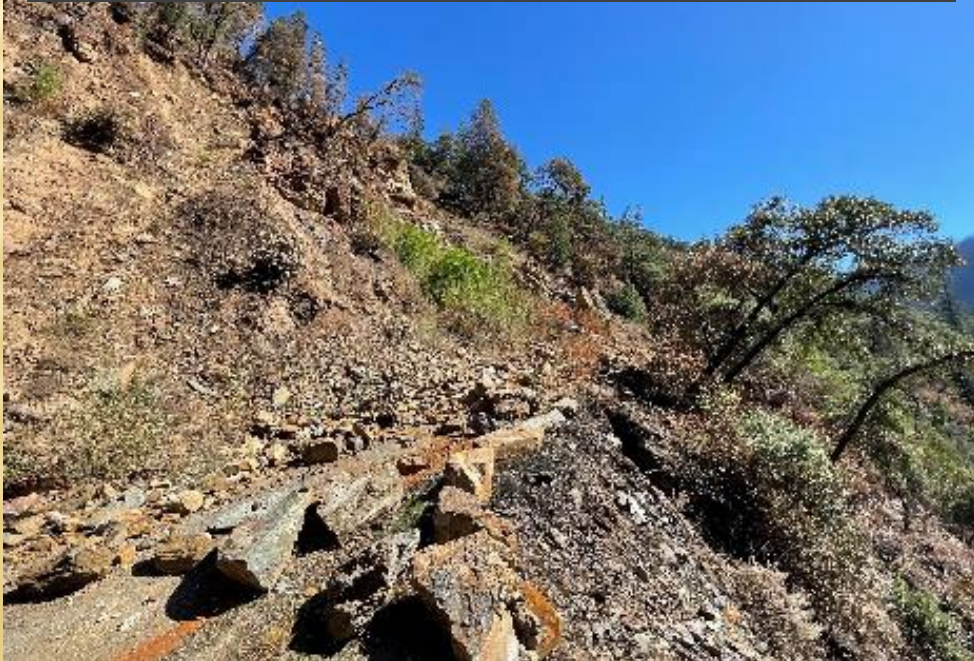
Existing landslides along Blacksmith Flat Road

Rockfall signage and road closures recommended

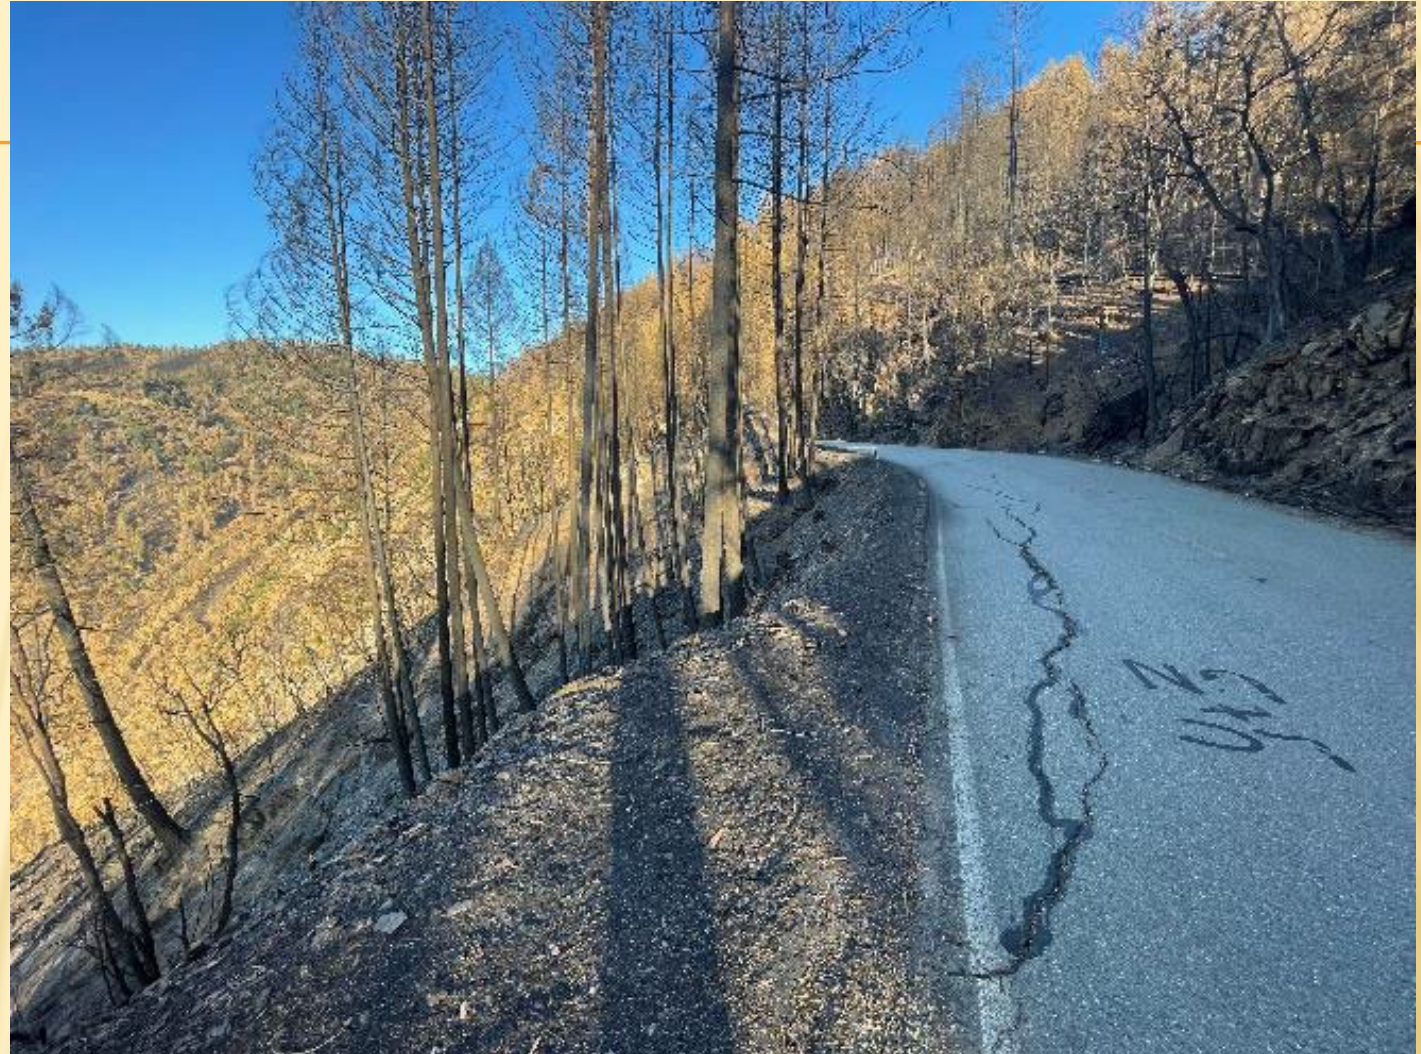
Mosquito Ridge Road on landslide-prone slopes

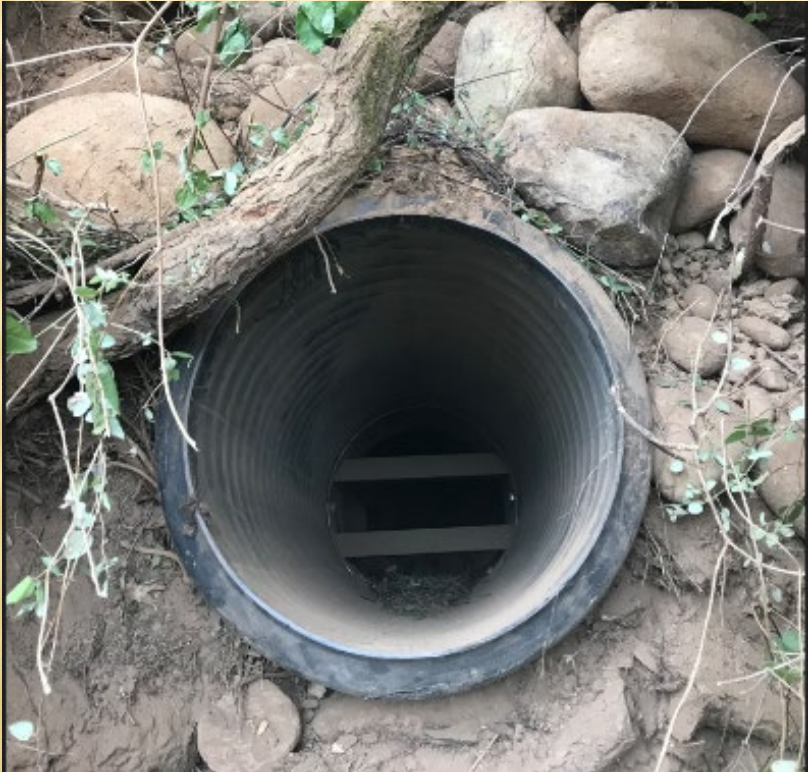
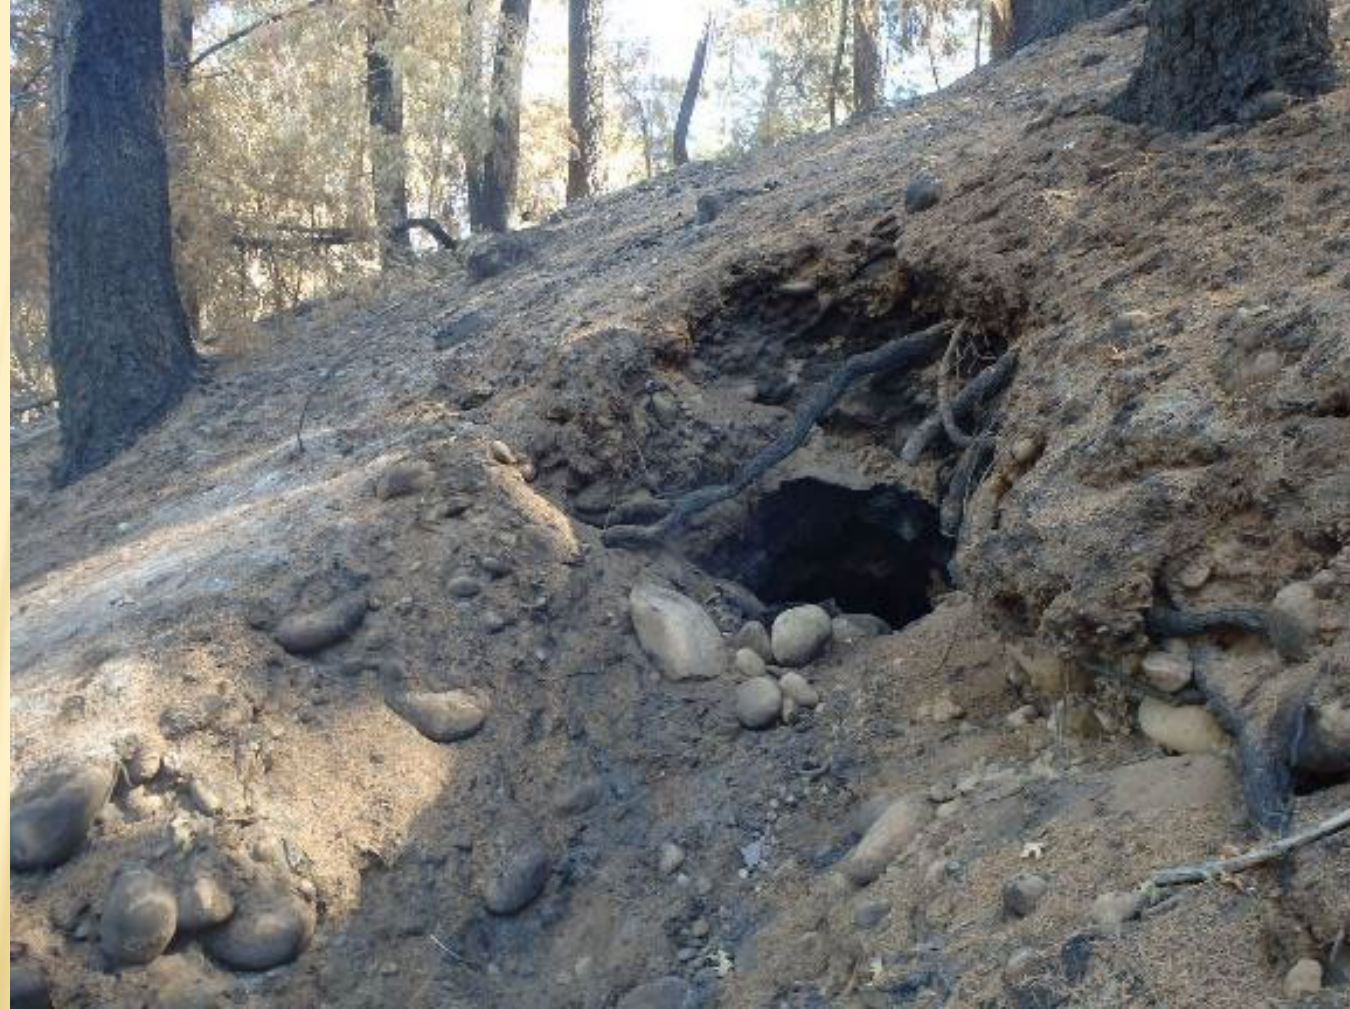
Cash Rock Adit Bat Culvert 1 before (left) and after (above) the fire.

- Install bat-friendly metal culvert gates into the 3-adit portals.
- Close the Cash Rock mine shaft with a Polyurethane foam (PUF) plug.
- Install 2-bat gates
- Install a temporary fence and post warning signs around 1-abandoned water well and 7-hazardous mine openings

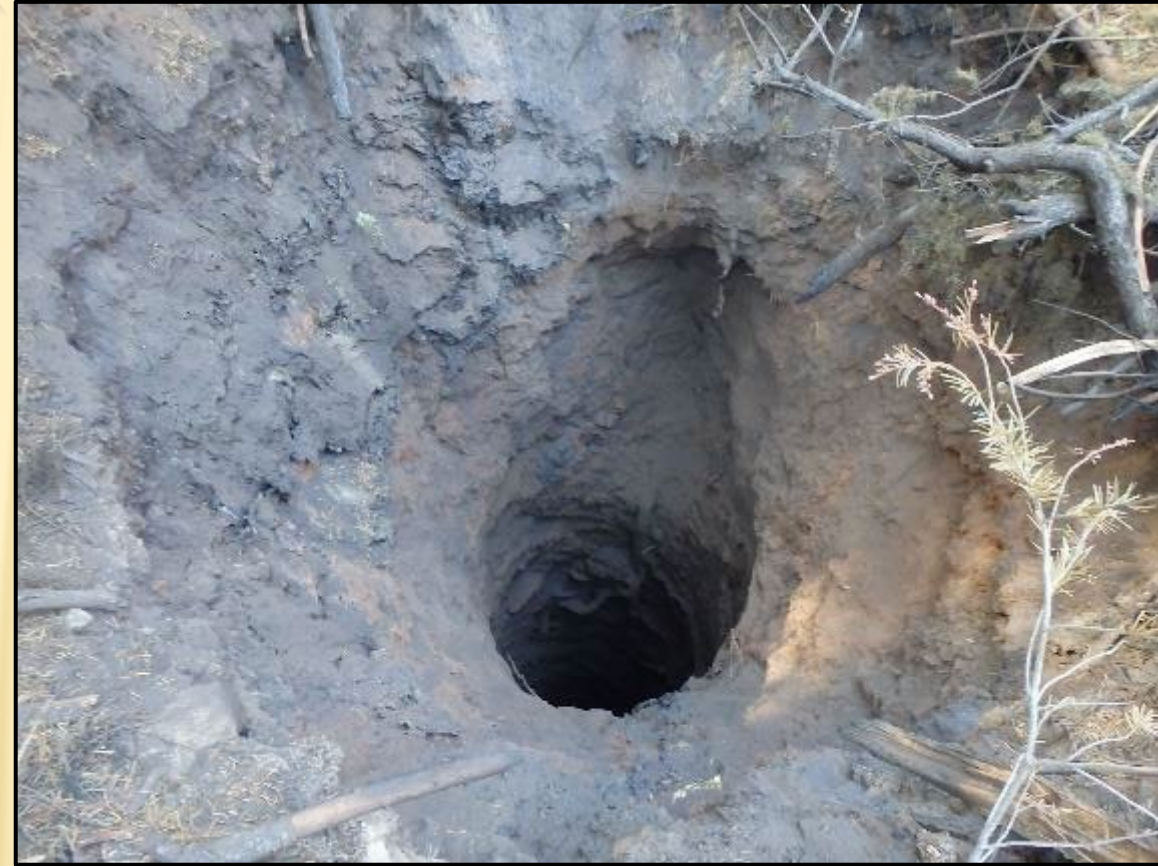
Cash Rock Mine Shaft near Volcanoville

- Injury or loss of human life from one vertical (shaft) and nine horizontal (adits) underground mine hazards.
- Human disturbance of bat habitat causing infection of white-nose syndrome, a disease of hibernating bats.

Overall Risk: **High** to **Very High**

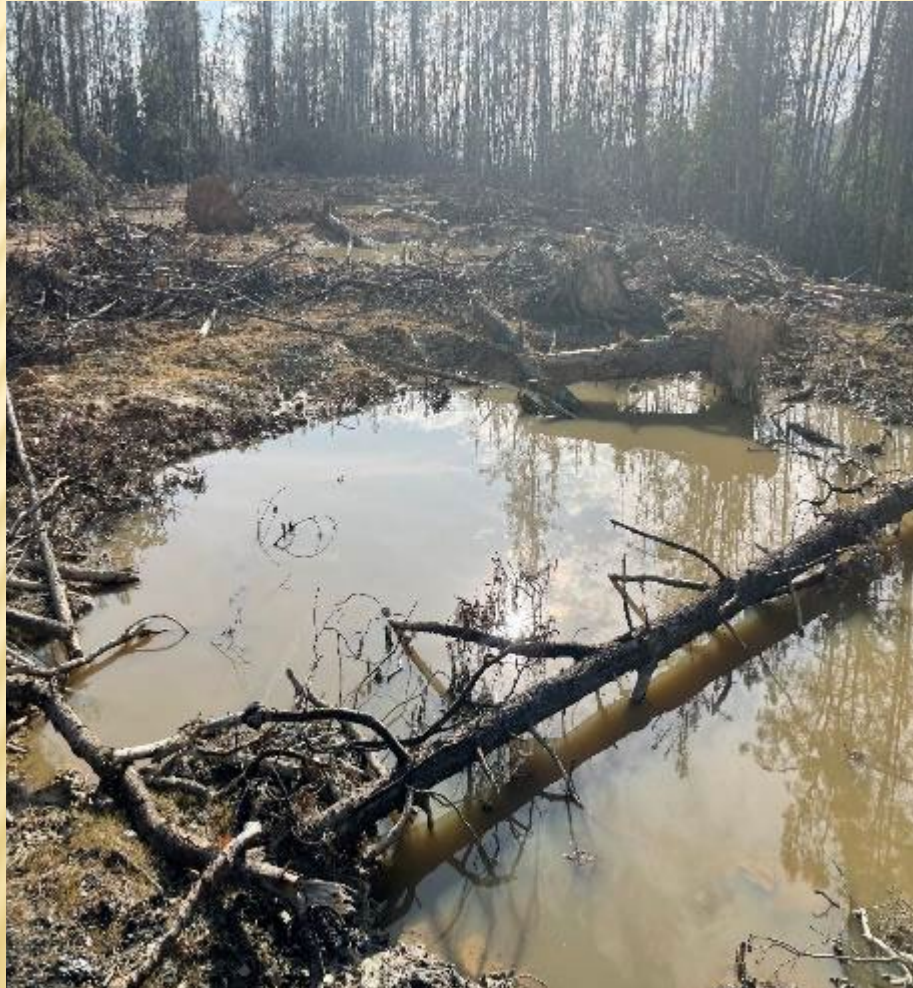
Wetland #17 Pre-Fire (Notice the Large Woody Material-LWM)

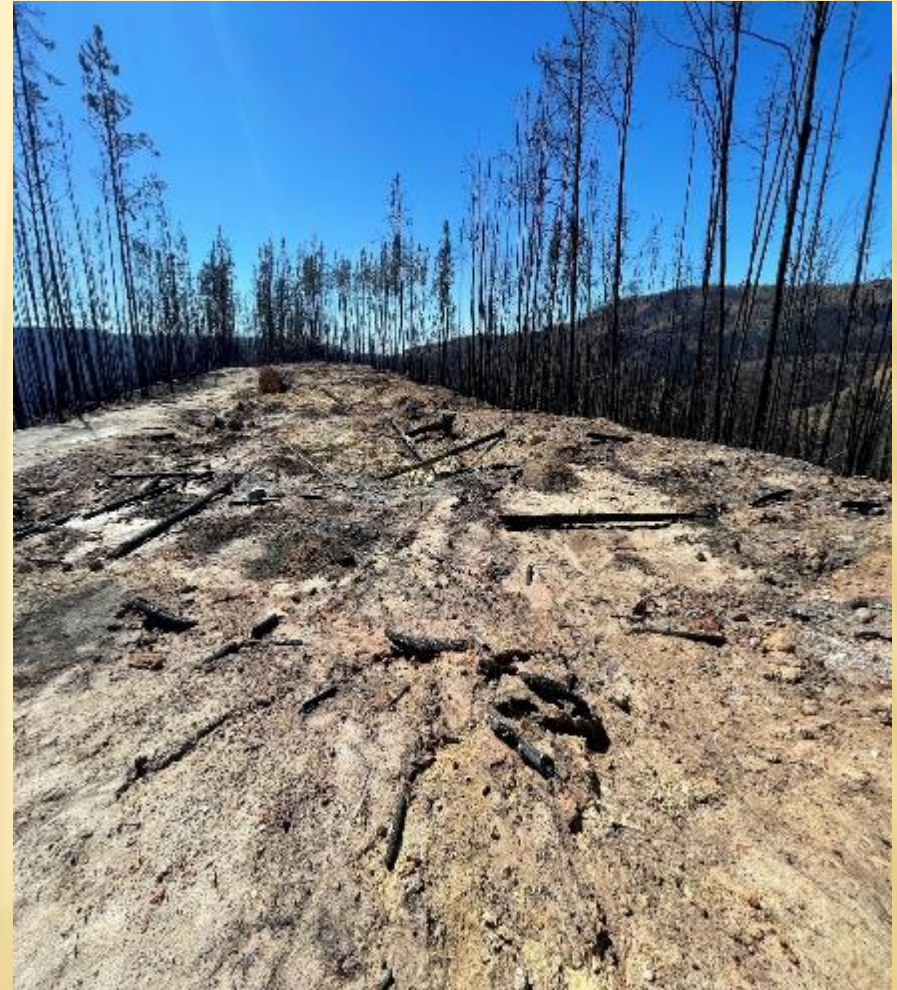
Wetland #17 Post-Fire (Notice LWM completely denuded)

- Sedimentation (pool filling and impaired breeding)
- Decreased water quality

- Probability of damage to DCH is likely
- Magnitude of consequences is moderate
- Risk is high = emergency

Possible treatments such as water bars and wood mulch will reduce sediment and ash input into the suitable habitat

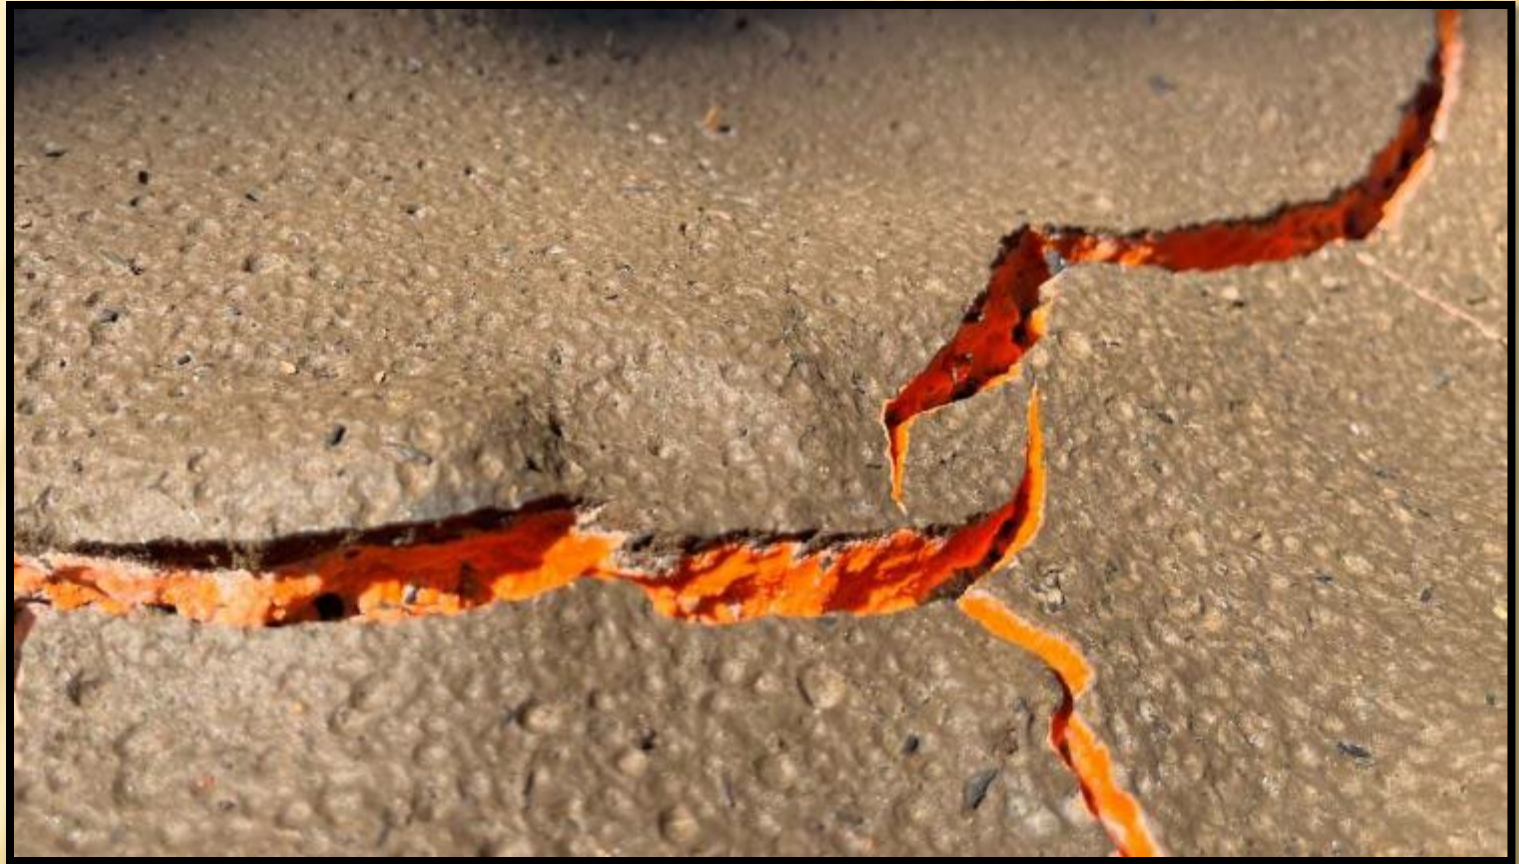
The photo to the right is the first sign of soil healing in the Mosquito Fire following the first rains. The charred vegetation feeds the molds and fungus causing rapid growth.
