August 22, 2022**OAK FIRE BURNED-AREA REPORT**

A. Fire Name: Oak

F. Forest: Sierra National Forest

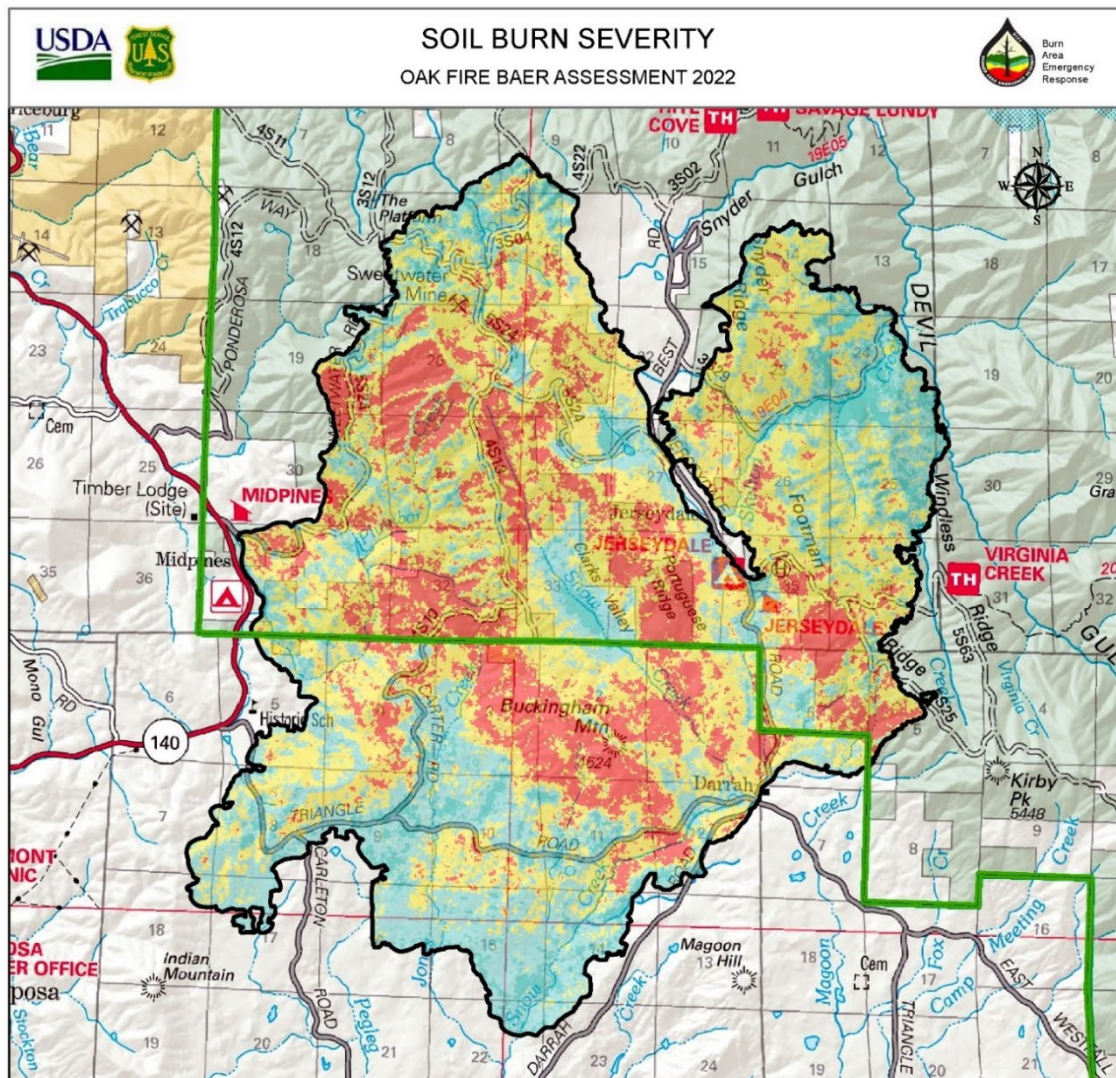
Soil Burn Severity	NFS	BLM	Private	Total	Percent
Unburned	547	2	849	4,003	7
Low	1,763	13	3,503	8,800	27
Moderate	4,570	17	4,213	5,279	45
High	2,324	23	1,656	1,397	21
Total	9,204	55	10,221	19,480	100

Oak Fire Soil Burn Severity :				Acres of Soil Burn Severity by Land Ownership		
Soil Burn Severity	%	Total Acres (Approx.)	USDA Forest Service	Bureau of Land Management	Private	
High	21	4,003.41	2,324.07	23.46	1,655.88	
Moderate	45	8,800.17	4,569.92	17.05	4,213.19	
Low	27	5,279.29	1,763.29	12.50	3,503.50	
Unburned	7	1,397.42	546.97	1.83	848.62	
Grand Total	100	*19,480.29	9,204.26	54.84	10,221.20

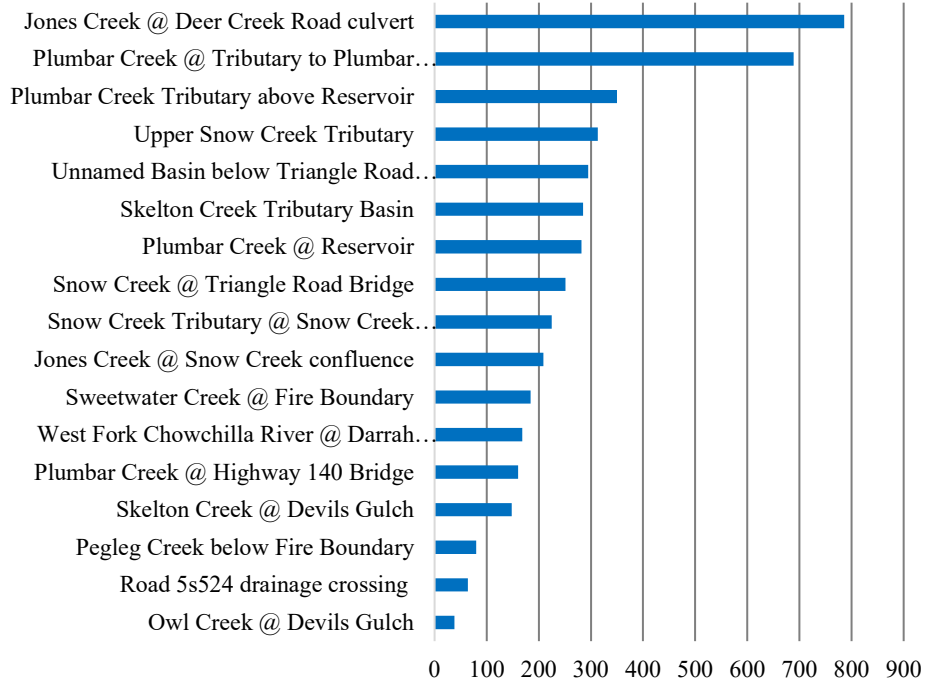
Post-fire 2-Year Peak Flow Percent Increase

Watershed Response: Hydrologic modeling for post-fire discharge was completed for burned watersheds for design storms of 2-, 5-, 10-, 25-, 50-, 100- and 200-year peak flows (see hydrology report). Because increased watershed response conditions tend to occur during the first five years post-fire, the 2-year (Q2) and 5-year (Q5) peak flow events are of particular concern. Based on results of hydrologic modeling, the watersheds predicted to have the highest post fire watershed response (up to 200 to 300 and above percent flow increases) are within the Plumbar Creek, Snow Creek and Jones Creek watersheds and tributaries (see Figure below). Post- fire runoff and sediment during storm events are likely to create impacts to Forest Road and trail infrastructure.
