HAPPY CAMP COMPLEX FIRES

Burned Area Emergency Response Assessment

September
2023

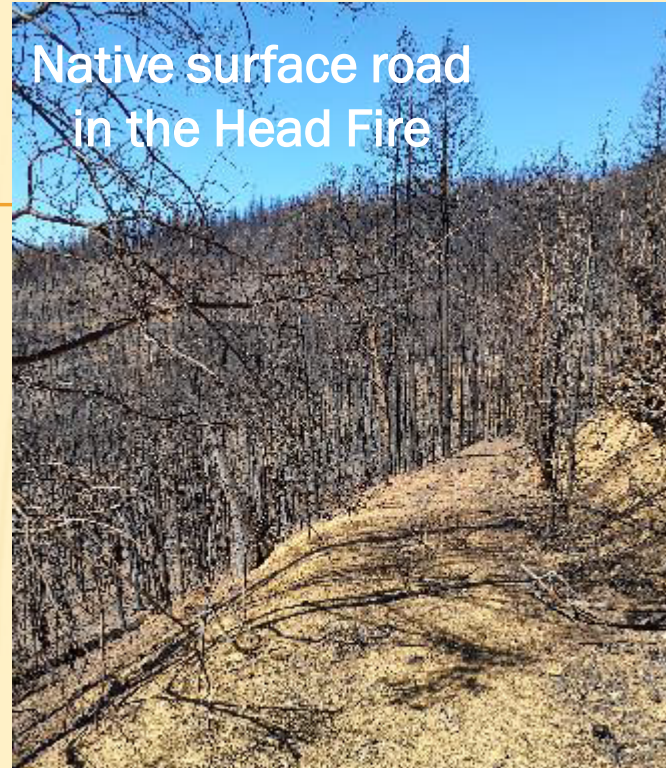
Native surface road
in the Head Fire

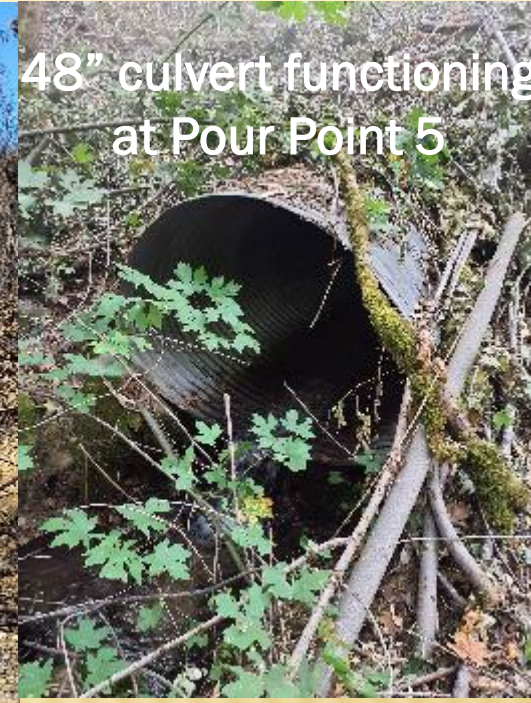
48" culvert functioning
at Pour Point 5

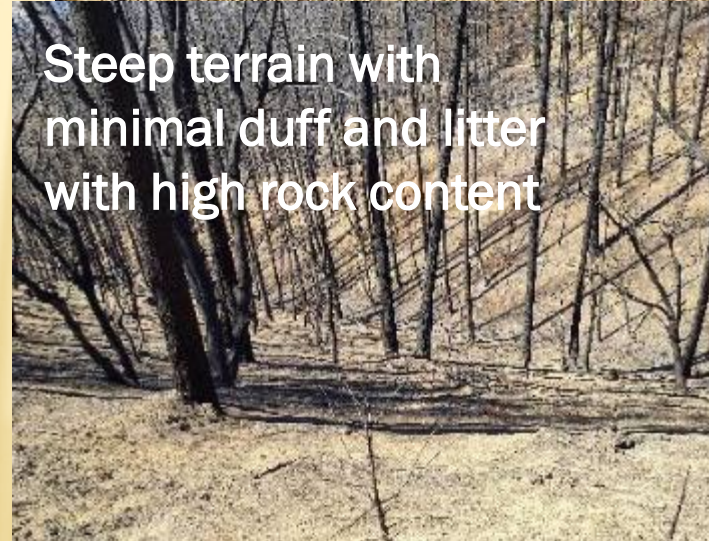
Steep terrain with
minimal duff and litter
with high rock content

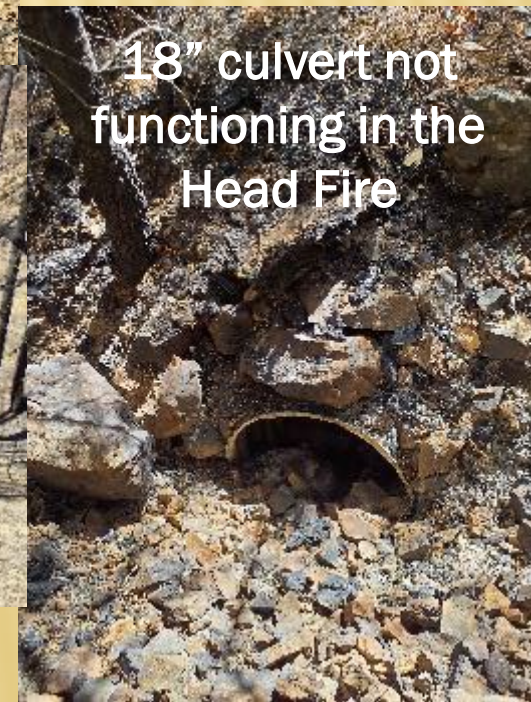
18" culvert not
functioning in the
Head Fire

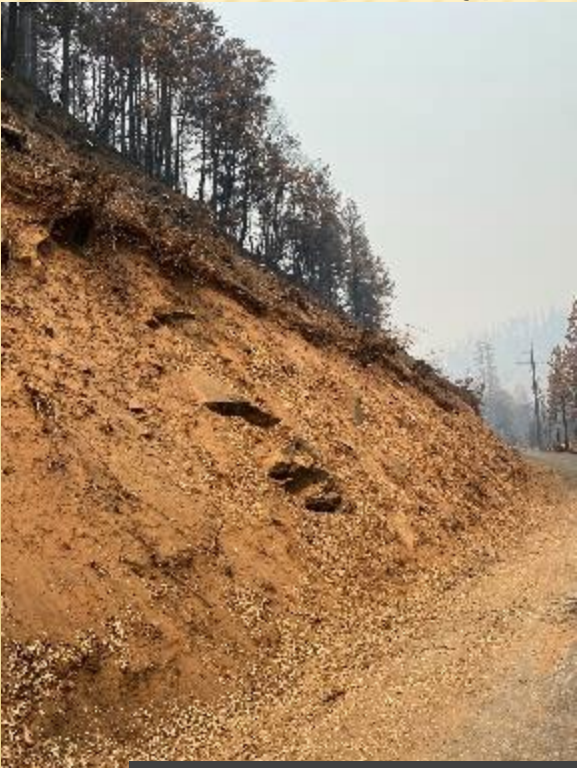
Active landslide along 7F002

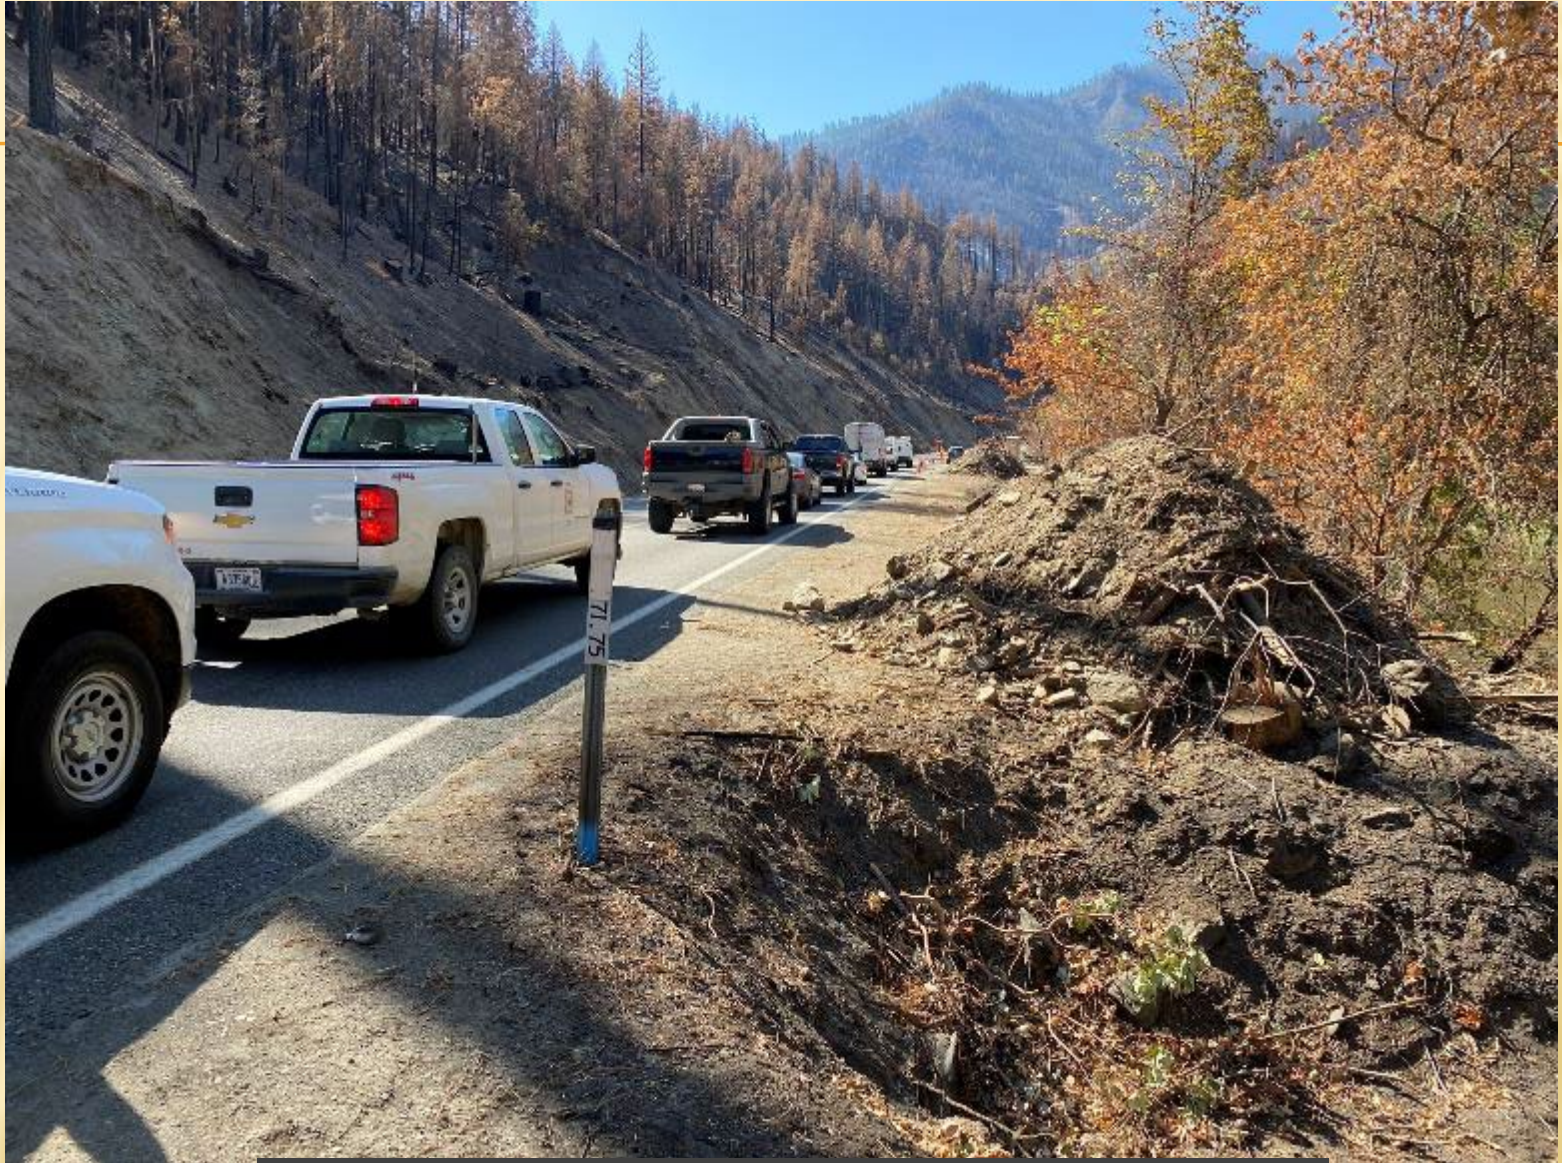
Erosive slopes along highway 96 in the HEAD fire

Burn-area hazard warning signage recommended

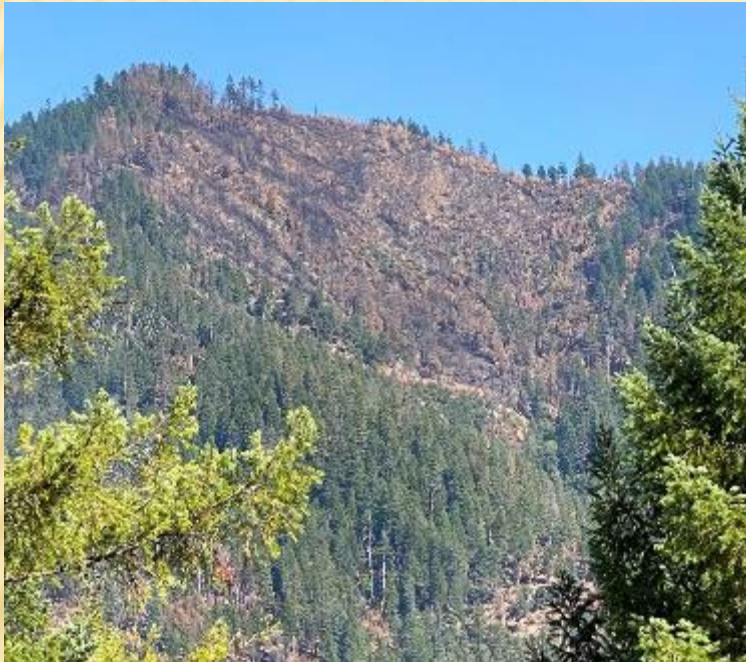
UFISH creek headwaters – limited sediment available

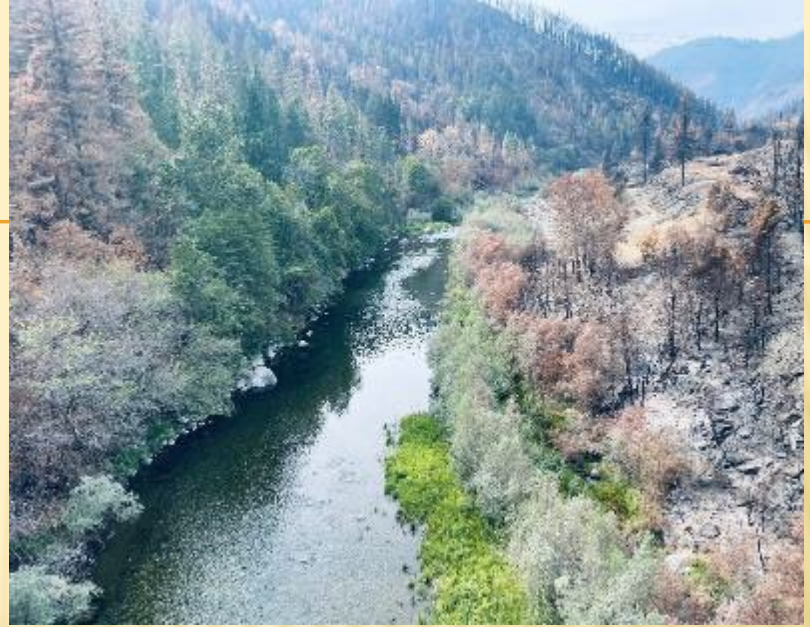
Intact riparian vegetation observed along the Scott River. The riparian area remained largely intact (only 7% impacted) .

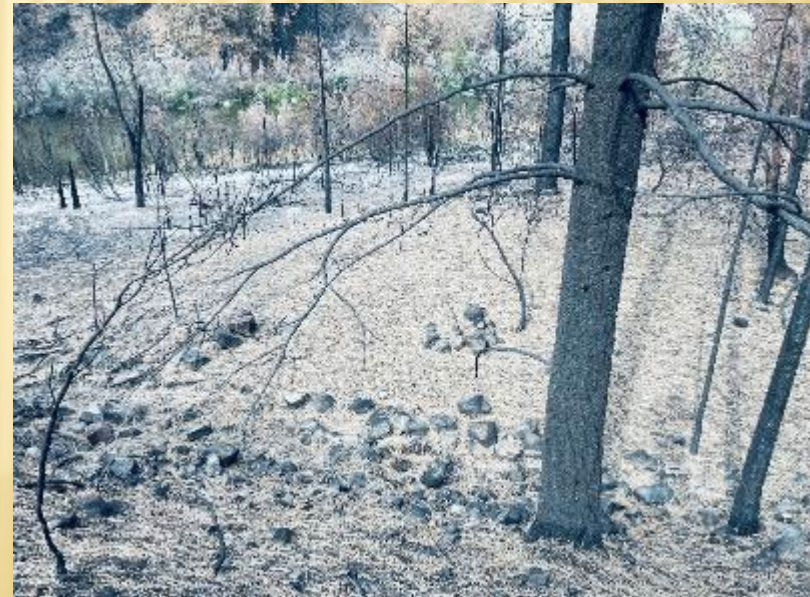
Needle cast observed in moderate SBS along the Scott River creating initial ground cover.

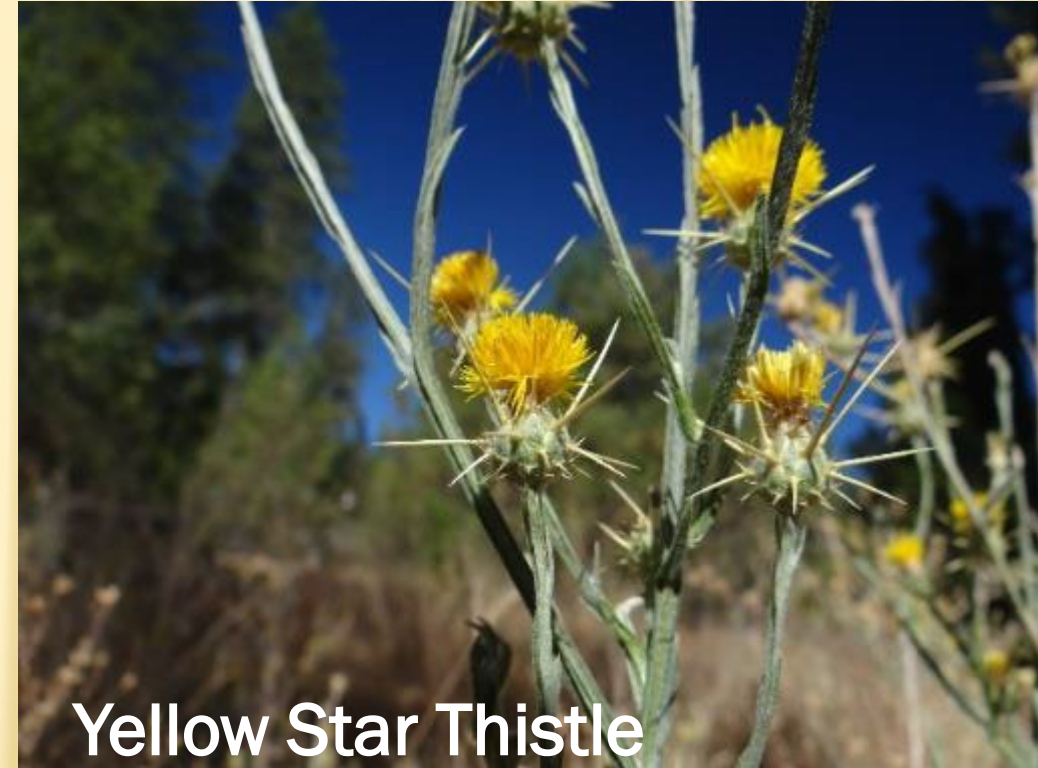
One of the base camps on the incident was located on a large infestation of Yellow Star Thistle example seen above.

- Early detection, rapid response (EDRR) surveys are proposed on areas disturbed by suppression activities (~80 miles) on Forest Service lands and 230 acres within fire perimeter near known infestations.
 - EDRR is a combination of early surveys combined with immediate treatment of new infestations.
 - This is the most effective and cost-efficient treatment to mitigate establishment of infestations.
