Smith River Complex Post Fire BAER Assessment August-September 2023

Six Rivers & Rogue River-Siskiyou National Forests

Smith River Complex BAER Assessment

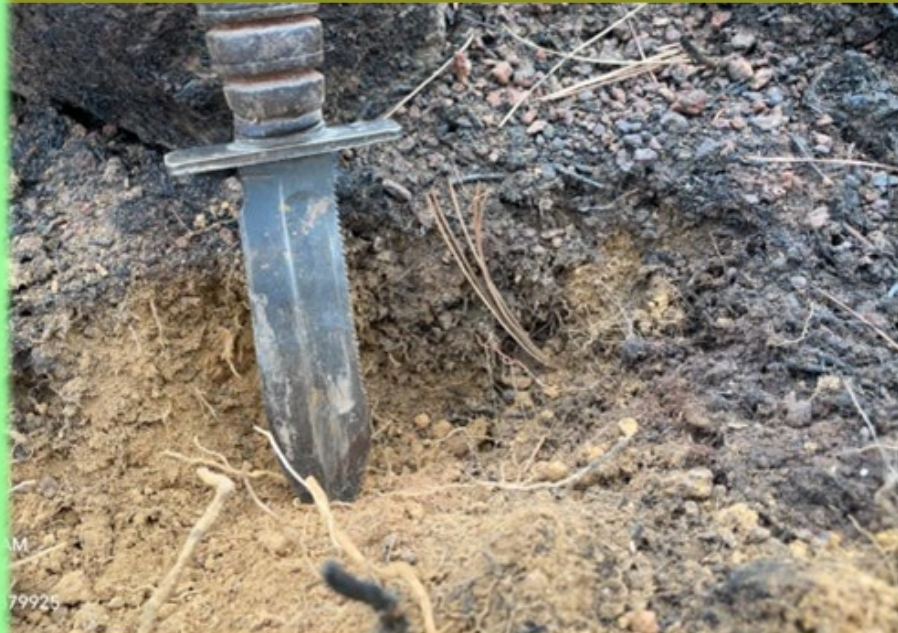
Moderate Soil Burn Severity

- Soil structure weakened.
- Roots dry and brittle or charred

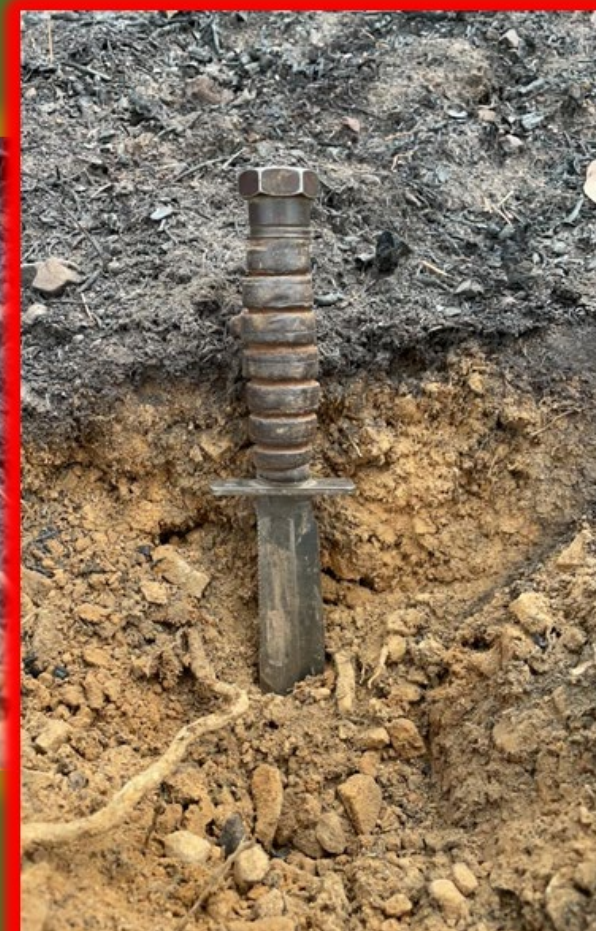
High Soil Burn Severity

- Surface soil structure weakened or destroyed.
- Roots charred or consumed

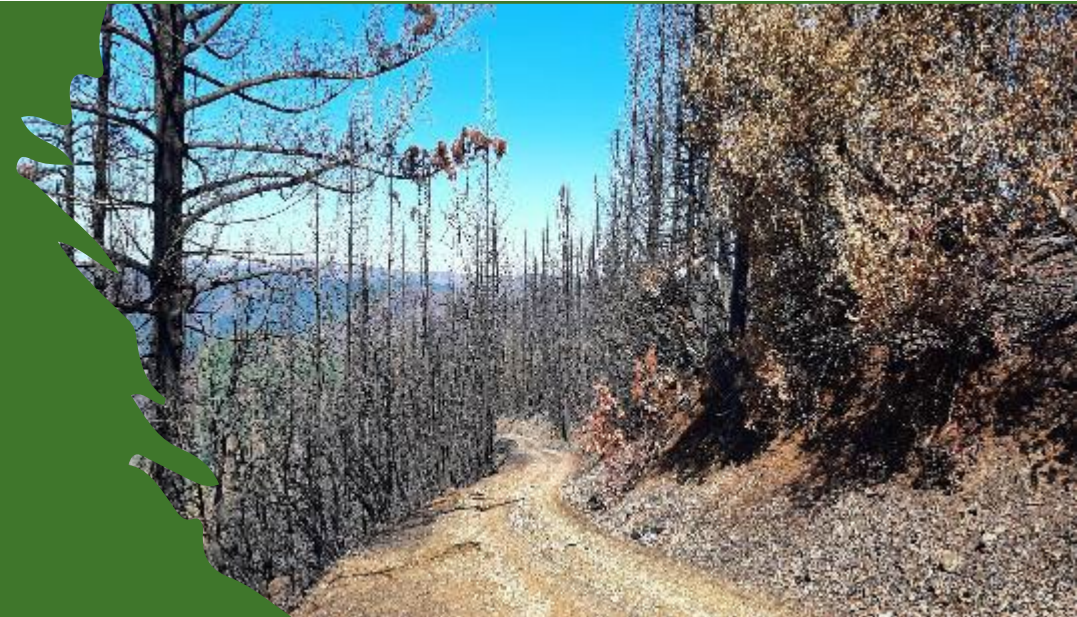
18N17 ridge near repeater

- 67.9 miles of the roads burned in Moderate or High Soil Burn Severity areas
- Erosion exacerbated by rainstorms that occurred after the fire
- Future storms could lead to erosion that damage culverts which lead to road failures

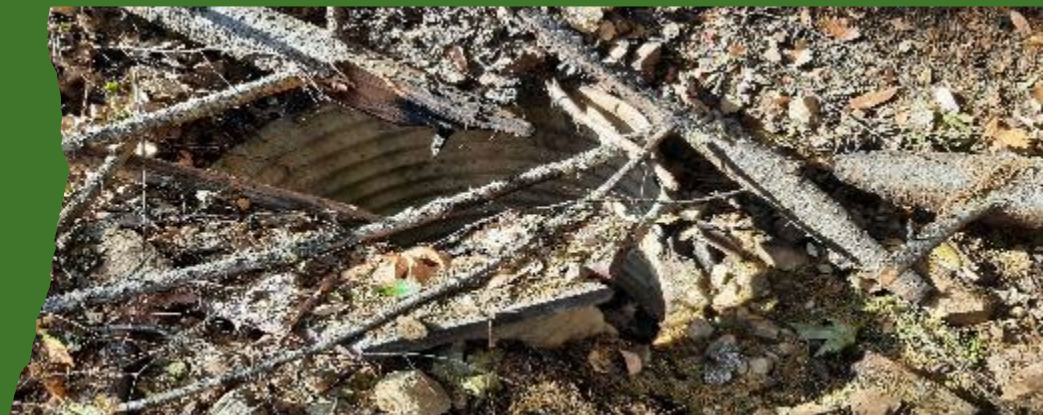
Plugged Culvert

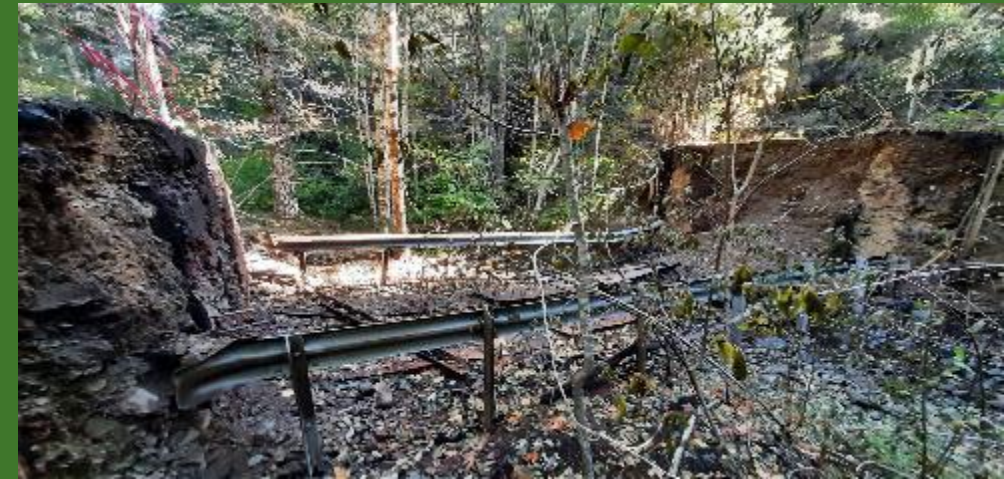
Burned Bridge

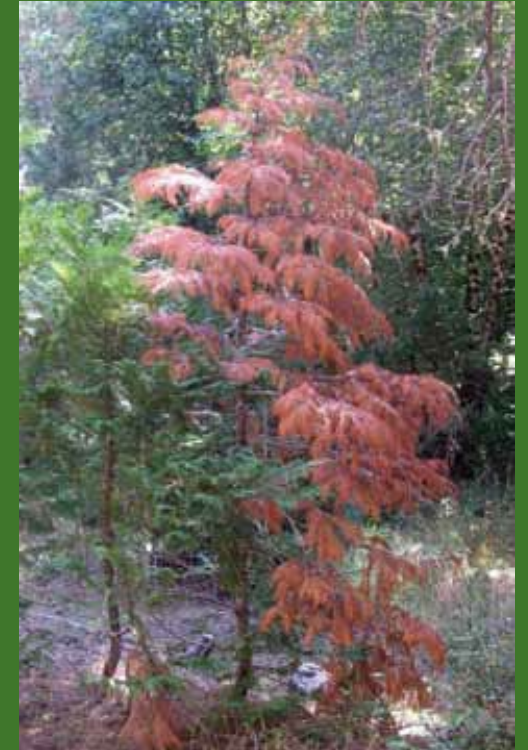
Phytophthora lateralis
infected Port Orford cedar

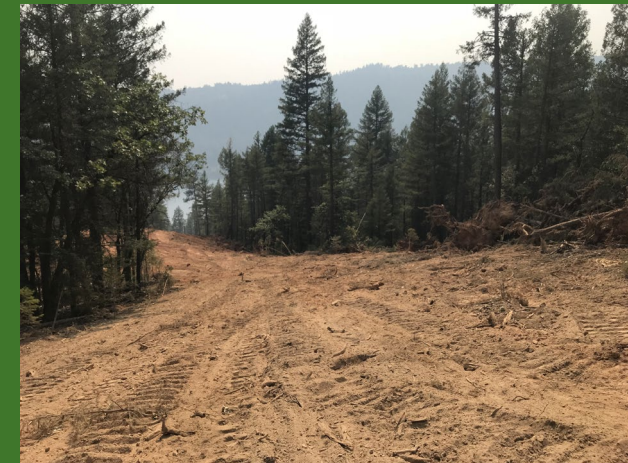
Dozer line disturbed ground

- BAER Early Detection Rapid Response EDRR – invasive noxious weeds
- P1b Suppression Disturbance EDRR - invasive noxious weeds
- P3 Other Plant Treatments - Plant Pathogen Testing/Monitoring/Treatments

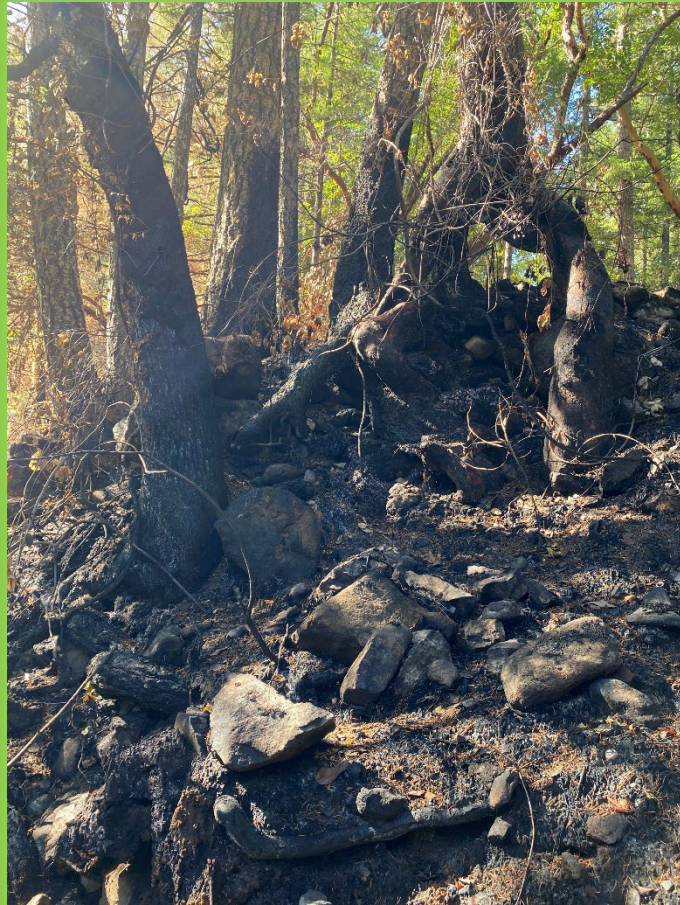
Burned
Hazard
Trees
around
historic
features

Hydrological
models
project
accelerated
erosion of
historic
masonry
along stream
(historic
swimming
area)

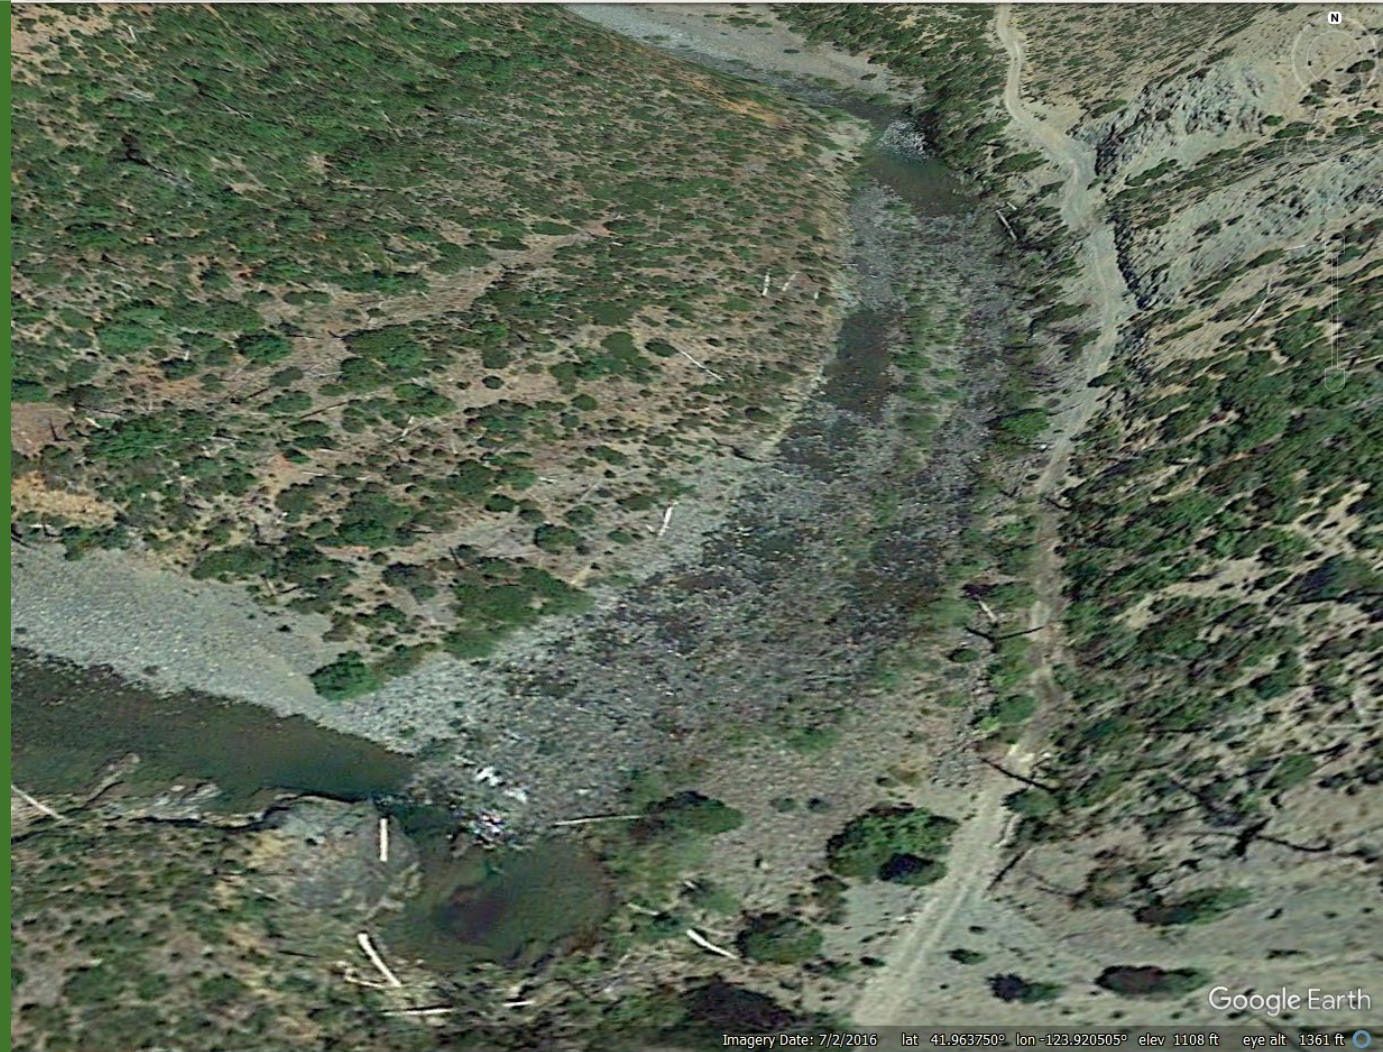
Diamond Creek location where wood could be added

No BAER treatments recommended
