Post Fire Burned Area Summary

Burned Area Report

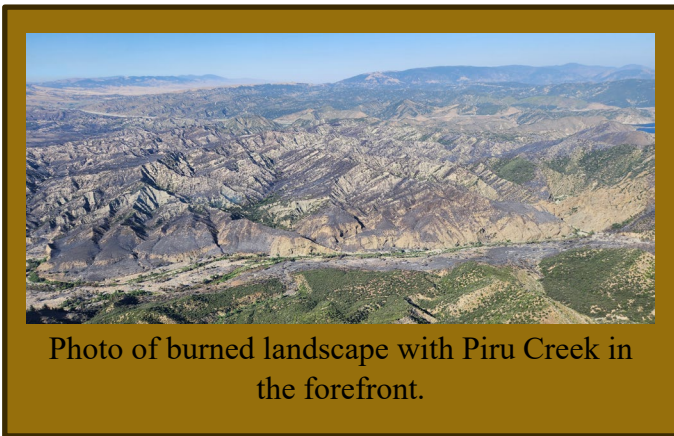
Photo of burned landscape with Piru Creek in the forefront.

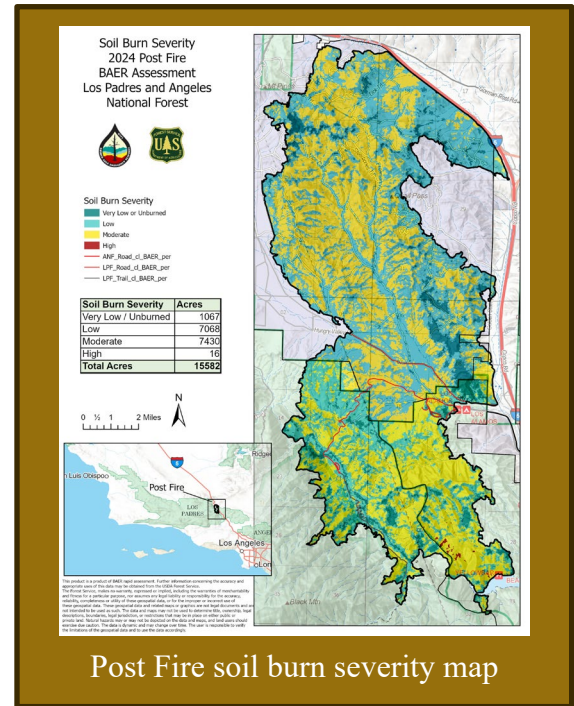
Post Fire soil burn severity map

Mapped and validated SBS for the burned area is High (<1%), Moderate (48%), Low (45%), and Very Low/Unburned (7%) see map on page 1. The more severe a fire's effects are on the soil, the more likely those soils will erode in subsequent rainstorms – especially in locations with steep slopes. Erosion after fires can cause tremendous damage to homes and other structures in the years after a fire. The Post Fire had very little high soil burn severity; therefore, there should be minimal long-term damage to soils that would slow vegetative recovery.

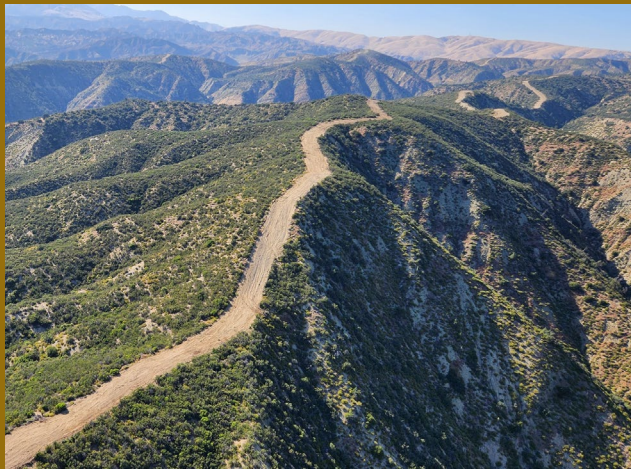
Non-native plants can expand into disturbed areas such as dozerlines, replacing native vegetation.

Current infestations are primarily located along roads, old dozer lines, campgrounds, and trails throughout the burned area, with interior areas being largely un-infested. However, the burned area creates conditions for invasive species to outcompete native plants, especially in riparian areas which were seen to harbor isolated populations of invasives.

The team recommends a treatment of Early Detection, Rapid Response (EDRR) to monitor for noxious weed infestation and expansion in areas disturbed due to mechanical suppression activity and burned areas prone to new noxious weed infestations. At-risk areas will be surveyed for weeds and mechanical and chemical treatments will be employed if weeds are present.
