Borel Fire Burned Area Summary

Burned Area Report

**Borel Soil Burn Severity
 Burned Area Emergency Response (BAER)**

Borel Fire BAER Debris Flow Likelihood
 Burned Area Emergency Response (BAER)

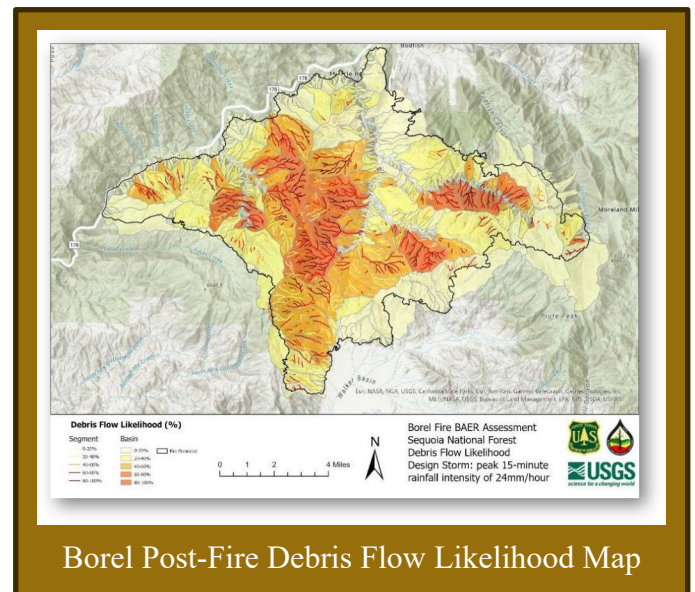
The team provided soil burn severity field data to the US Geological Survey (USGS) Landslide Hazard Program to assist in forecasting the probability, potential volumes, and hazards of debris flows through their developed empirical models. (See Borel Post-Fire Debris Flow Likelihood Map Below)

The USGS debris flow analysis of the Borel burn area presented debris flow hazard classes, probability of occurrence, and volumes of materials occurring for multiple precipitation events. The BAER team selected a design storm of a peak 15-minute rainfall intensity of 24 millimeters per hour (0.9 inch/hr.) rate to evaluate debris flow potential and volumes, based on the NOAA Atlas 14 Point Precipitation Frequency Estimates for a one-year return interval for this area.

The highest debris flow potential is in Havilah Canyon from both west and east-facing slopes. This is supported by the USGS debris flow model under conditions of a peak 15-minute rainfall intensity of 24mm/hr. (0.9 inches/hr.) showing probabilities ranging from 60-100% and the presence of legacy debris flow deposits along the eastern flank of the Breckenridge Mountains in drainages adjacent to the community of Havilah such as Goff Ranch (Don Lindsey, personal communication, 2024). As such, the CalFire Watershed Emergency Response Team (WERT) conducted a detailed analysis of debris flow potential for the Havilah Canyon, and the reader is encouraged to review their report for further details.

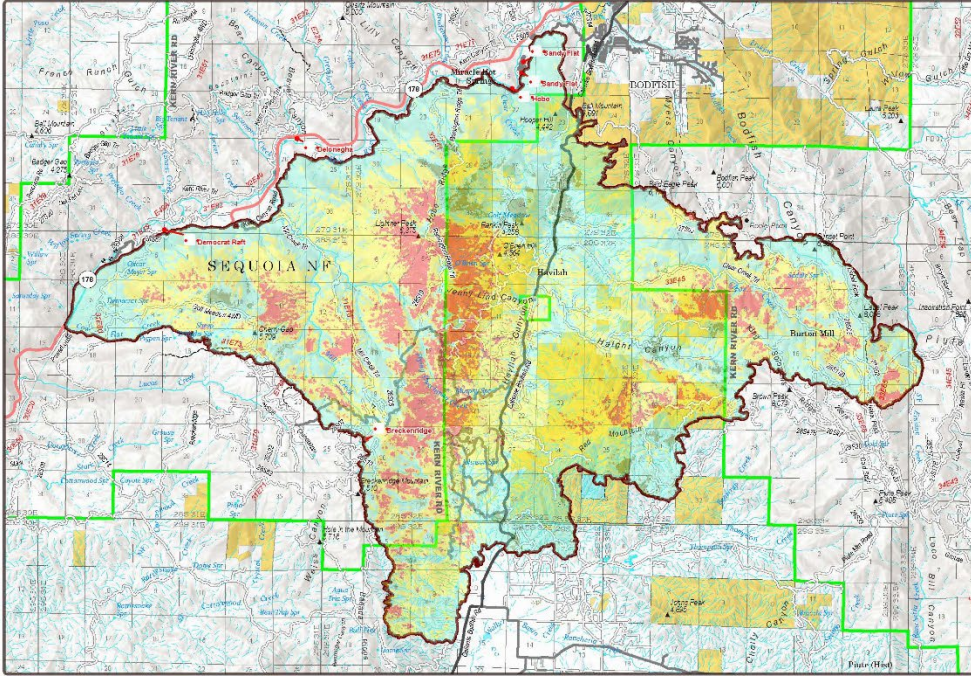
Mapped and validated SBS for the burned area is High (9%), Moderate (37%), Low (49%), and Very Low/Unburned (5%) (see map on [insert page number]). The more severe a fire's effects are on the soil, the more likely those soils will erode in subsequent rainstorms – especially in locations with steep slopes. Erosion after fires can cause tremendous damage to homes and other structures in the years after a fire.

Soil Burn Severity is a measure of the fire's effects on the ground surface and soil condition. This map identifies the fire-induced changes in soil and ground surface properties that may affect infiltration, runoff, and erosion potential. The BAER Team uses this map to identify areas of unacceptable risk to a critical value and where mitigating treatments may be most effective. This product is appropriate for wildland landscapes and does not represent fire effects in developed areas.

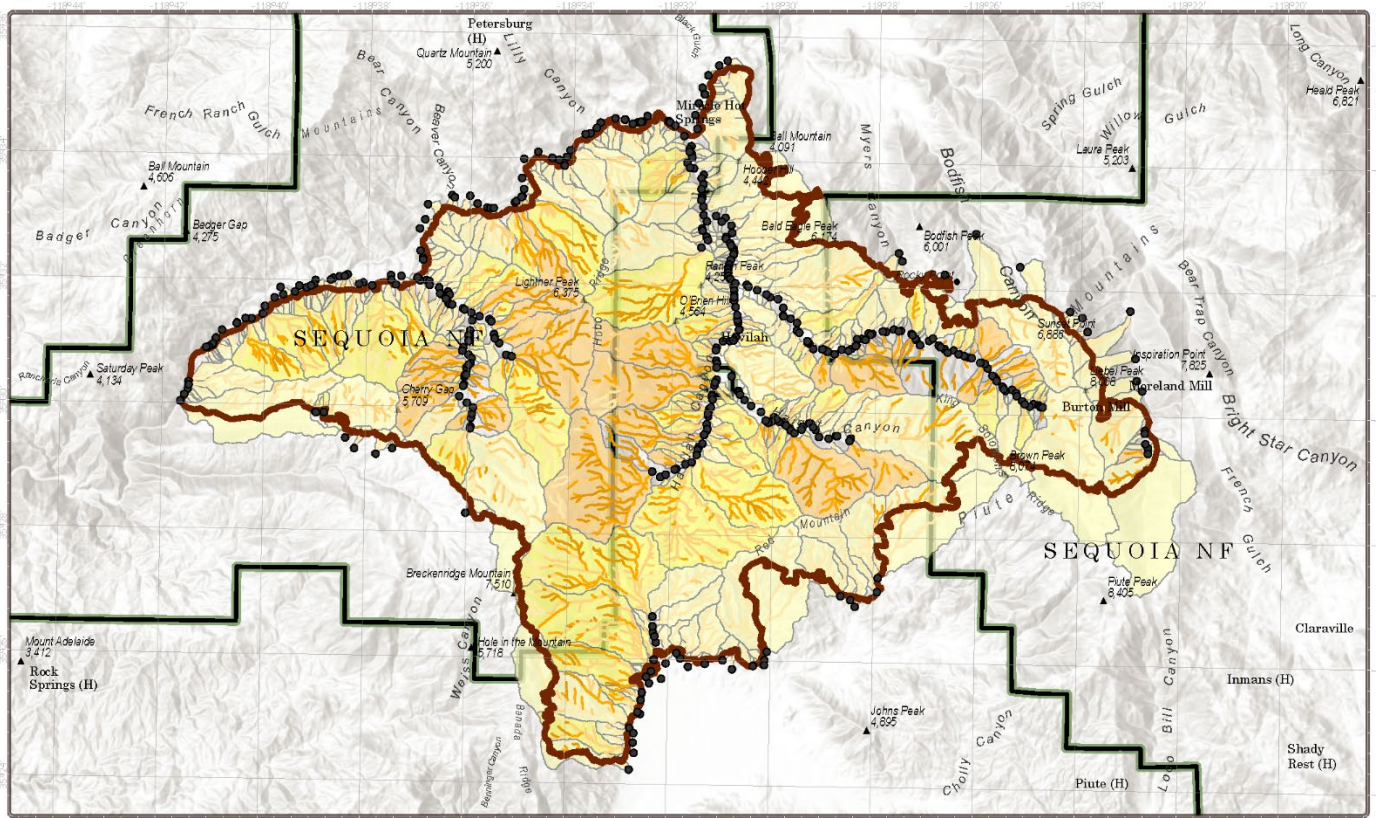
Although Havilah Canyon is most susceptible to debris flow hazard, the drainage just east of the Havilah Fire Station (Dutchman Creek/Havilah Canyon) did not show evidence of legacy debris flow deposits, nor did the surrounding hillslopes show much potential for debris flow initiation. Lack of legacy debris flow deposits may indicate that hyper-concentrated flows and nuisance sedimentation may be more likely for this site.
