Park Fire Burned Area Summary

Burned Area Report

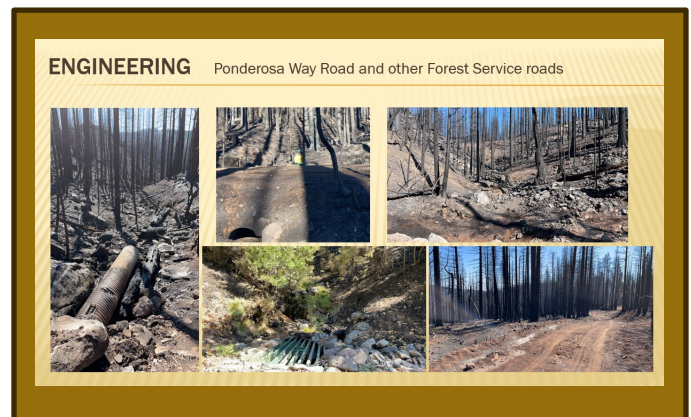
In addition, two bridges within the burned area were catastrophically impacted, Black Rock Bridge and Lower Deer Creek Bridge. To address immediate post-fire needs, closure of the bridges is the recommended BAER treatment.

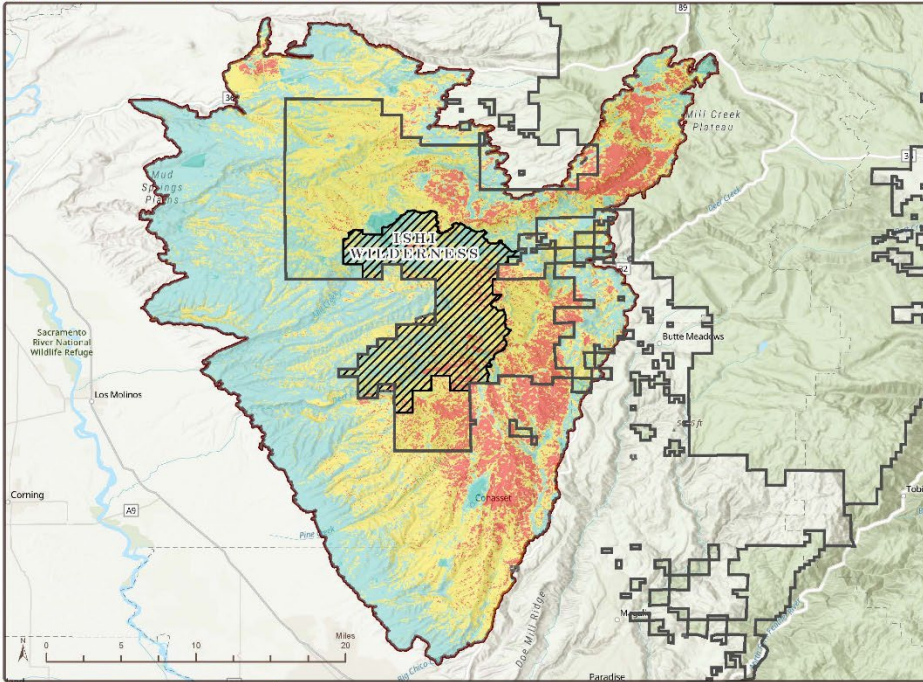
2024 Park Fire Soil Burn Severity
Burned Area Emergency Response (BAER)

Mapped and validated SBS for the Park Fire burned area is:

- High (7%),
- Moderate (36%),
- Low (53%), and
- Very Low/Unburned (4%) (see map above).

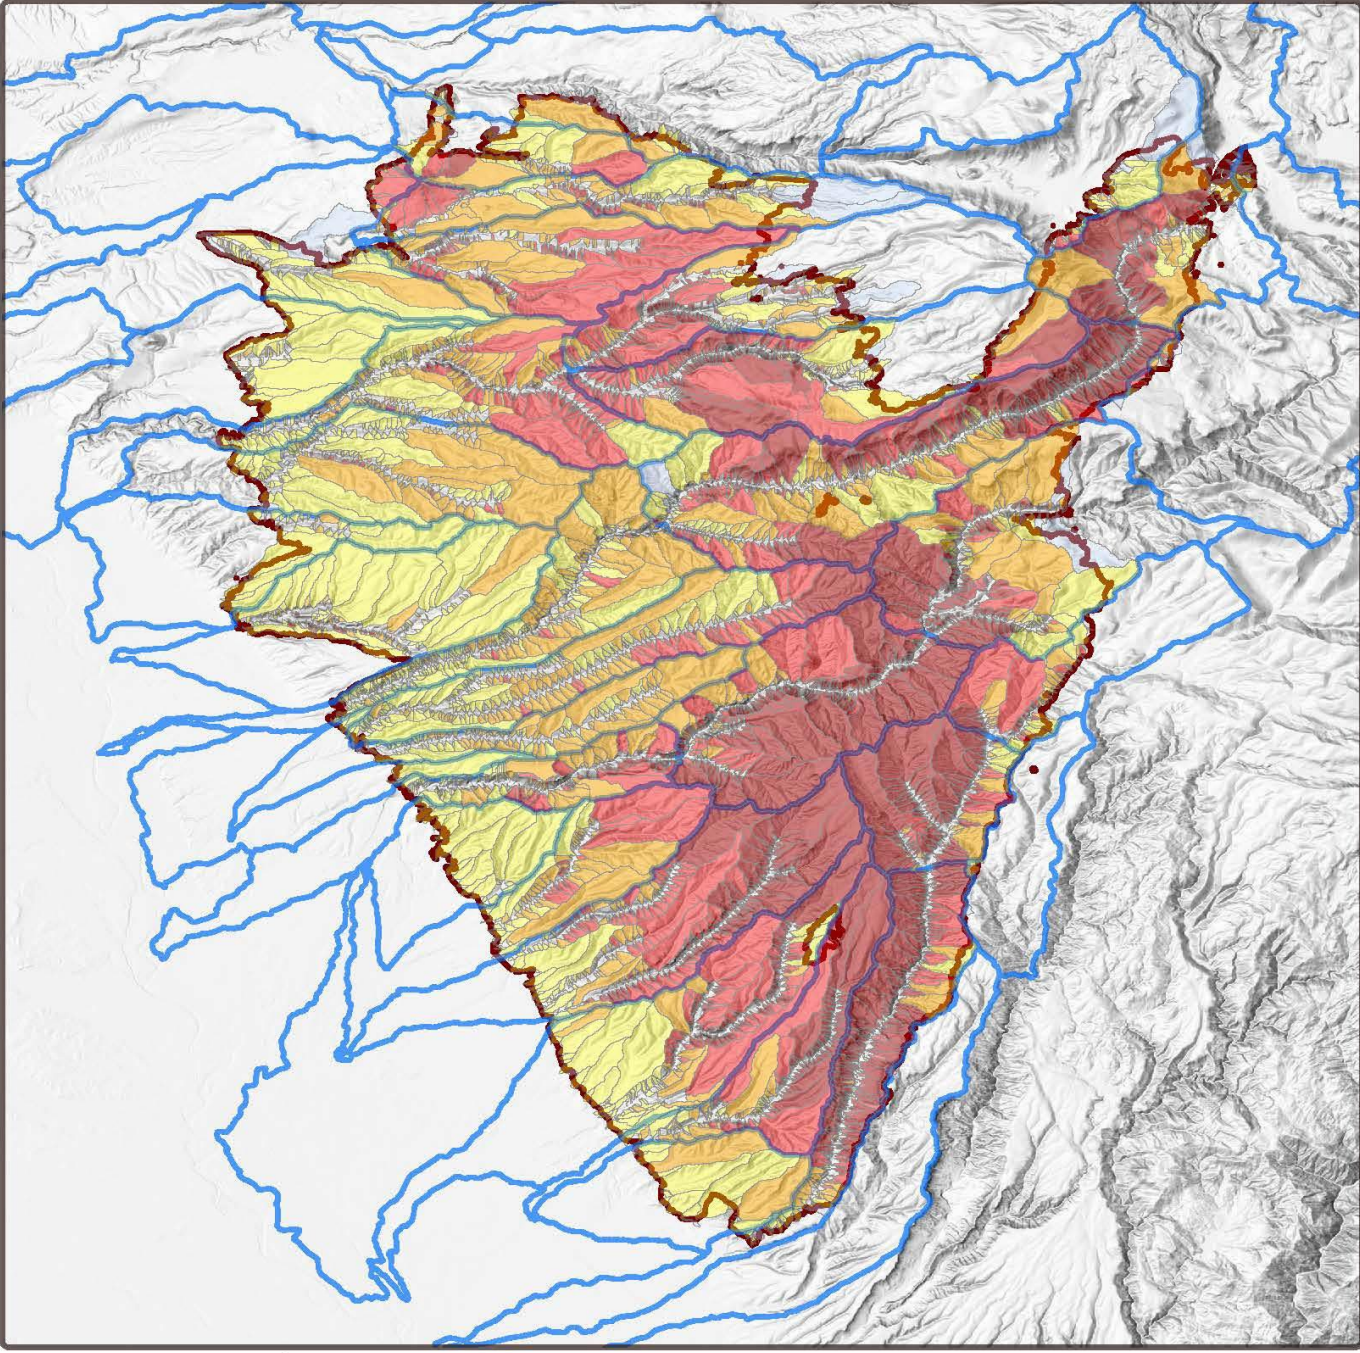
Resource - Geology Debris Flow Burned Area Emergency Response (BAER)

Within the Park burn area, several high potential debris flow, landslide, and rock-fall hazard areas were identified, based on ground observations and the USGS Post-Fire Debris Flow Hazard Model.

The magnitude of storm that was chosen for analysis was a peak 15-minute rainfall

intensity storm of 32 mm/hr rate (1.25 in/hr), equivalent to the accumulation of 8 mm (0.31 in) over 15 minutes. Based on NOAA Atlas 14, this peak 15-minute intensity has a 1-year recurrence interval (RI) in the Upper Mill Creek area. The 15-minute peak intensity has been shown to be the most predictive metric for debris flow initiation as post-fire debris flows are most often triggered by high-intensity, short-duration bursts of rain (USGS). (see map above).
