EATON & HURST FIRES BURNED AREA EMERGENCY RESPONSE (BAER)

BAER Team
Assessment
January 27, 2025

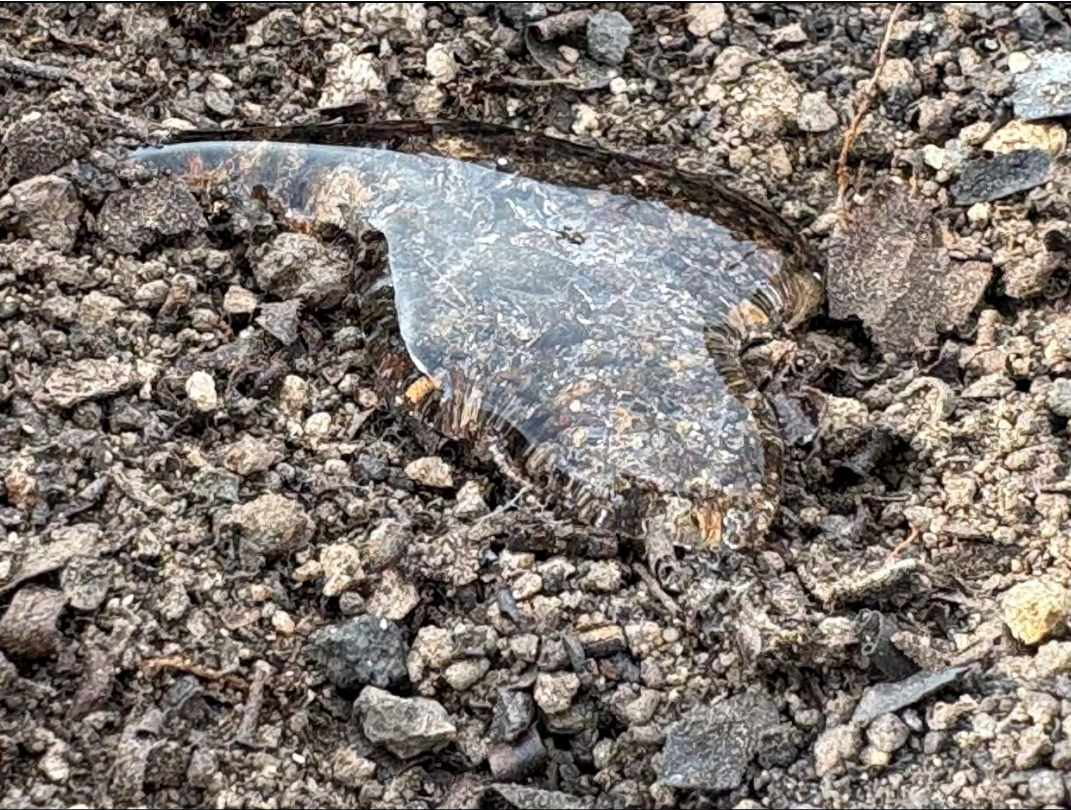
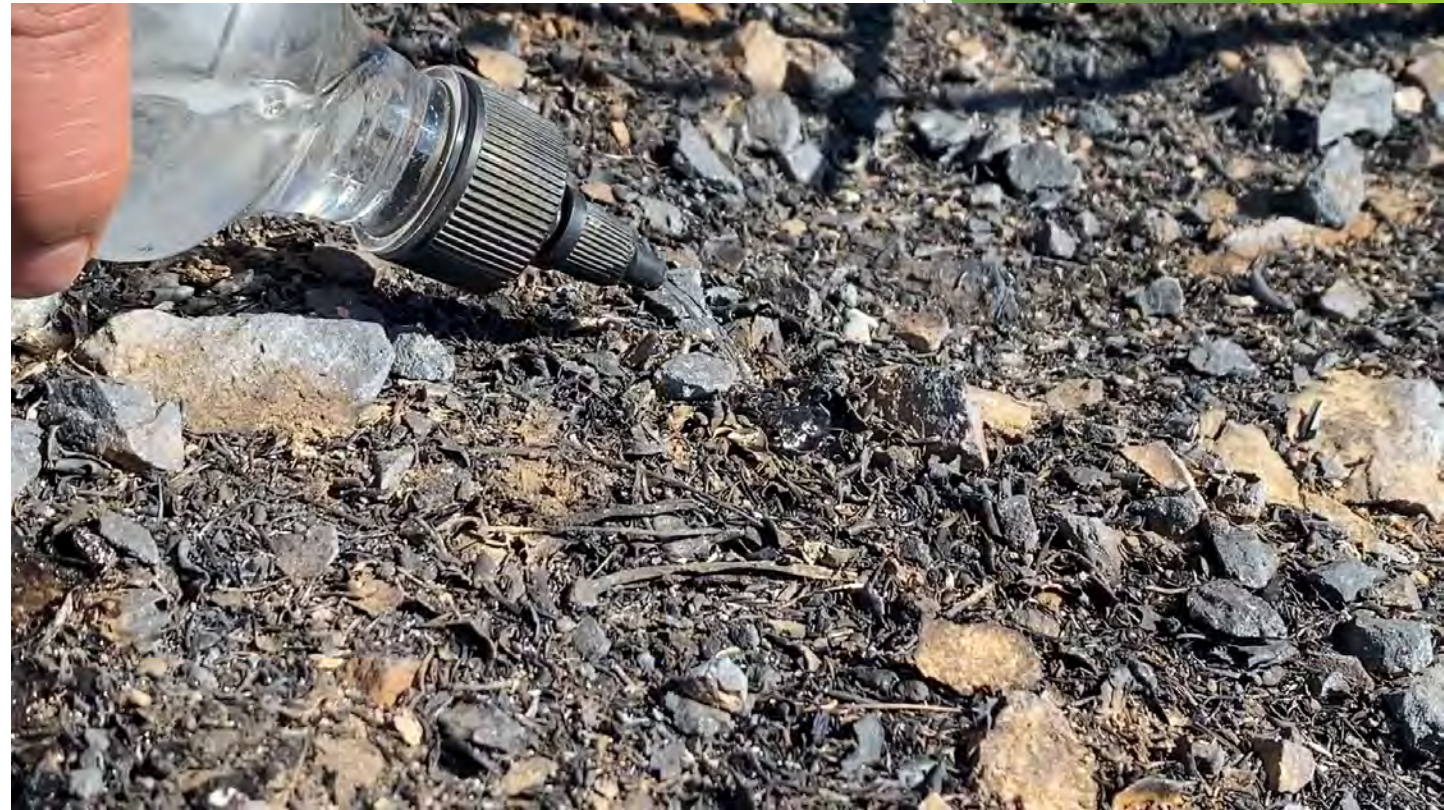
Extreme water repellency

- Up to 15 cm thick strong water repellency.
- Increases flow bulking (by making water flows highly efficient at transporting sediment).
- Increases runoff delivery which increases debris flow risk and quicker hydrologic response.
- Decreases water storage which increases flood flow volume.
- Decreases soil moisture for plant uptake.

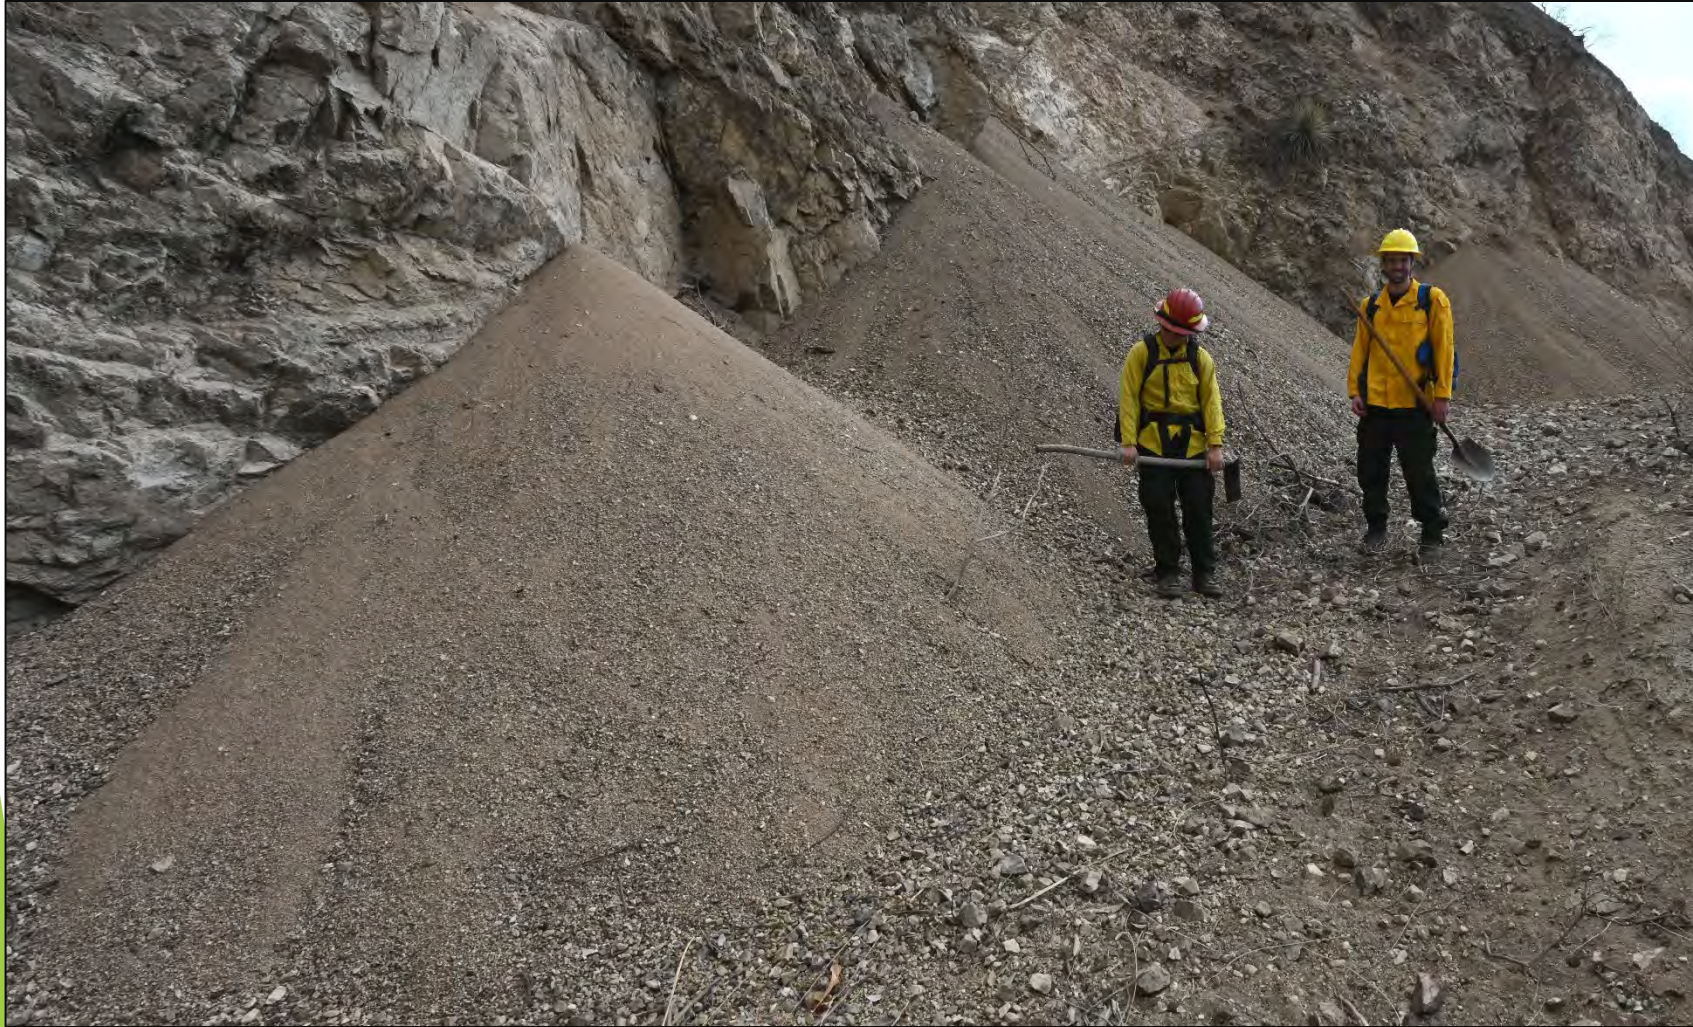
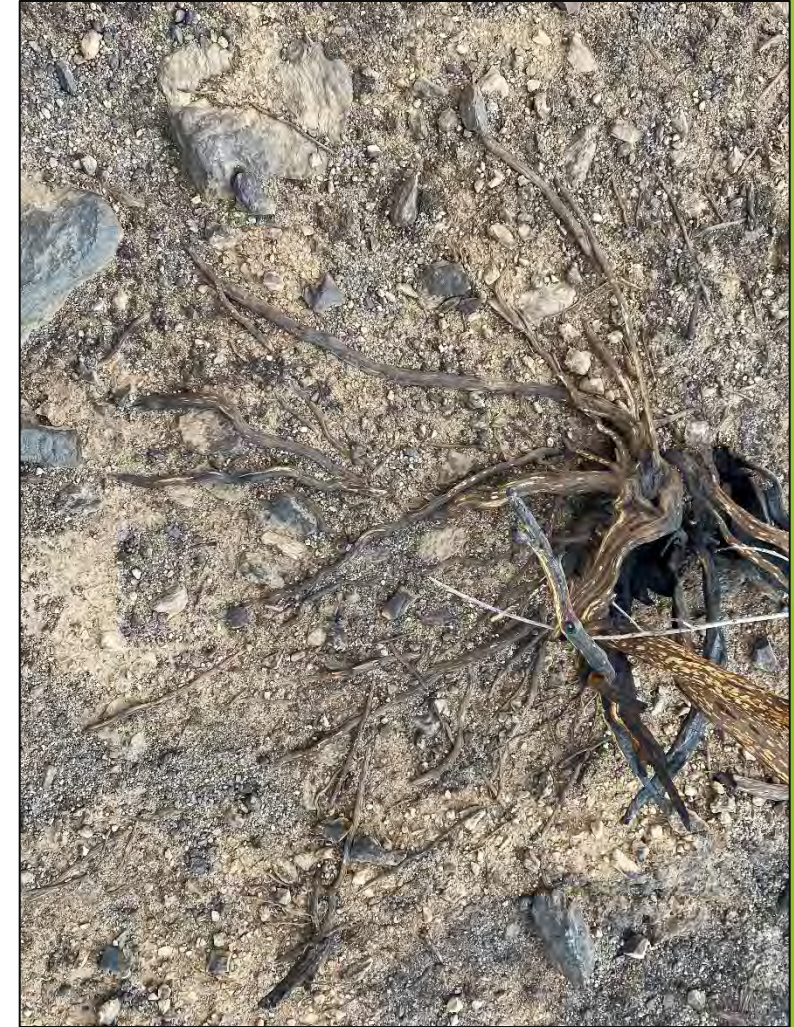
Extreme gravity and wind erosion

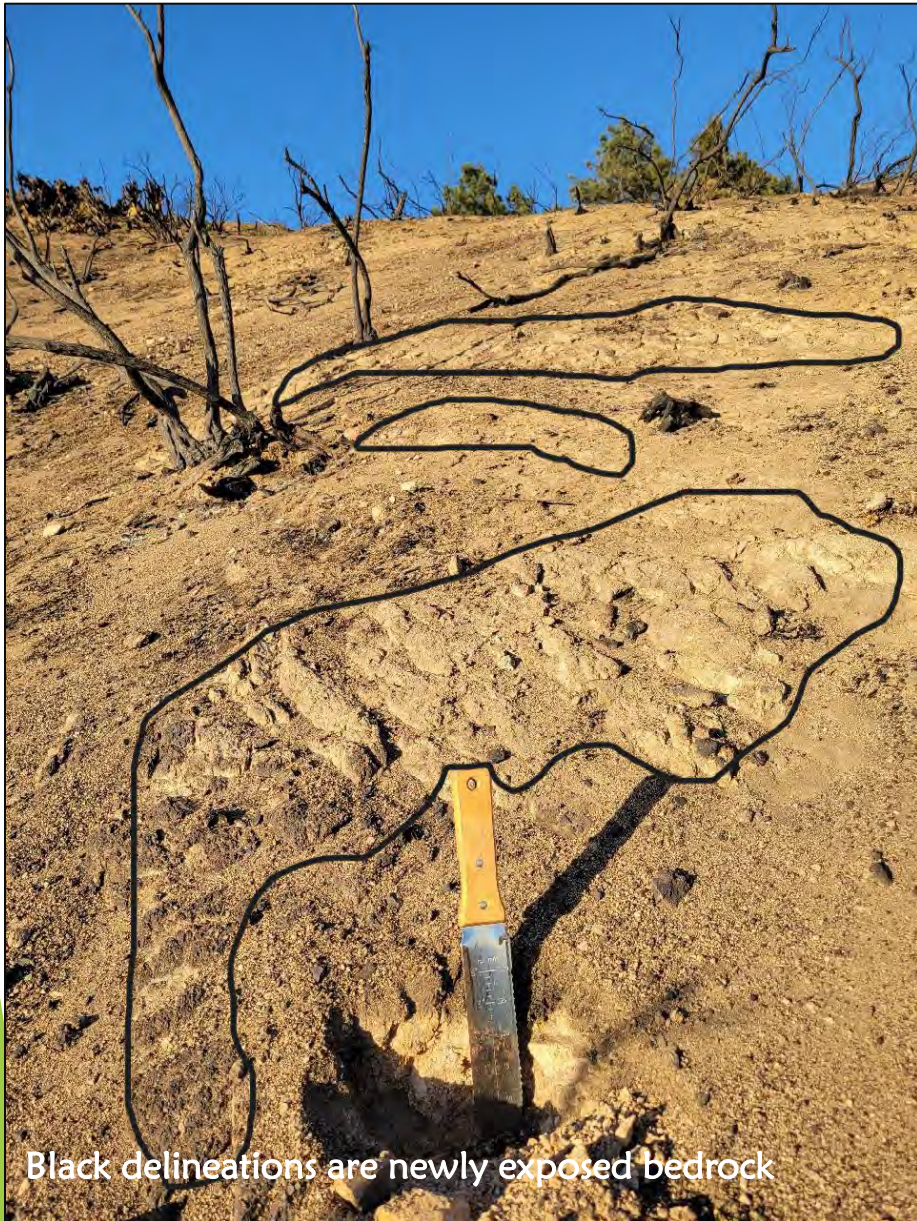
Black delineations are newly exposed bedrock

Significant loss of soil productivity and soil hydrologic function in the lower elevations:

- Extreme winds removed surface soil and seed bank.
- Bedrock and subsurface soil exposed decreasing recovery potential.
- Resulting in rapid surface runoff and decreased potential for natural vegetation recovery.

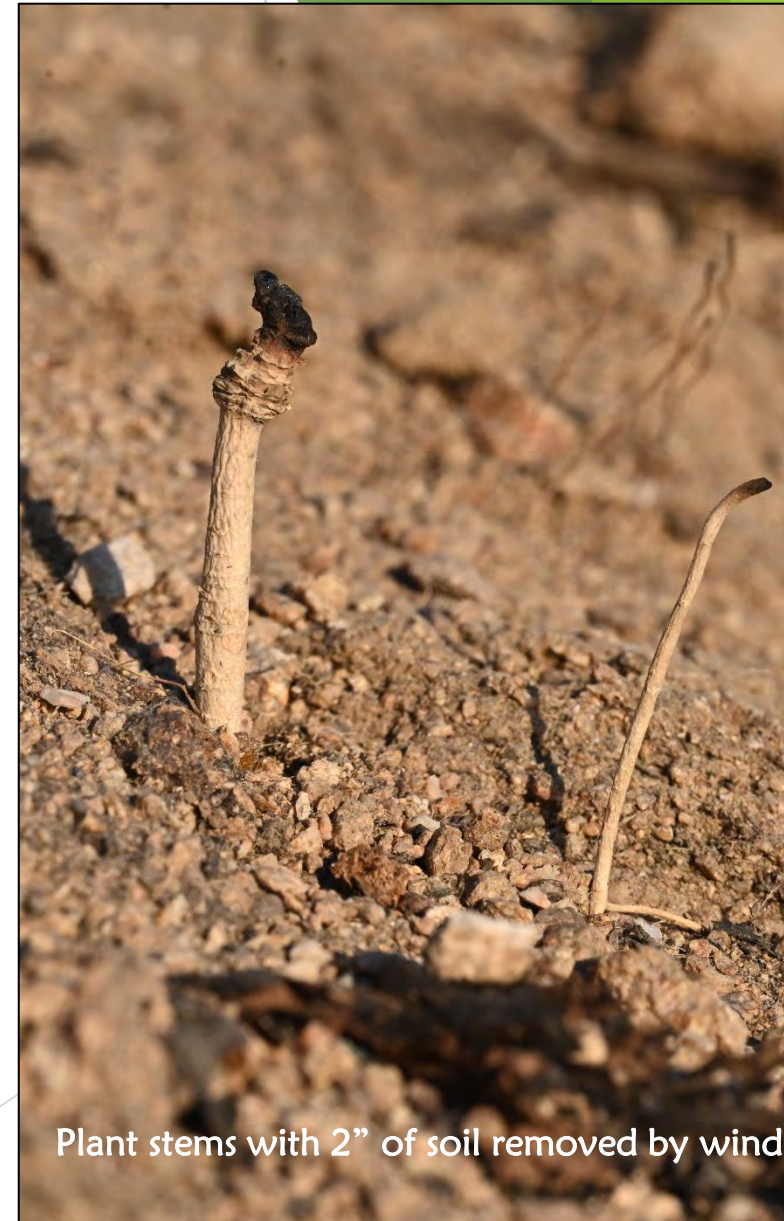
Plant stems with 2" of soil removed by wind

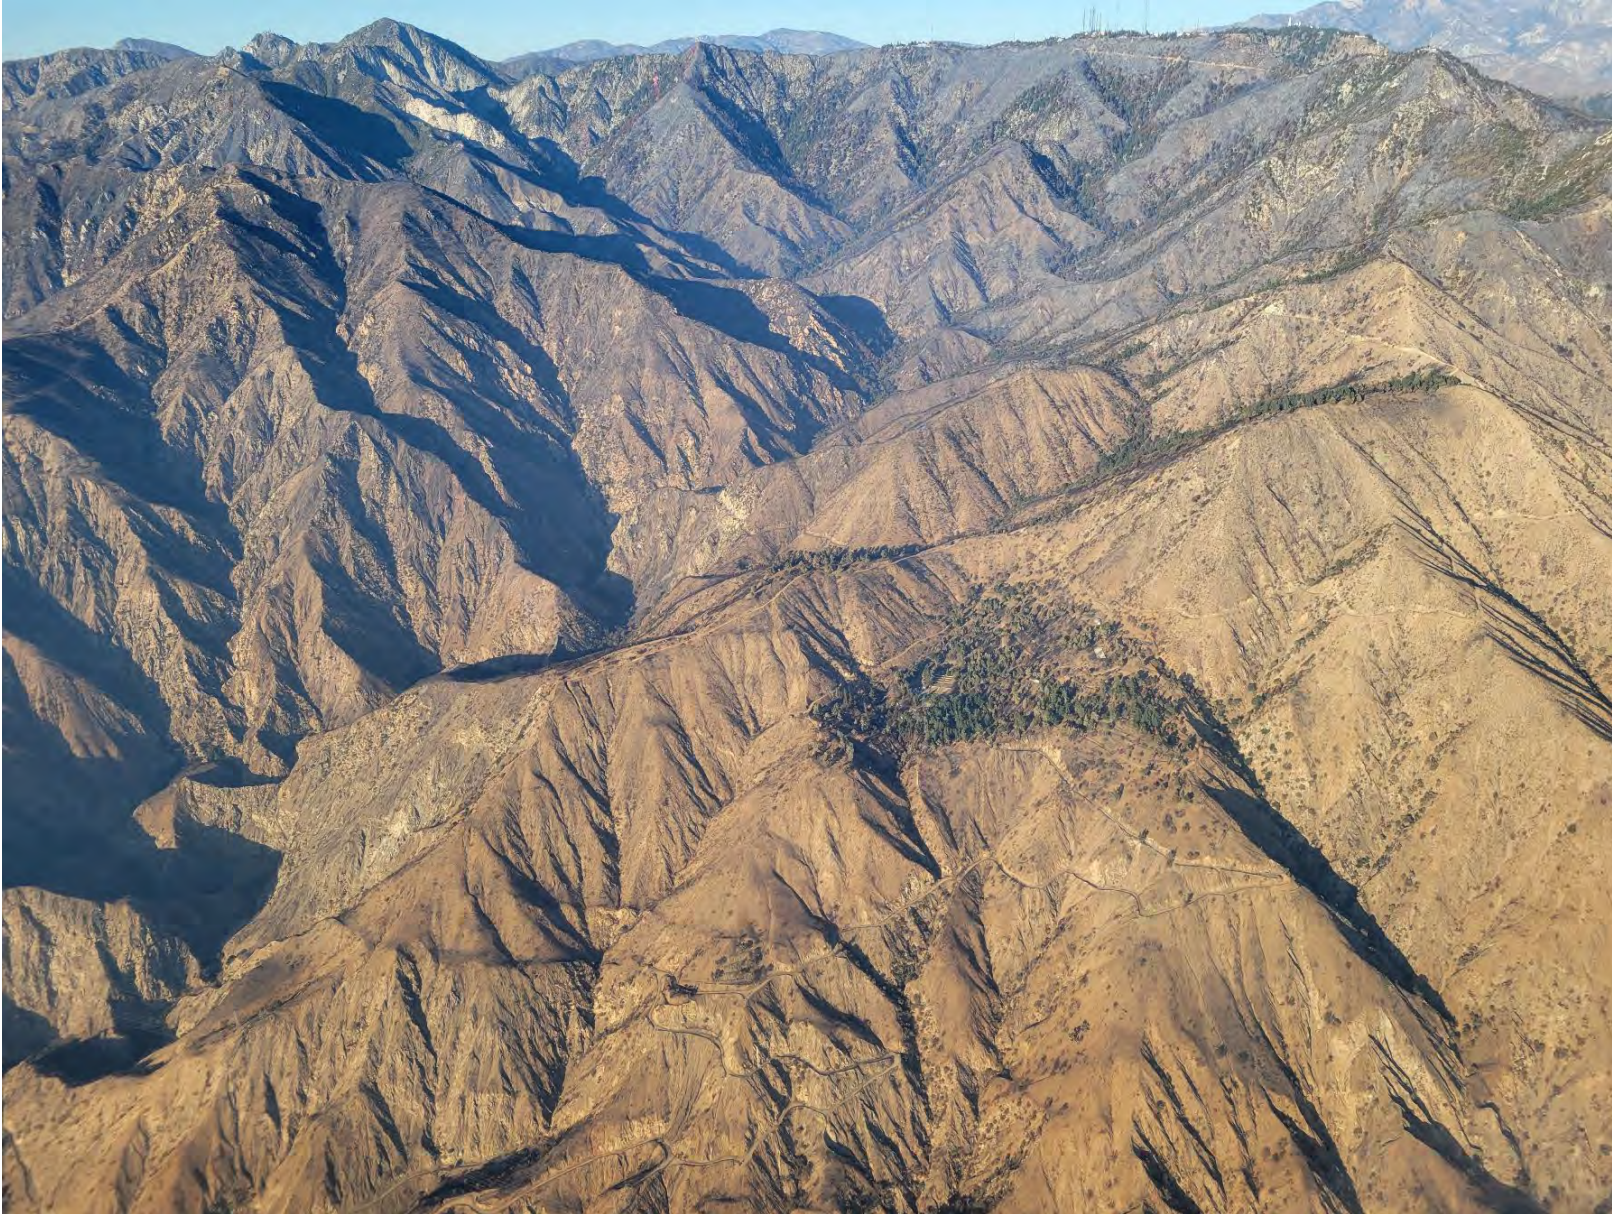
- Lower elevation areas experienced more wind erosion
- Upper elevation areas retained more ash and surface soil

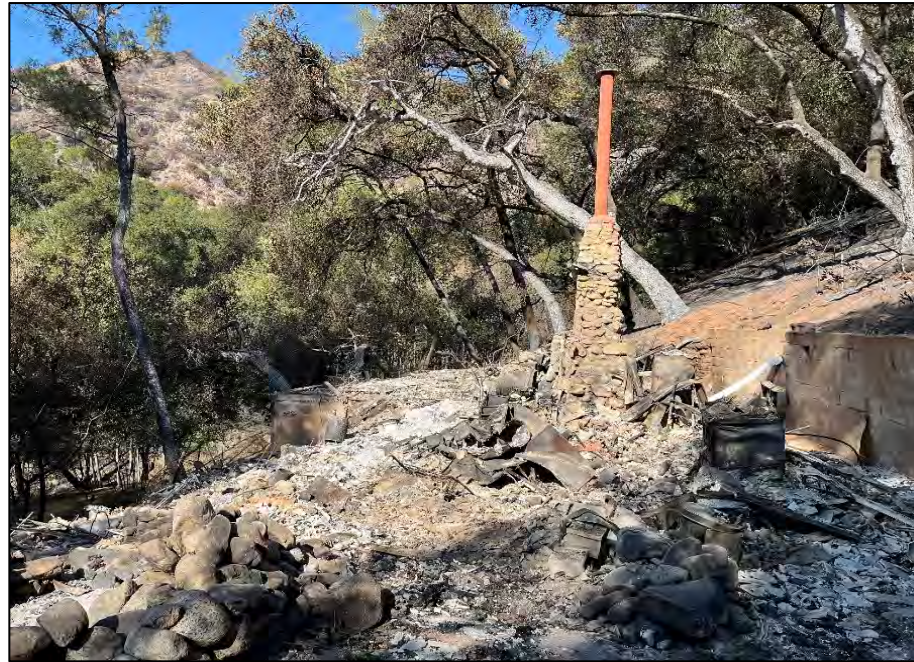
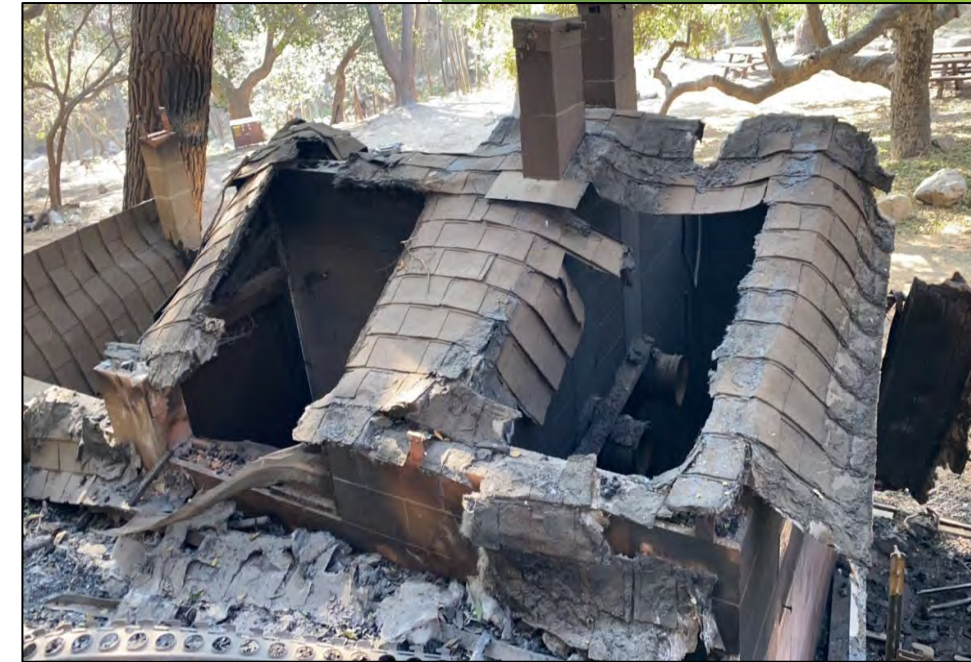
able Vault Toilet

- Public Hazmat Exposure
- Mobilization of Contaminants into Soil and Water

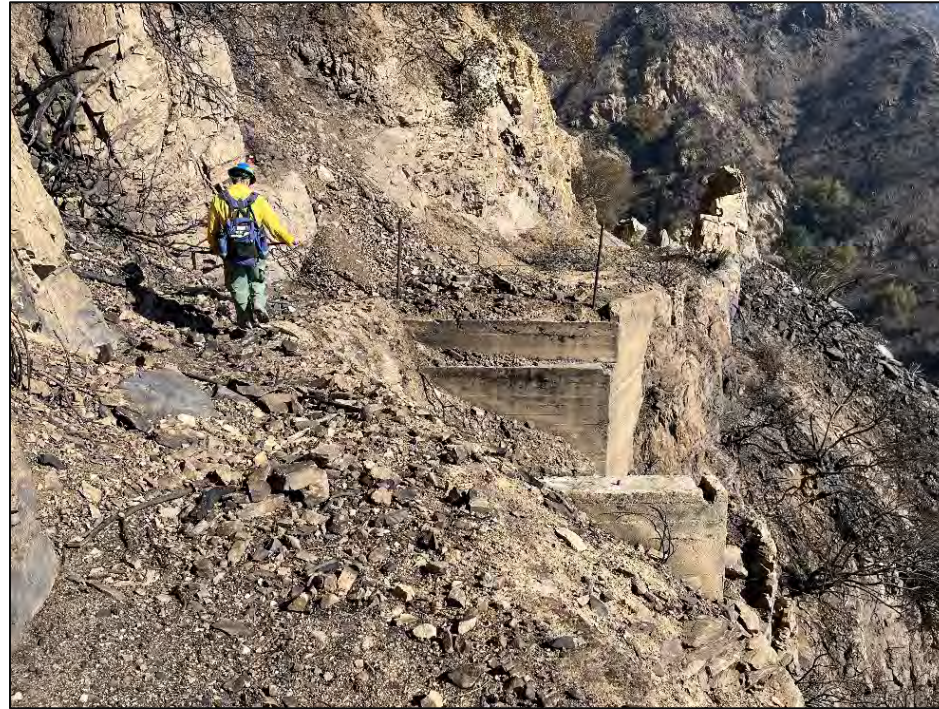
Echo Mtn Trail one week after Eaton Fire and almost impassable. Railway bridge abutments visible.
