Eaton Fire Burned Area Summary

Burned Area Report

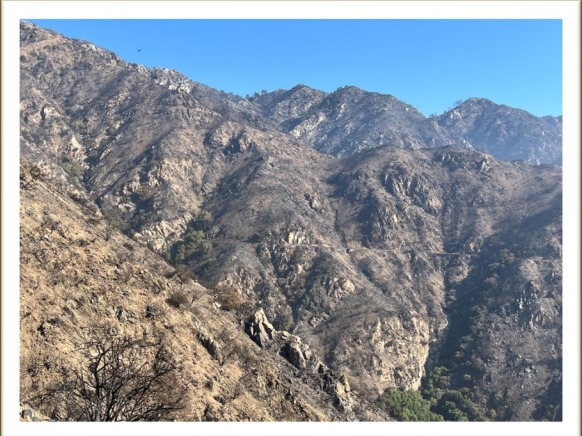
Based on the steep slopes in the burn area, the soil burn severity, the elevated hydrophobicity/water repellency of the burned soil, and the amounts of stored sediments in most drainages in the burn area, it is estimated that as a result of short duration, high intensity storms (>40 mm/hr.), the probabilities of hyper-concentrated flows and/or debris flows are high to very high in most channels in the Eaton Fire burn area. These channels for the most part flow into communities impacted by the fire and downstream of the fire.

Steep Slopes within Eaton Fire

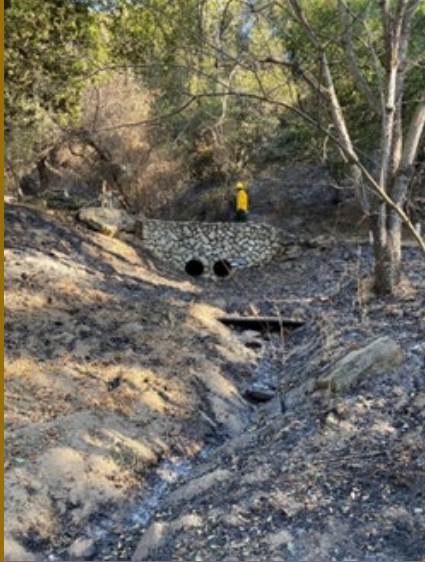
Road crossing near Millard Campground have potential for culverts to plug

Critical values addressed in the BAER report include Forest Service system roads and related drainage features. Treatments for the protection of these roads include restoring drainage features, armor drainage crossings, conduct storm inspections

and response actions, and install warning signs to alert travelers of hazardous conditions within the Eaton burned areas.

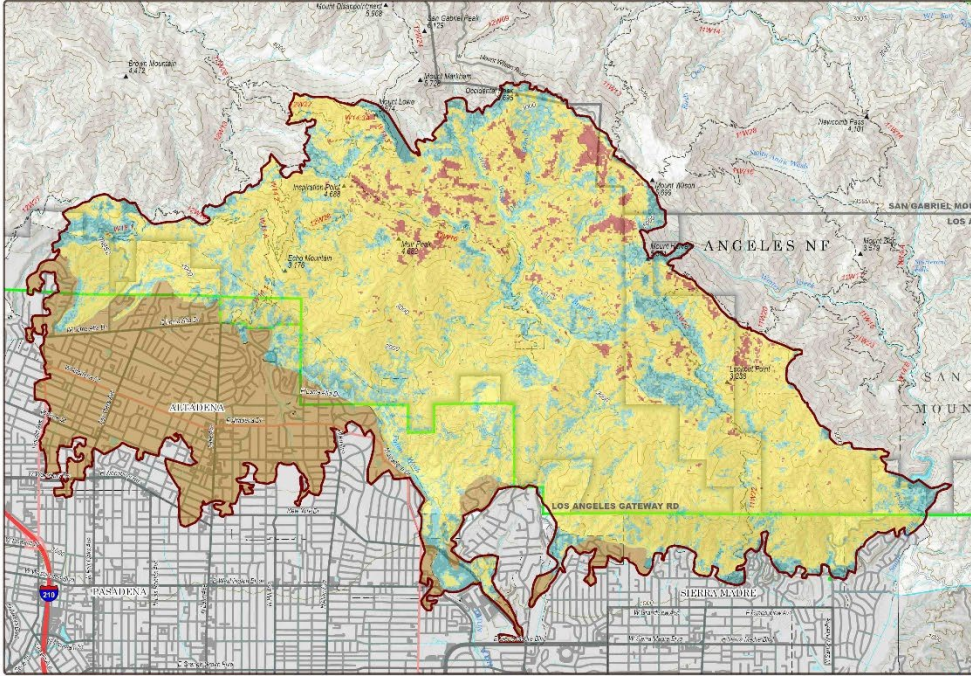
**Eaton Soil Burn Severity
Burned Area Emergency Response (BAER)**

Mapped and validated SBS for the burned area is High (4%), Moderate (74%), Low (17%), and Very Low/Unburned (5%) (see map on page 7). The more severe a fire's effects are on the soil, the more likely those soils will erode in subsequent rainstorms – especially in locations with steep slopes. Erosion after fires can cause tremendous damage to homes and other structures in the years after a fire.

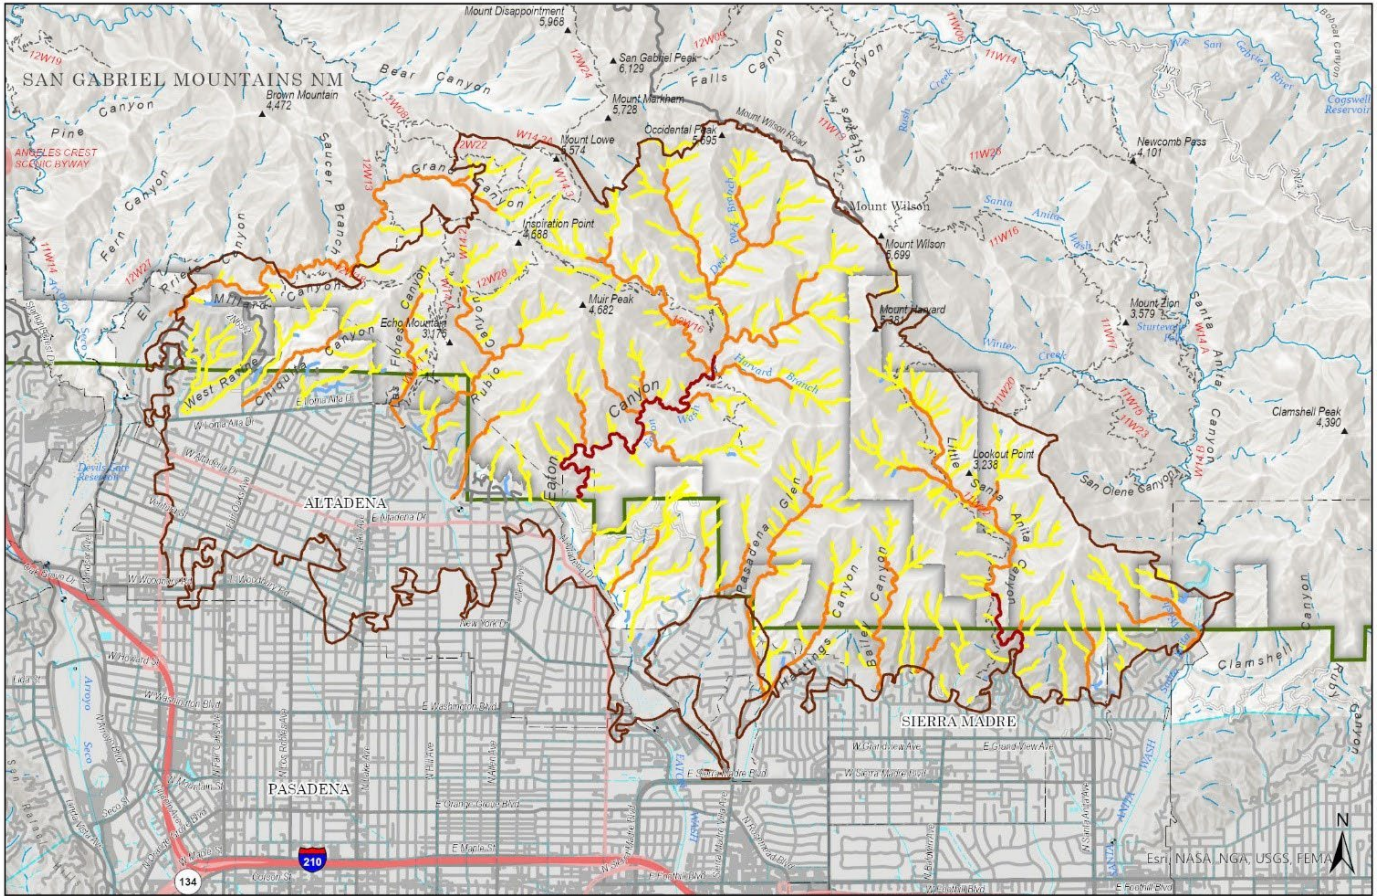
Debris Flow Volume Prediction
 Eaton Fire - Angeles National Forest
 January 2025

The team provided soil burn severity field data to the US Geological Survey Landslide Hazard Program to assist in forecasting the probability, potential volumes, and hazards of debris flows through their developed empirical models. The USGS Post-fire Debris Flow Hazard Model estimates that under conditions of a peak 15-minute rainfall intensity storm rate of 1.57 inches/hour, corresponding to a 1-year return interval storm, a majority of the drainages in the burn scar show high to very high likelihood of debris flow initiation, with a high combined hazard rating (see debris flow maps on pages 8-10).
