Moon Complex Fire Burned Area Summary

Burned Area Report

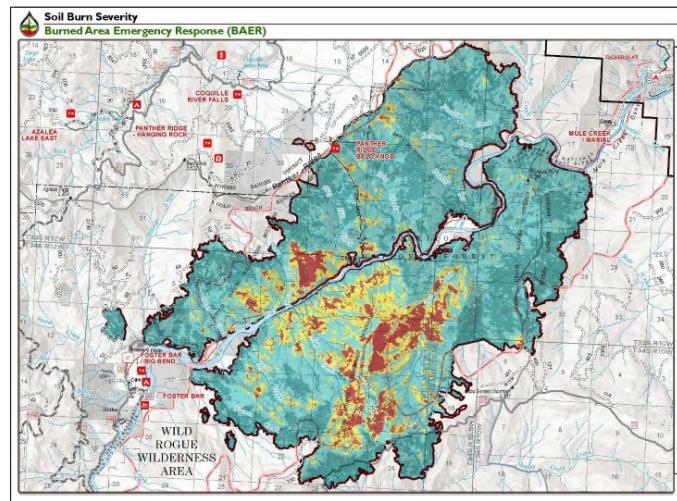
Figure 1. Soil burn severity within the Moon Complex Fire.

Mapped and validated SBS for the burned area is High (6%), Moderate (13%), Low (50%), and Very Low/Unburned (31%) (see map on page 8). The more severe a fire's effects are on the soil, the more likely those soils will erode in subsequent rainstorms – especially in locations with steep slopes. Erosion after fires can cause tremendous damage to homes and other structures in the years after a fire.

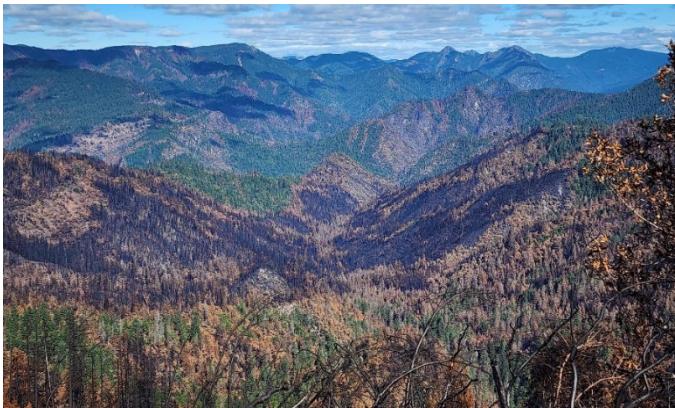
Figure 2. Mosaic burn pattern showing unburned, low, moderate, and high soil burn intensities looking down into East Creek drainage from the 712-spur road.

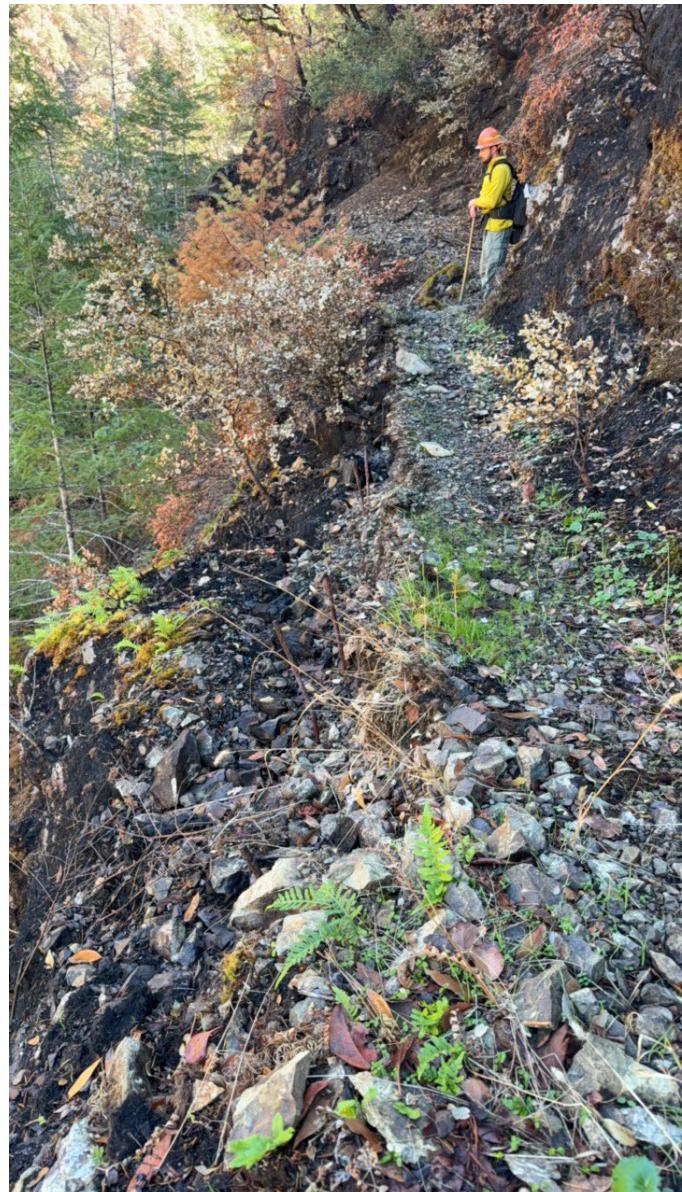
Figure 4. BAER Recreation Specialist assessing burned crib walls along the Rogue River NRT #1160.

The team proposes trail drainage stabilization treatments, which include armoring and/or cleaning existing water control features and adding additional drainage features to provide additional capacity for elevated sediment laden post-fire runoff. Other trail treatments include trail structure stabilization, trail storm inspection and response, tree felling of fire-weakened or dead trees to protect trail tread, trail bridge infrastructure protection, recreation site-human waste containment and infrastructure removal, and continued public information sharing during the first year of BAER implementation to alert users of potential hazards or impassable trail conditions.

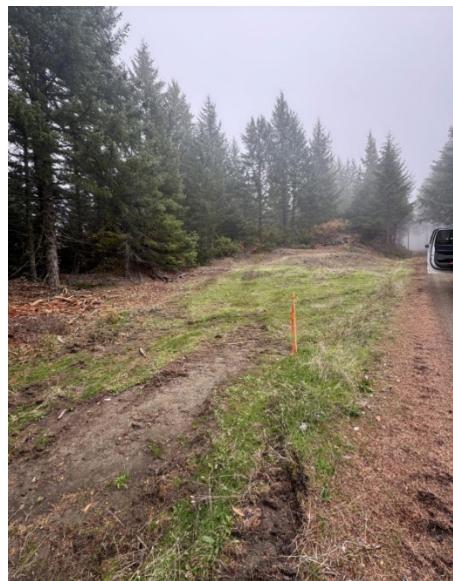
Fourteen species of non-native invasive plants are documented or mapped weed infestations within the burned area and are primarily located along hand line, dozer line, landings and log decks, fire camp, heli-spot and base, and dozer pushouts adjacent to roads that created new soil disturbance beyond the existing road features. However, the burned area creates conditions for invasive species to outcompete native plants. The team recommends a treatment of Early Detection, Rapid Response (EDRR) to monitor noxious weed infestation and expansion in areas disturbed due to mechanical suppression activity and burned areas prone to new noxious weed infestations.

Figure 5. Ground disturbance caused by fire suppression activities along FSR 2300-700 potentially expanding the infestation of Yellow- Star Thistle (*Centaurea solstitialis* CESO3).

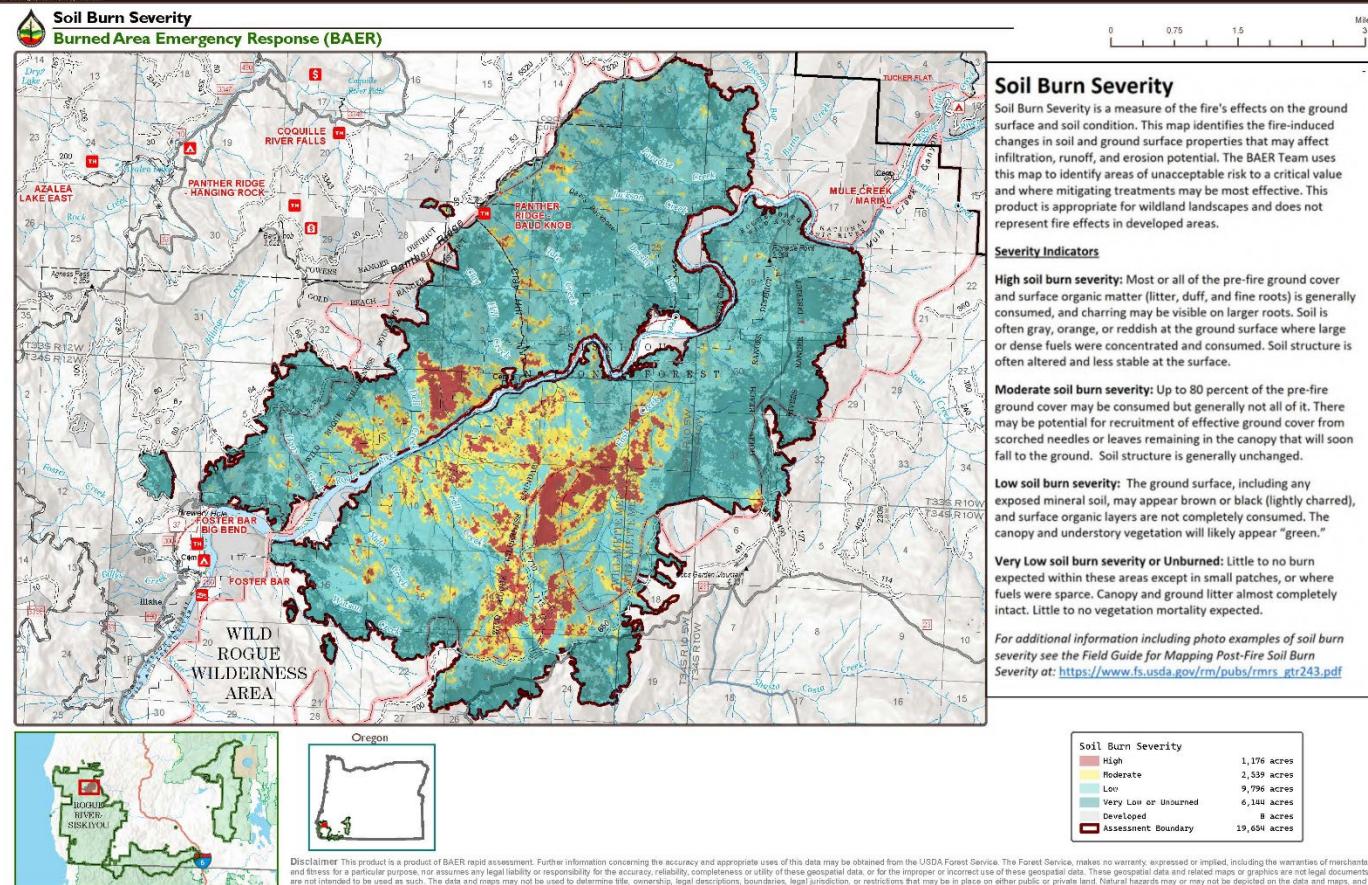
Figure 6. Soil burn severity within the Moon Complex Fire.

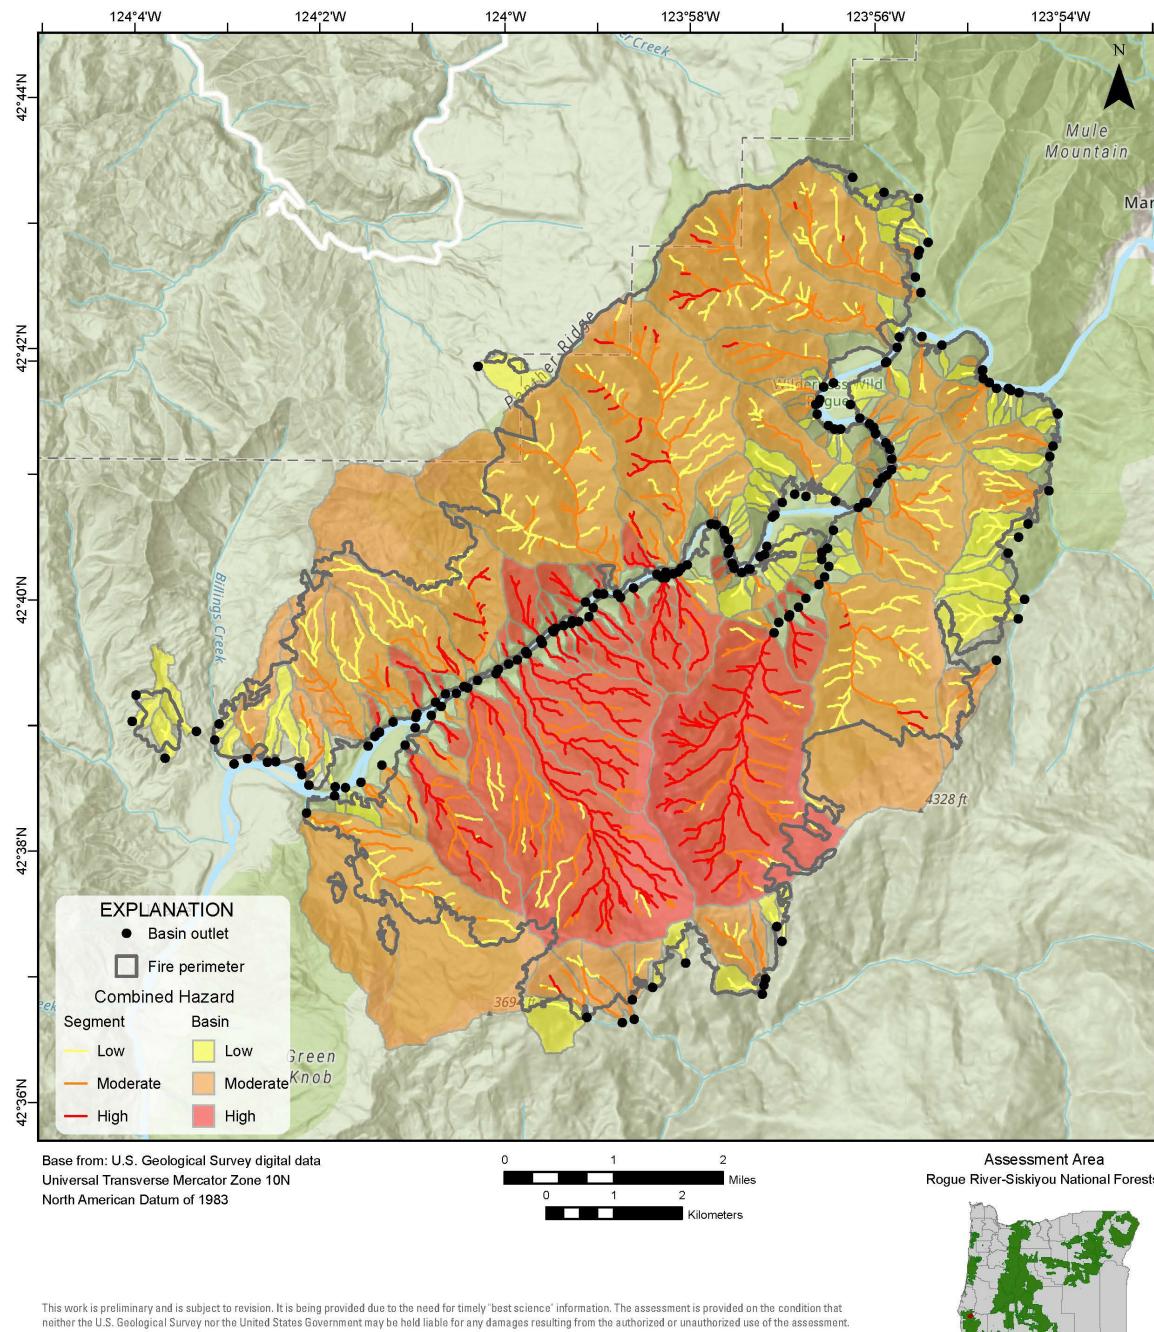
potential volumes, and hazards of debris flows through their developed empirical models. The USGS Post-fire Debris Flow Combined Hazard Model estimates the Moon Fire Complex burn area falls under a Moderate to High combined hazard, with few exceptions. Notably, drainages feeding into East Creek, Fall Creek, and the unnamed segment between Flora Dell and Clay Hill Creek are mapped as High hazard zones (see map on page 9).

Figure 7. Debris flow combined hazard (risk) based on the peak 15-minute 40 mm/h design storm in the Moon Complex Fire burned area.
