BAER Specialists Assess Mosquito Burned Area

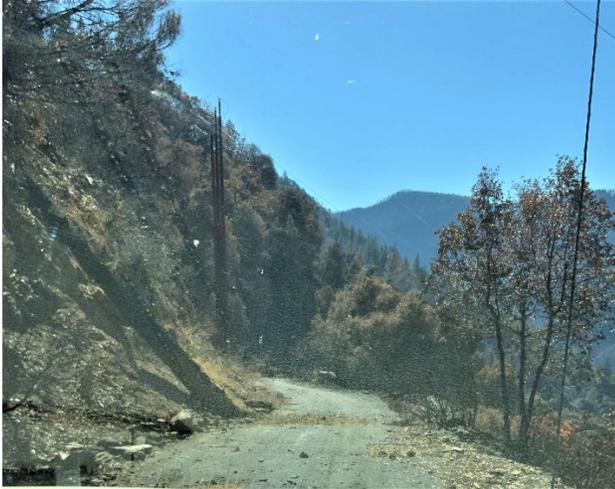
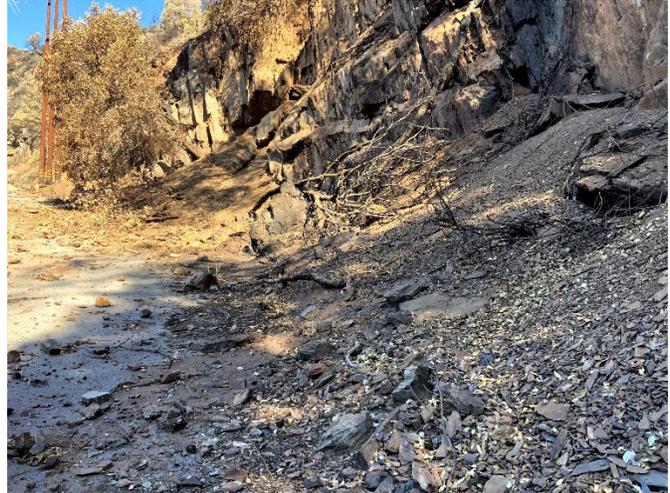
The next two photos show rocks and other debris in the roadway on Forest Service (FS) Road 14N25 in the Eldorado NF side of the Mosquito Fire on the way down to Oxbow reservoir. Rock fall zones can become more active post-fire and become hazardous when driving through the burned areas.

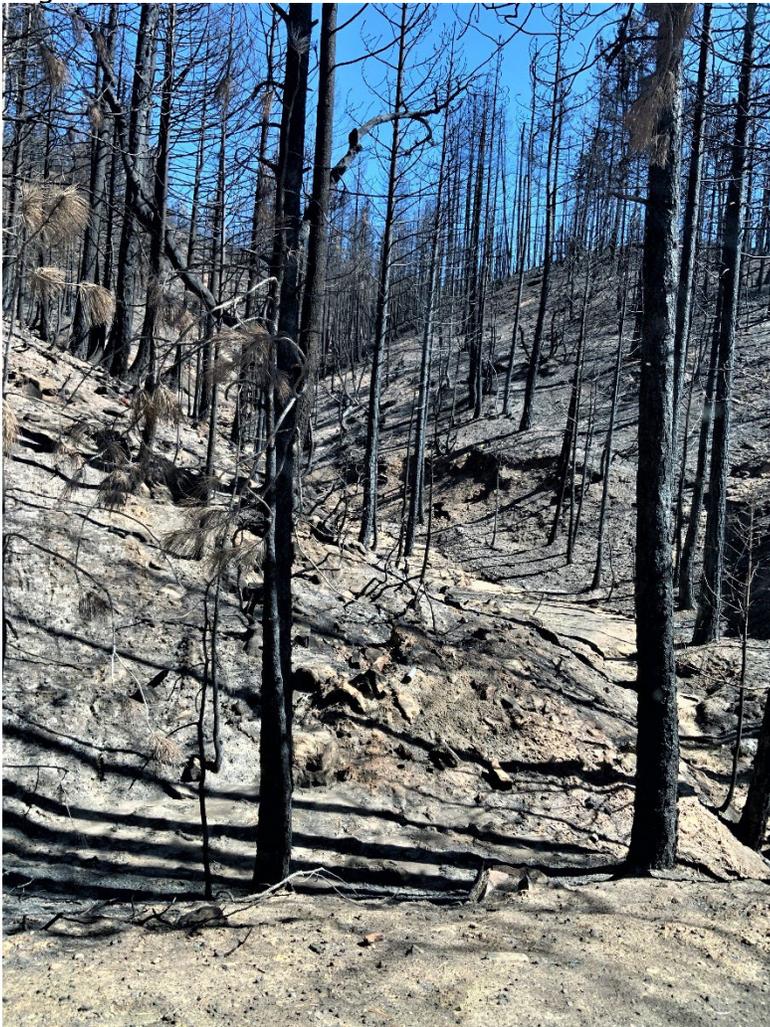
The next photo is a catch basin adjacent to a road with limited capacity for runoff along Forest Route 33 on the Tahoe NF in the Mosquito burned area on the way to the Grouse Falls area. The culvert will likely not be able to handle increased flow, and the catch basin may overtop and lead to road washout and erosion. Because of the fire, there is no vegetation to slow the flow of water or hold the sediment in place.

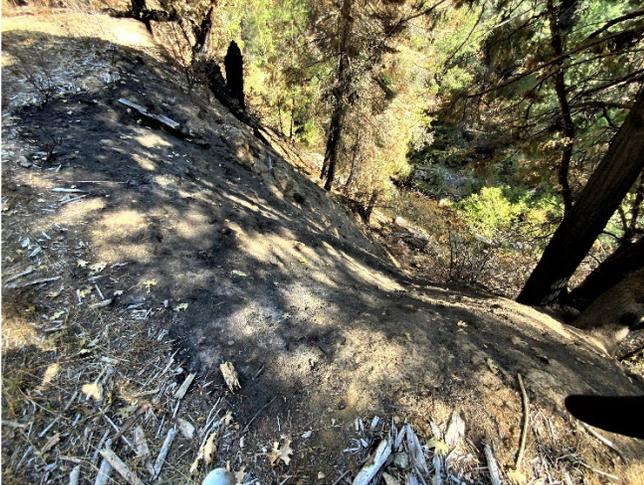
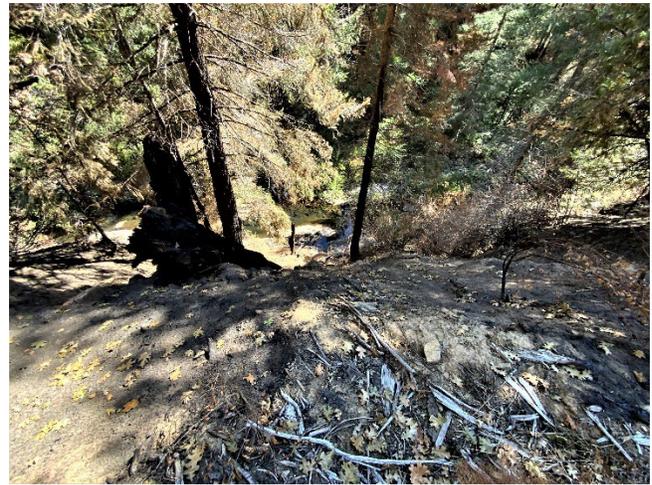
These next two photos show the beginning of a road edge failure along FS Road 13N48 above Pilot Creek. The side of this dirt road drops sharply off into the creek. BAER Engineers will recommend emergency stabilization actions and treatments to ensure that the roads do not wash away or fail. The treatments also need to reduce the amount of sediment entering the waterways, as well as maintain the road width for driver safety.

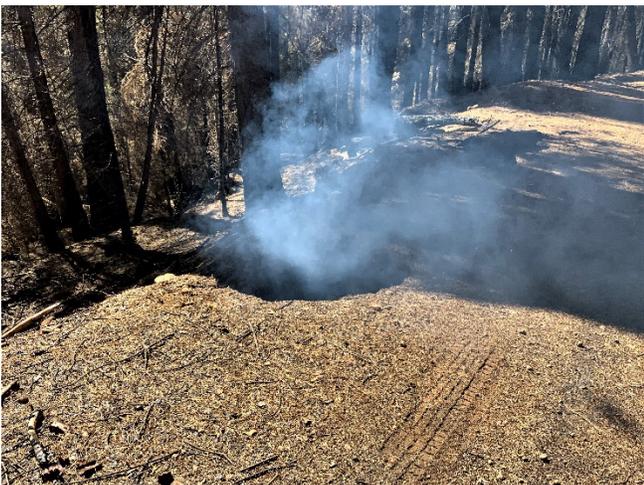
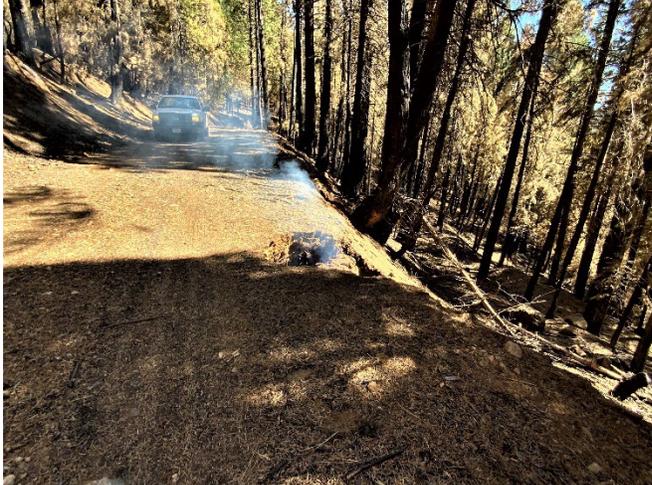
These two photos below show a smoldering tree stump hole along FS Road 13N48 near the Blodgett Experimental Forest in the burned area. Stump holes can be a big road hazard since they are often much deeper and wider than they look on the surface and are prone to caving in. These stump holes were at least three feet deep.

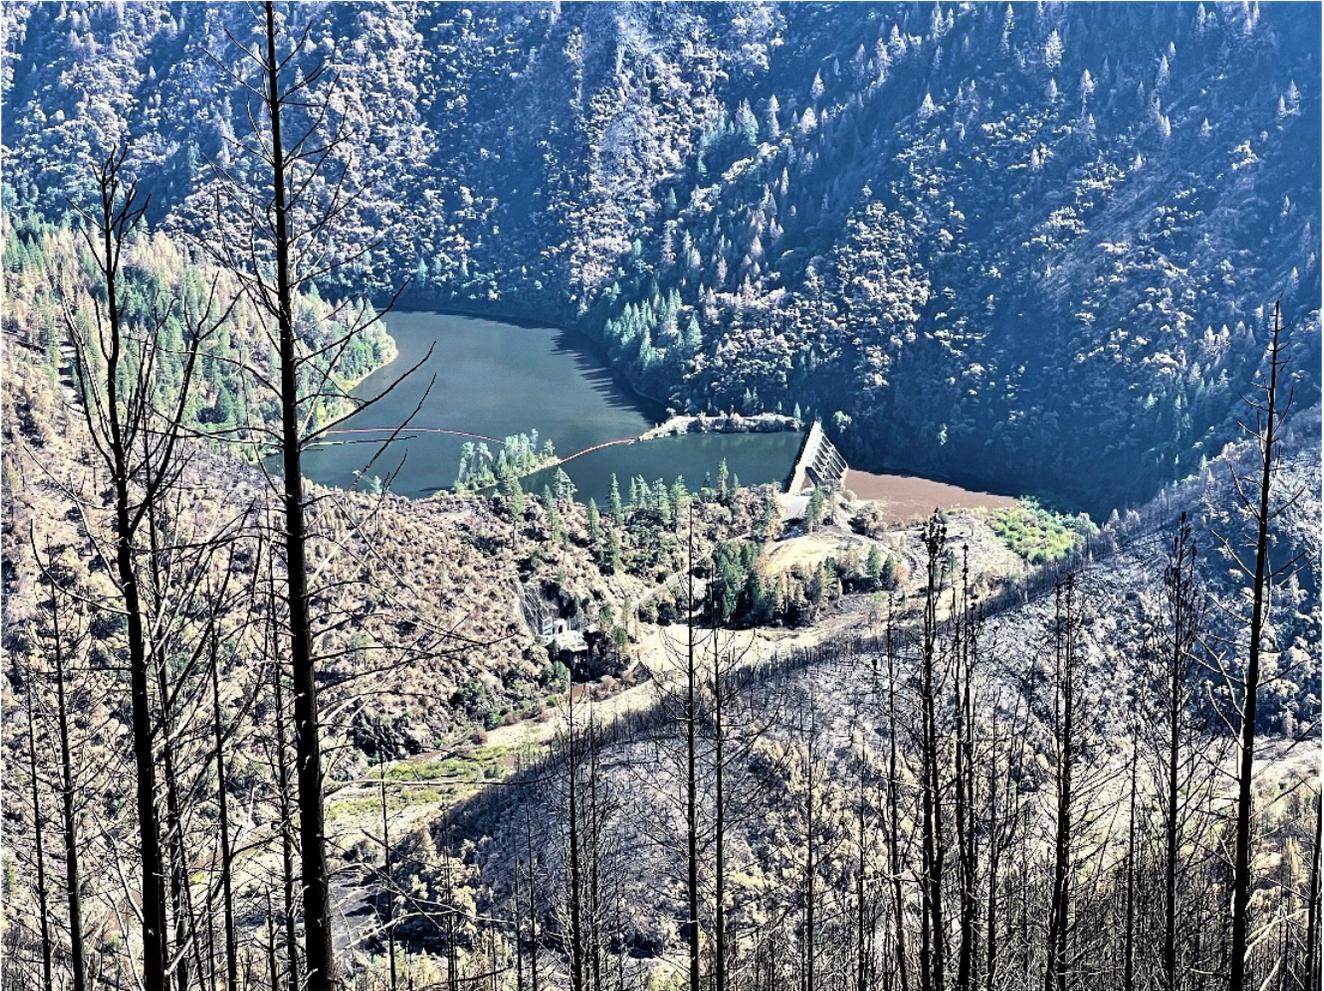
This next photo was taken by BAER Aquatic Biologist Dan Teater during his assessment of the Mosquito burned area. The photo shows Ralston Afterbay Dam located on the Middle Fork of American River and is showing signs of elevated turbidity from ash and sediment because of the rain the burned area received in September. Rain events occurring during a wildfire can impact water quality and the feeding behavior of fish and frogs occupying rivers and streams. Water quality and TES (Threatened and Endangered Species) are also BAER natural resources critical values that are evaluated for post-fire impacts.

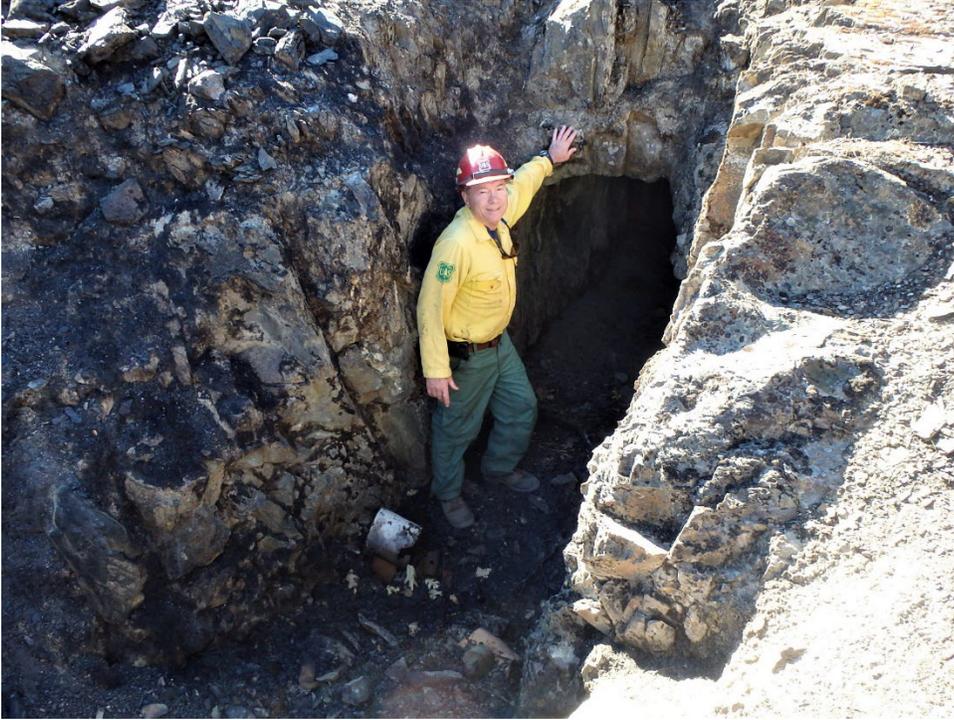
In this next photo, Rick Weaver is assessing an abandoned mine opening near the Gorman Ranch Road. This mine was previously unknown and is now considered a threat to public safety.

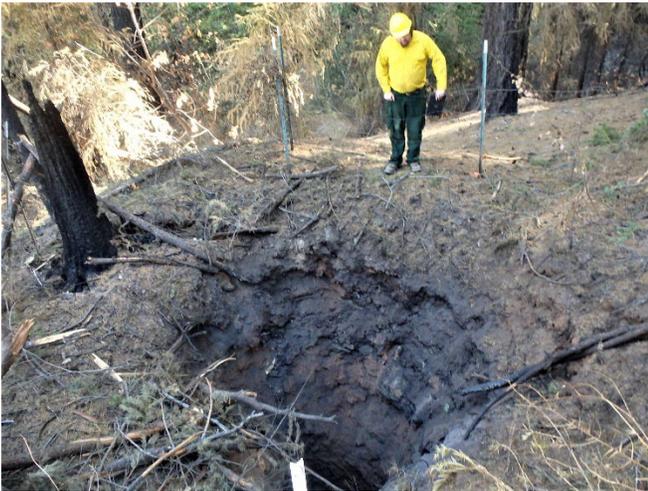
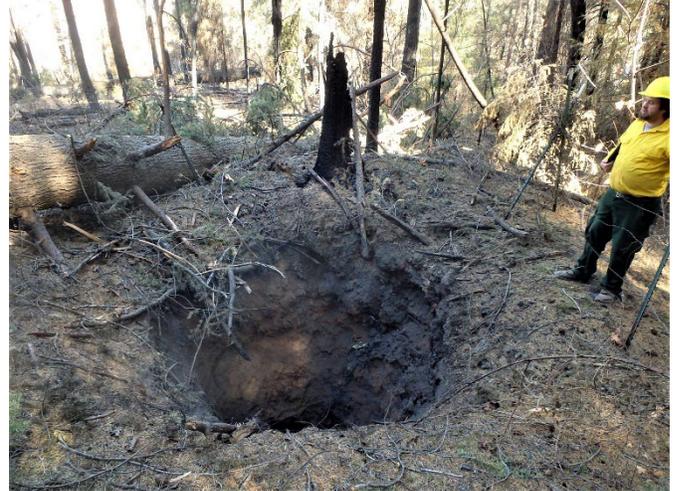
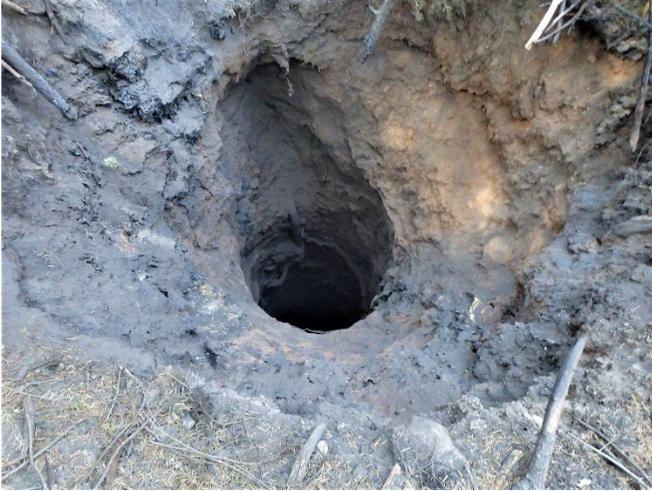
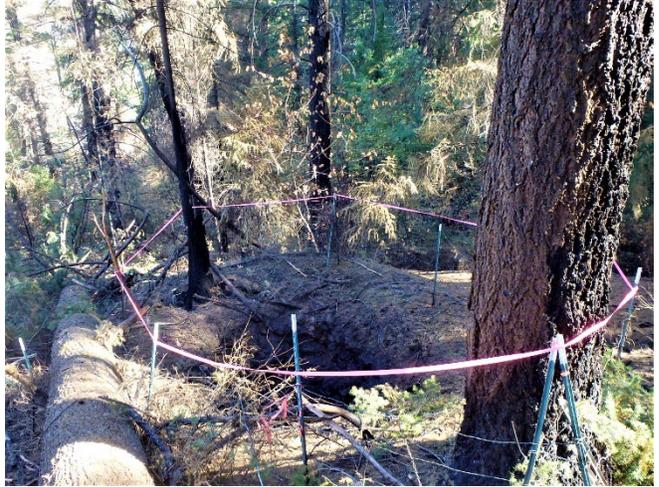
These next four photos show a burned over mine shaft that Jeremy Olson and Rick Weaver assessed in the Mosquito burned area. The shaft was previously closed by a polyurethane foam (PUF) plug. The heat from the fire melted the PUF plug. The BAER team will recommend an emergency stabilization treatment to mitigate the hazard to provide for public safety. The BAER specialists temporarily surrounded the mine shaft with colored flagging to warn anyone who comes upon it.

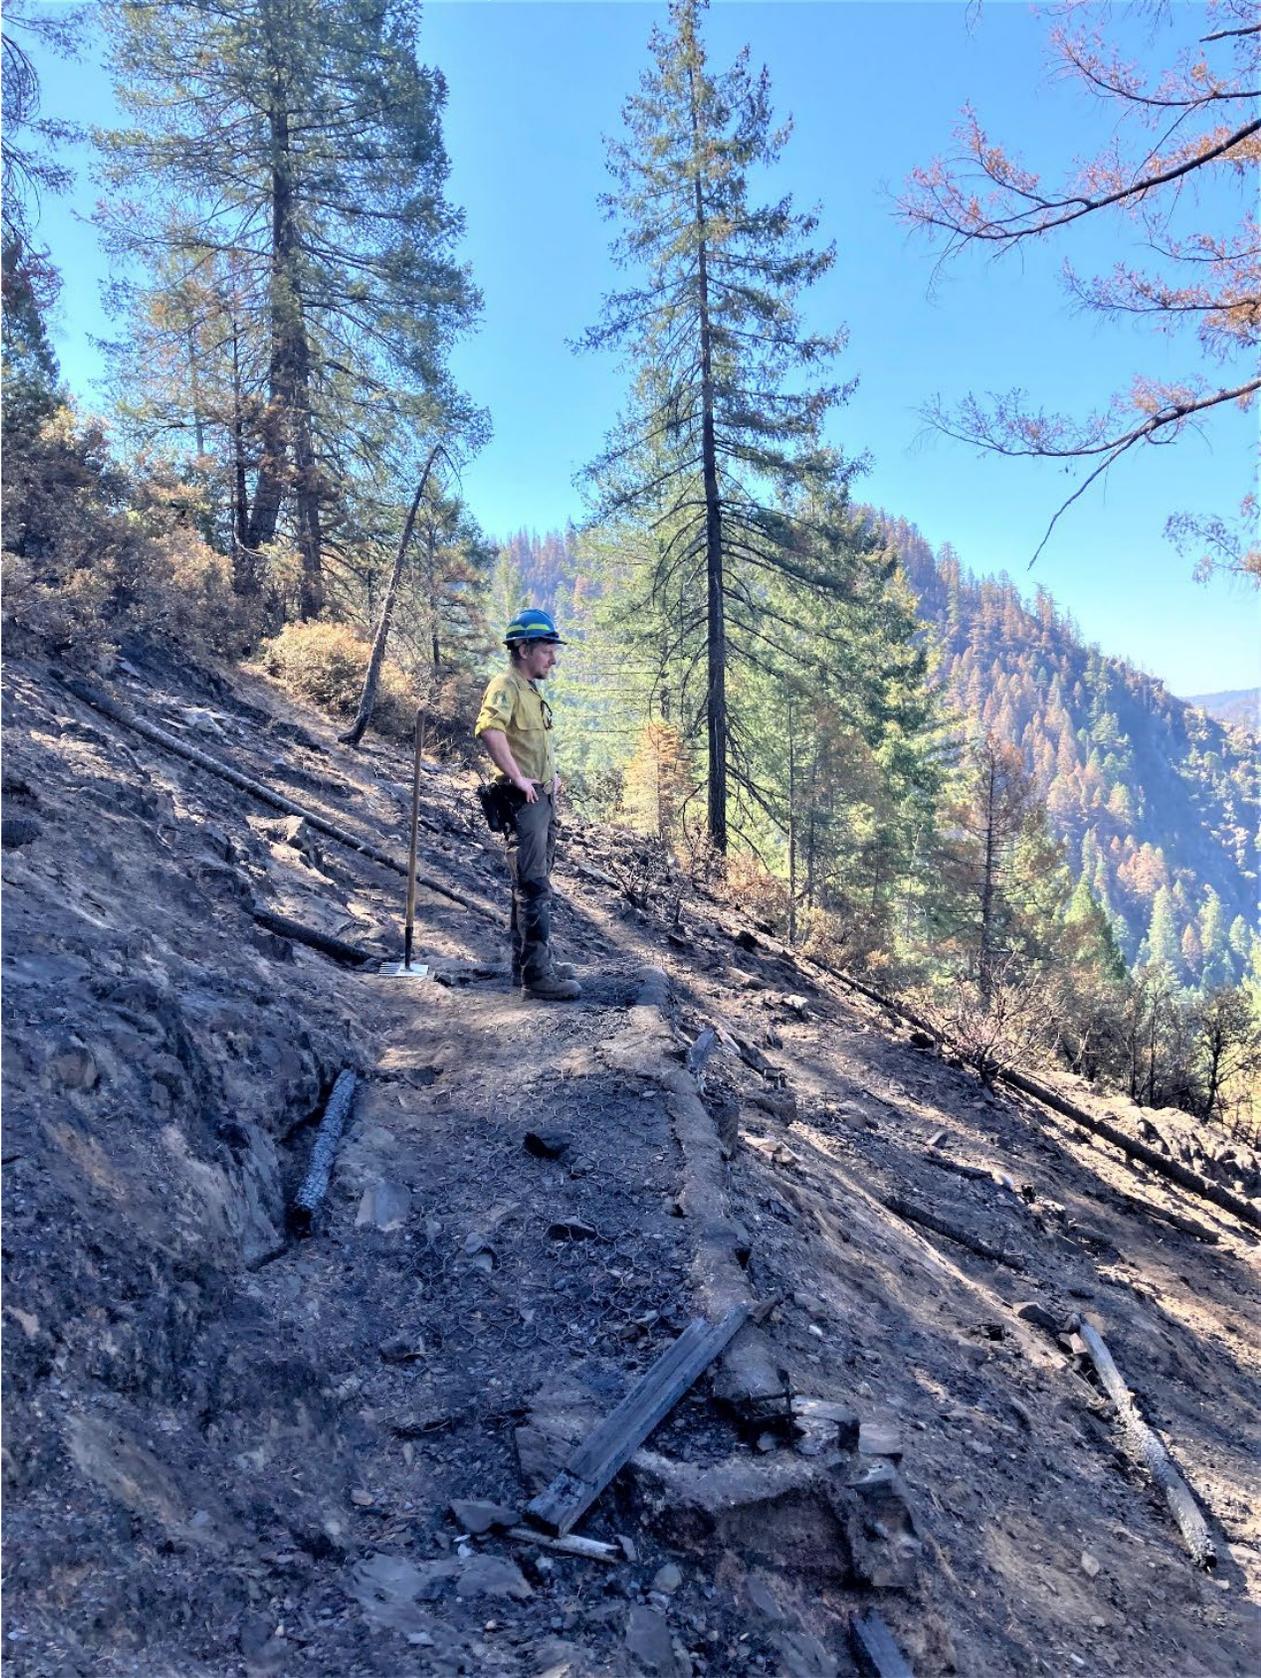
This next photo below shows Tyler Segura assessing Grouse Falls Overlook, which unfortunately burned in the Mosquito Fire.
