Phase I BAER Assessment Team Specialists Evaluate the Hermits Peak-Calf Canyon Fire for Flooding Risks

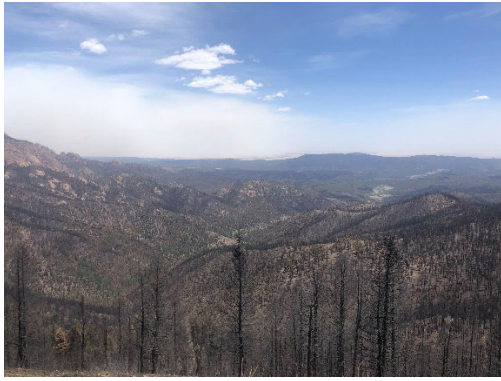
Photo 1: BAER specialists overview of the Headwaters of Gallinas Watershed from the top of Johnson Mesa.

At this location, BAER Hydrologists Paul Brown, Edgar Martinez, and Alex Makic were overlooking the burned watershed and its overall drainage system as data in their evaluation of its post-fire condition and response.

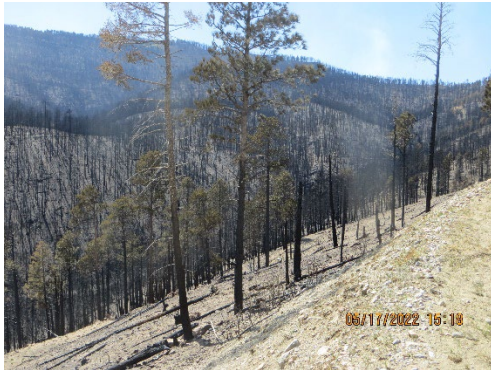
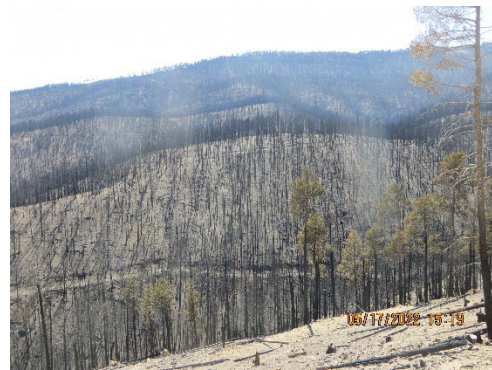
Photos 2 & 3: Overview look of Hermits Peak-Calf Canyon burned watersheds.

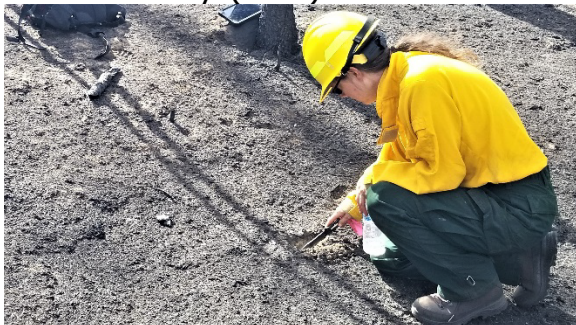
Photo 4: BAER soil specialist trainee Susan Roe is assessing soil hydrophobicity (water repellency) and changes to soil structure in a high soil burn severity (SBS) area of the Hermits Peak-Calf Canyon Fire.

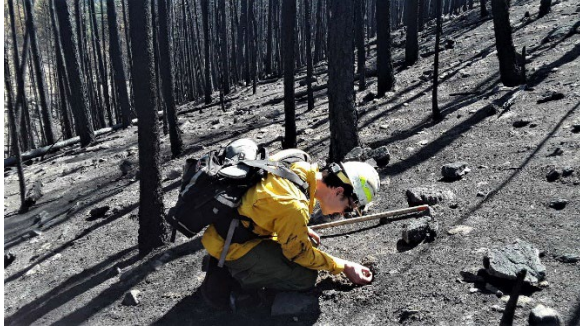
Photo 5: BAER team soil scientist Robert Ballard is evaluating SBS near Gallinas Creek and USFS Road 156.

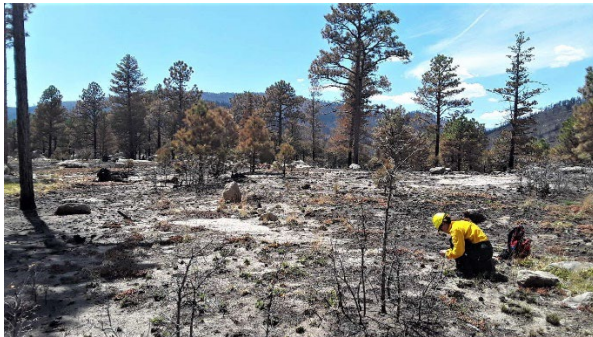
Photo 6: BAER team soil scientist is gathering SBS data to evaluate and map the level of severity within the burned area near USFS Road 156 and USFS Road 18.

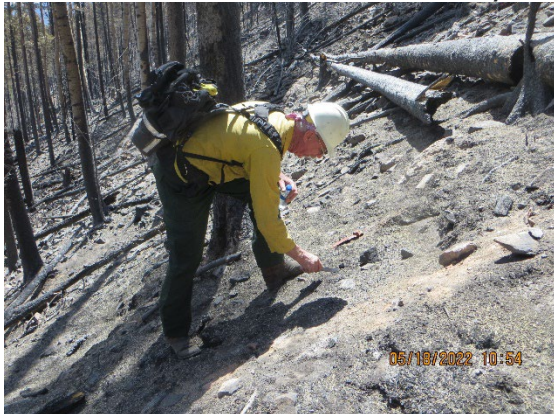
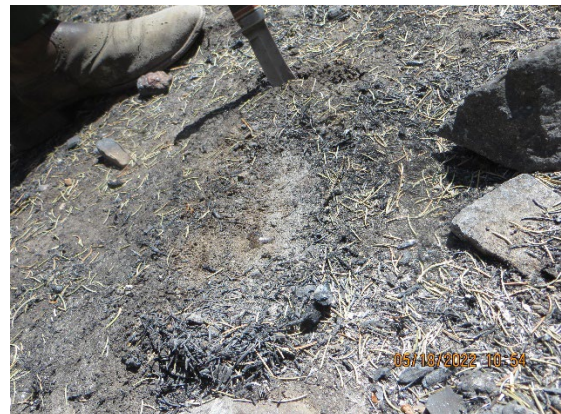
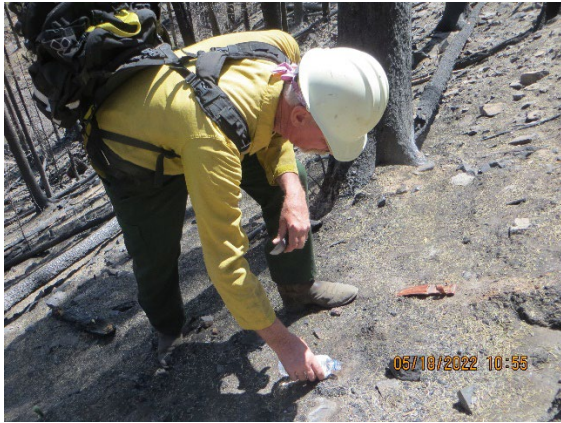
Photos 7, 8, 9: BAER team soil scientist Mike Natharius testing for soil hydrophobicity. Mike captures a drop of water placed on the burned soil which was determined to be hydrophobic.

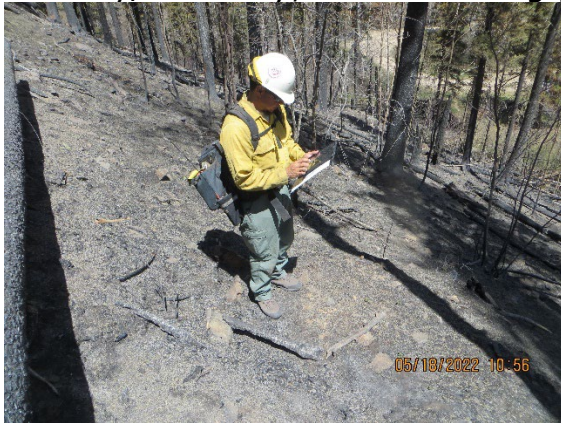
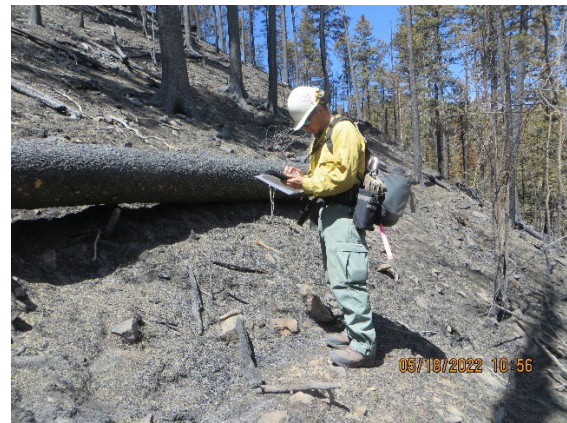
Photos 10 & 11: New Mexico Environment Department for Natural and Working Lands Coordinator Jeremy Klass assists the BAER team with data collection by entering information into the Survey123 database which includes: soil burn severity, soil structure, vegetation burn severity/mortality, and remaining ground cover.

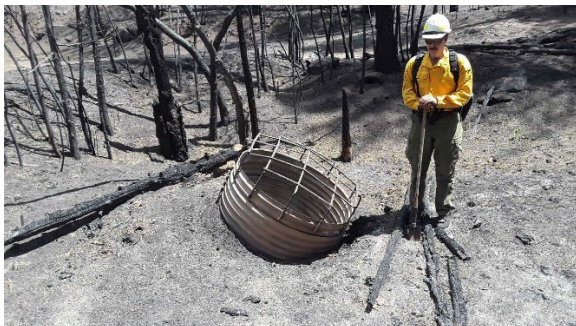
Photo 15: BAER team soil scientist Robert Ballard is inspecting a culvert along USFS Road 156. Culverts within the burned area on NFS land are evaluated to determine whether to increase its function (replace the culverts with a bigger one) to allow anticipated increased water and sediment flows to continue under roads unobstructed.

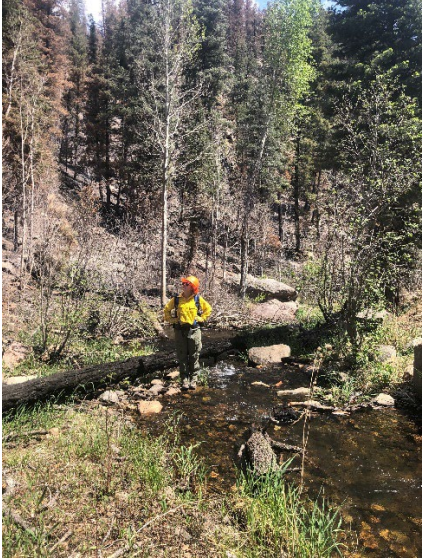
Photo 16: BAER trails and recreation specialist Sarah Smith is working with the BAER engineering and hydrology specialists to assess bridges within the Gallinas headwaters watershed.

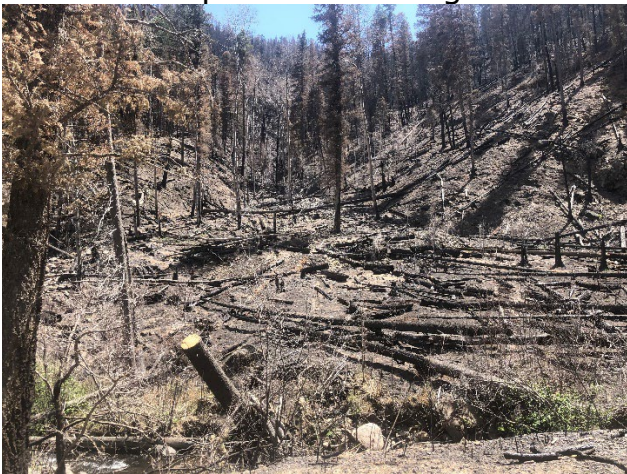
Photo 17: A burned drainage that flows into Gallinas Creek. Here BAER hydrologists were looking at potential impacts near and around the road that could cause potential damage to the road prism.
