Hermits Peak-Calf Canyon Burned Area Emergency Response (BAER) Phase 2 Assessment Report

Executive Summary

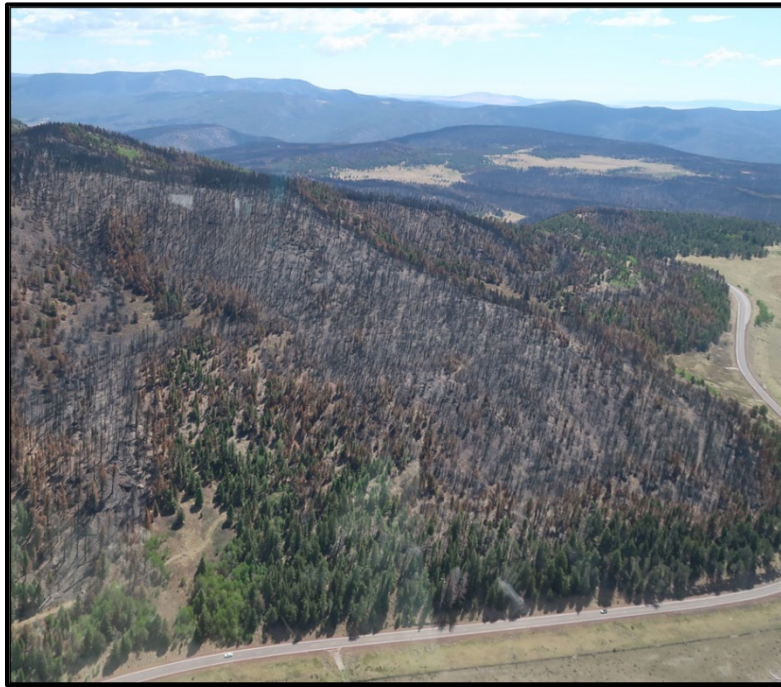
Figure. 1 Aerial View of Unburned, Low, Moderate, and High Soil Burn Severity in the Phase 2 HPCC Assessment Area

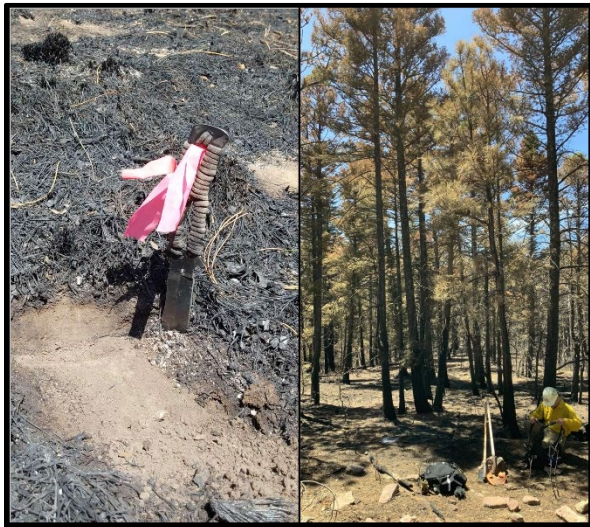
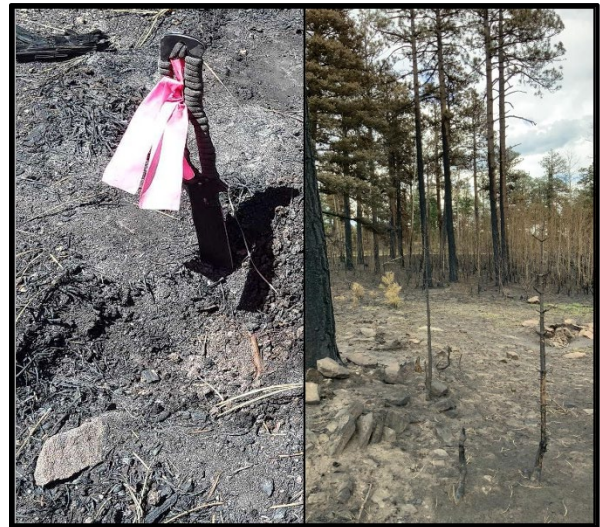
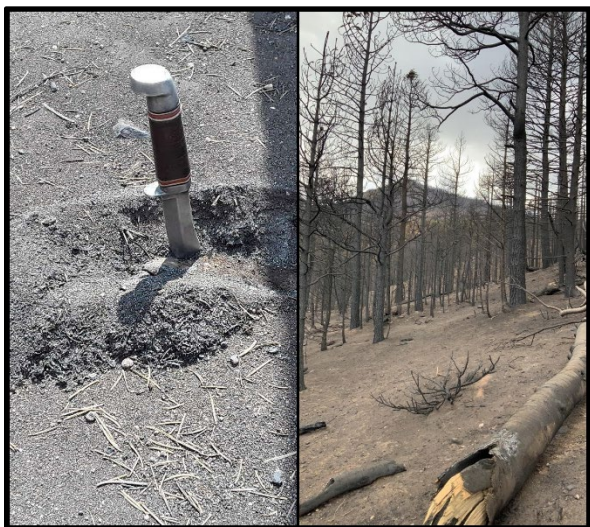
Figure 3: Examples of low (top left), moderate (top right), and high (lower left) soil burn severity in the burned area. These burn conditions, including remaining ground cover, soil integrity, hydrophobicity, remaining root structure, and surviving vegetation, assist to estimate the likelihood and intensity of future flooding, erosion, and debris- flows.

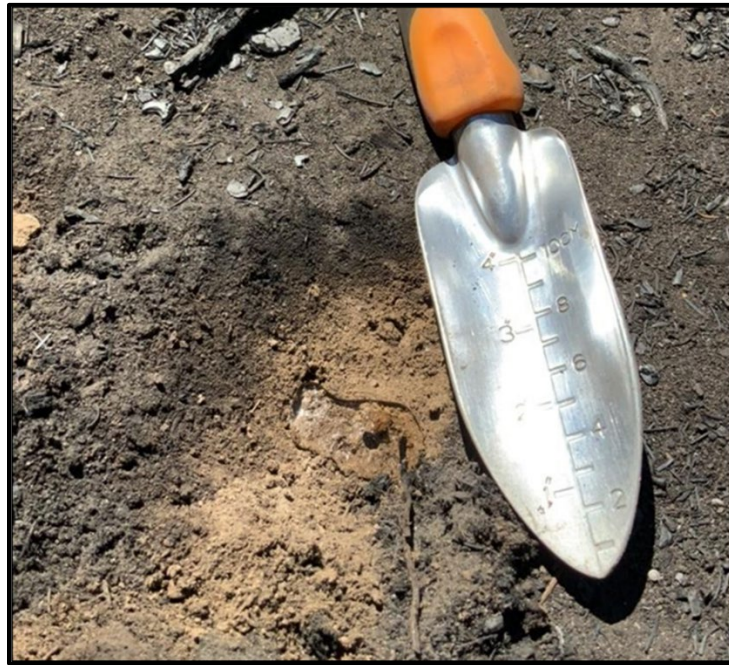
Figure 4: Strong hydrophobic soil conditions caused by moderate soil burn severity in mixed conifer forest. Note 2 cm diameter water drop that persists on soil surface.

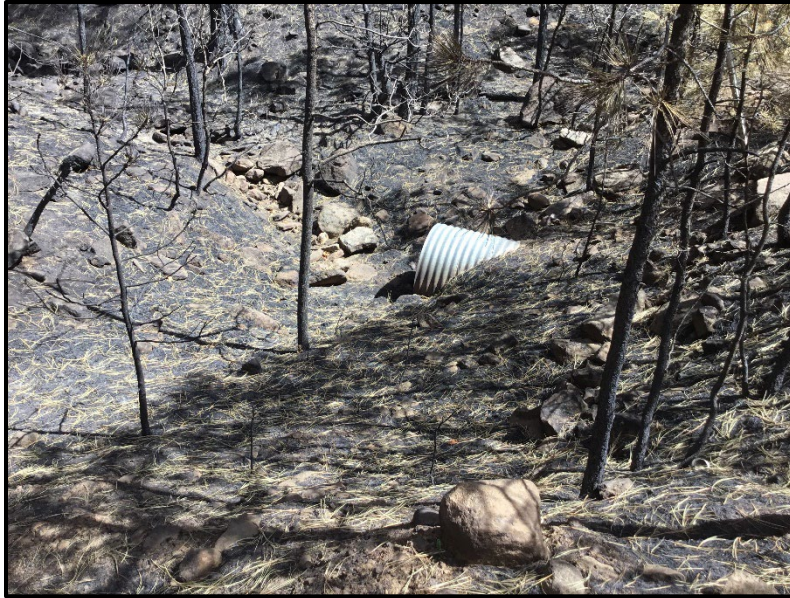
Figure 5. Burned area above culvert where increased erosion and sedimentation can plug culverts leading to a road being overtopped by flood waters.

The road prism may become impassible to vehicles and in extreme cases may be completely washed out due to fill slope failure. Road prisms may also be damaged due to falling rock and debris making the road impassible. Public safety hazards are significantly increased due to flash flooding, where road segments lie within the floodplain, fallen trees, destabilized rock slopes, damage to traffic safety structures and signs.

Common BAER emergency treatments could include signs warning travelers of the increased danger, closures of some Forest Service roads during monsoon season, storm inspection and response, creating armored dips, clean ditches to handle increased flows, and removing debris from stream channel.
