**Burned Area Emergency Response Assessment
Watershed Summary
Oak Fire, CA (CA-MMU-016149)
Mariposa County
August 2022**

Jonathan (Yonni) Schwartz, Geologist, Los Padres National Forest, CA
Casey Shannon, Hydrologic Technician, Inyo National Forest, CA
Curtis Kvamme, Soil Scientist, Stanislaus National Forest, CA

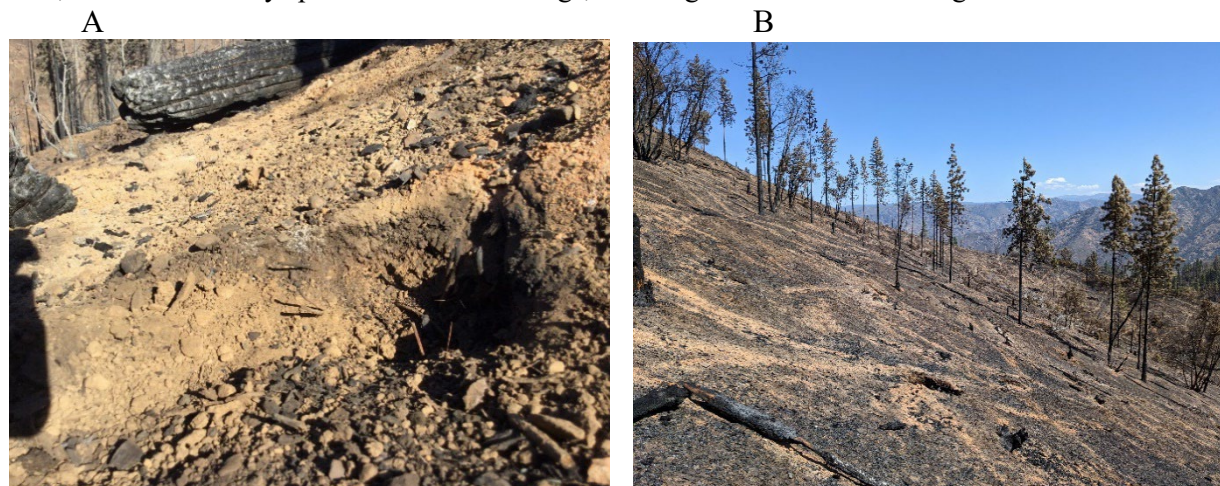
Figure 1- Reburn areas

A) Carstens reburn, deep soil heating under heavy surface woody debris loading, and **B)** Ferguson reburn area, with more widely spaced burned down logs, and no ground cover remaining.

The Soil Burn Severity product is used as an input for all the methods presented in this report; it is thus the basis for determining the severity of post-fire watershed response. Combined, Moderate (45%) and High (21%) soil burn severity cover most of the fire. Burn severity percentages by ownership are shown in Table 1, and a map of burn severity is in Appendix Map 1. In this fire, from a distance the high and moderate burn severities look very similar. In all vegetation types burned at moderate SBS, there is little or no intact canopy, no live vegetation remaining, and no potential for needlecast to act as a ground cover; only 10% of the sampled locations (2 of 20 in moderate and high SBS) had any potential for effective needlecast. The high SBS differs from moderate by having deeper soil heating and consumption of roots, and a thicker, deeper hydrophobic layer. Finally, in the reburn areas, particularly in the Carstens fire, there is very deep soil heating and structure loss underneath burned logs that were laying on the surface before the Oak fire (Figure 1A). In contrast (as usual), low SBS will have good ground cover or needlecast potential, some live vegetation cover, and lower expected erosion and runoff response. Low SBS was mapped in all vegetation types but is most extensive in oak woodland with a grass understory, and in parts of the Ferguson fire reburn that did not have large accumulations of fuel buildup, or where fire behavior was minimal.

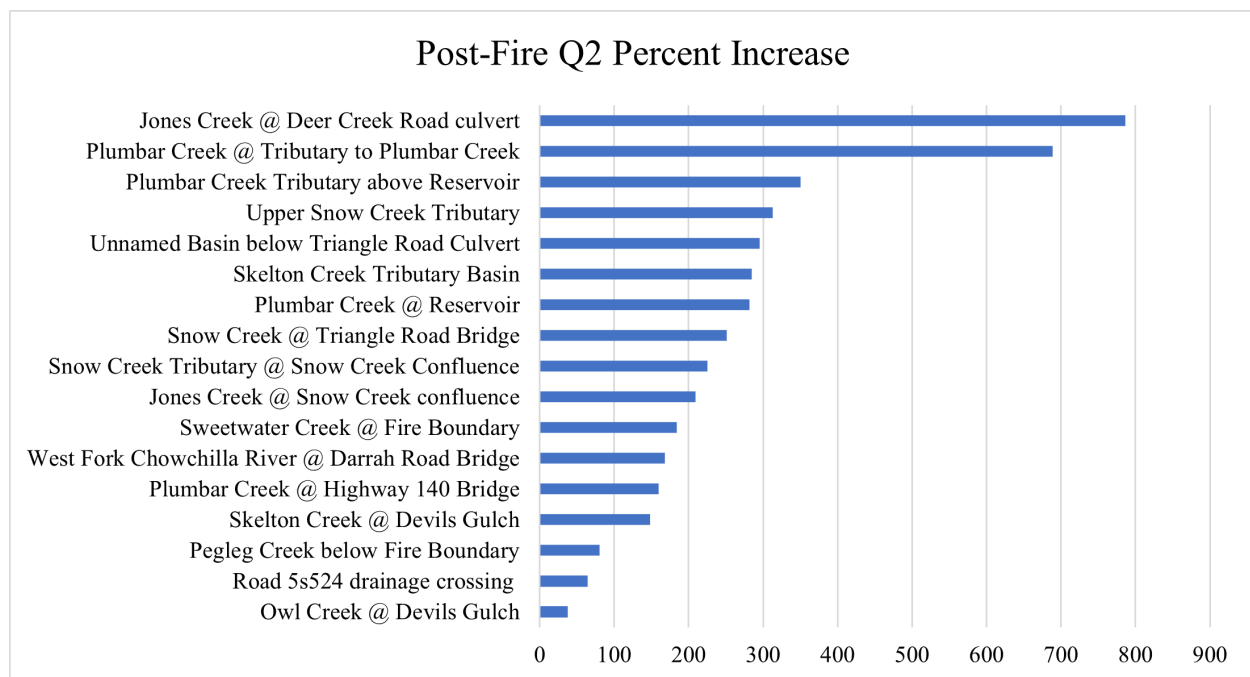
Figure 3- Modeled percent increase of a 2-year return interval peak flow (Q2, bulked)

Hydrologic modeling for post-fire discharge was completed for burned watersheds for design storms of 2, 5, 10, 25-, 50-, 100- and 200-year peak flows (results for all design storms are available in the BAER hydrology report). Because increased watershed response conditions tend to occur during the first five years post-fire, the 2-year (Q2) and 5-year (Q5) peak flow events are of particular concern. Percent increases in Q2 are shown in Table 3 below, and additional detail and flow numbers are shown in Appendix Table A. Based on results of hydrologic modeling, the watersheds predicted to have the highest post fire watershed response (up to 200 to 300 and above percent flow increases) are within the Plumber Creek, Snow Creek and Jones Creek watersheds and tributaries and high watershed response is likely. Post-fire runoff and sediment during storm events are likely to be substantial enough to create impacts to Forest Road and trail infrastructure. Forest roads and trails are the main critical values that increased watershed response will affect. Threats to Human Life and Safety on Forest lands are not as likely because of the lack of populated areas and infrastructure within the watersheds. Visitors on Forest roads and trails may encounter hazardous watershed conditions if present during large storm events or if present within drainages with high watershed response.
