BAER Scientists and Specialists Assess Yeti Fire – What They Do

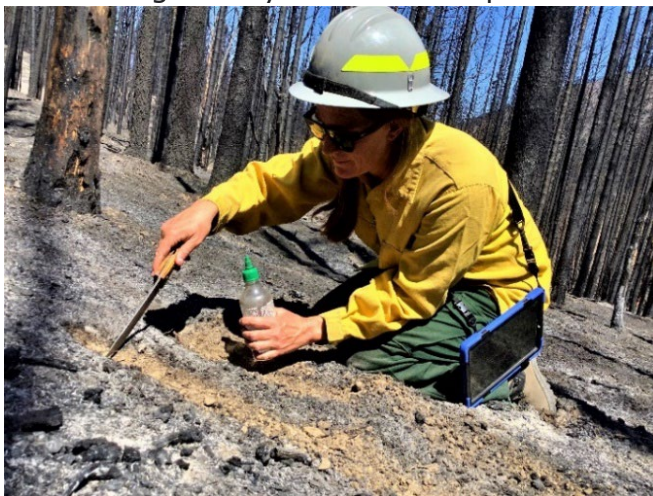
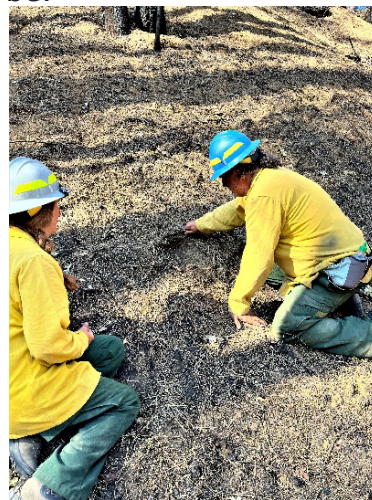
Below, these three photos show Forest Service Soil Scientist Eric Nicita and Hydrologist Jesse Merrifield assessing soil hydrophobicity (water repellency) and changes to soil structure in a high soil burn severity (SBS) burned area. Jesse digs a trench and drops water on the soil at multiple depths to determine how deep and how strong the layer of water-repellant soil may be.

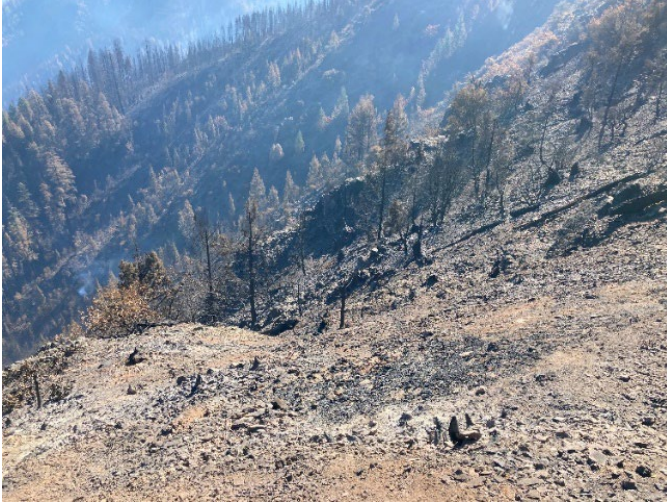
In this photo below, BAER Geologists Yonni Schwartz and Dennis Veich assessed these steep (90%) burn slopes below China Peak within the Yeti burn area for potential initiation of debris flows during major rainstorm events.

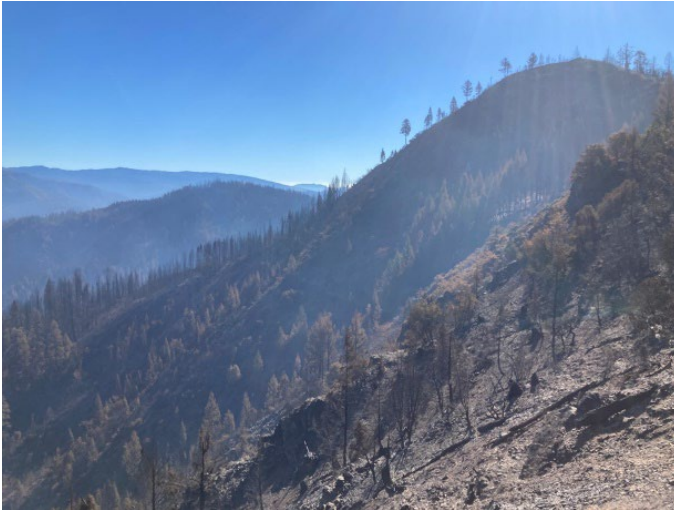
This photo below shows moderate and high soil burn severity areas on extremely steep slopes (80% and above) below China Peak.

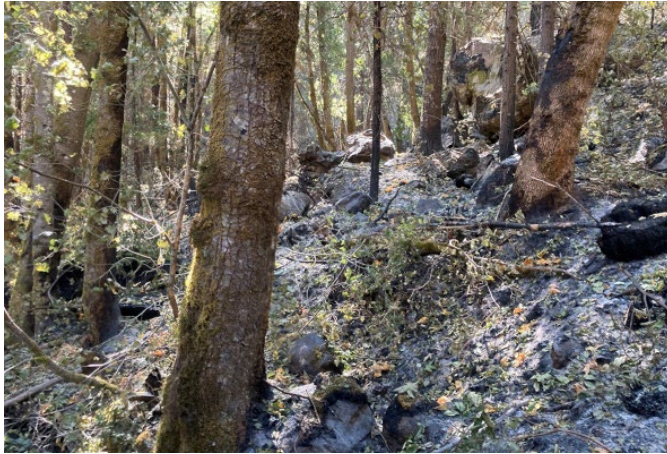
During Yonni and Dennis' Yeti burned area assessment, they found some slopes and drainages loaded with unsorted, unconsolidated materials comprised of rocks of all sizes including boulders, cobbles, gravels, and fine sediments.

In the photo below, West Grider Creek is loaded with rocks of all sizes, including boulders and cobbles.

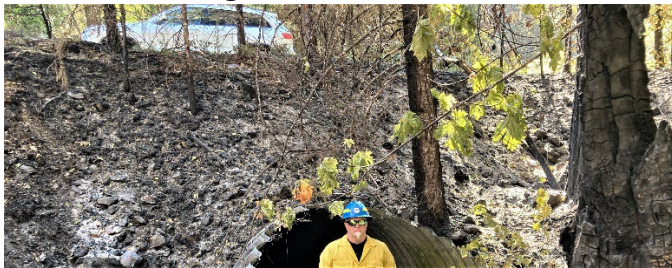
In this photo Dennis assesses potential increased sediment and debris flow impacts to road crossings and culverts in the Yeti burned area.

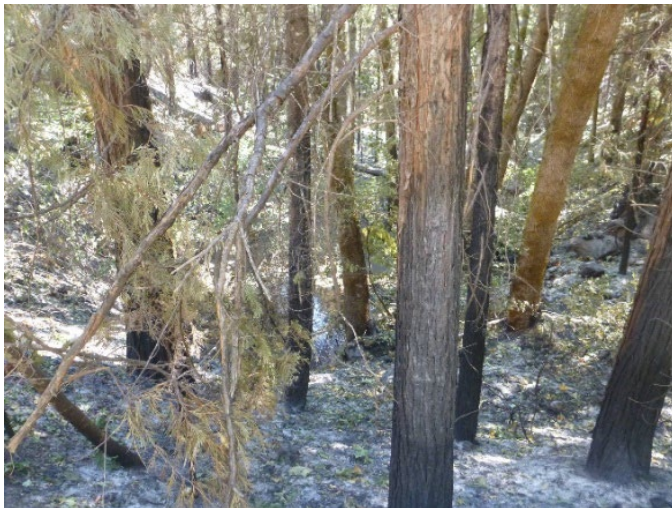
Another BAER specialist who conducted field surveys within the McKinney and Yeti burned areas to assess habitat conditions of critical aquatic species was Forest Service Fisheries biologist Maija Meneks. She captured these next two photos during her August 21, 2022, Yeti burned area assessment. Her photo below shows a downstream view of West Grider Creek from Forest Service Road 46N56 crossing.

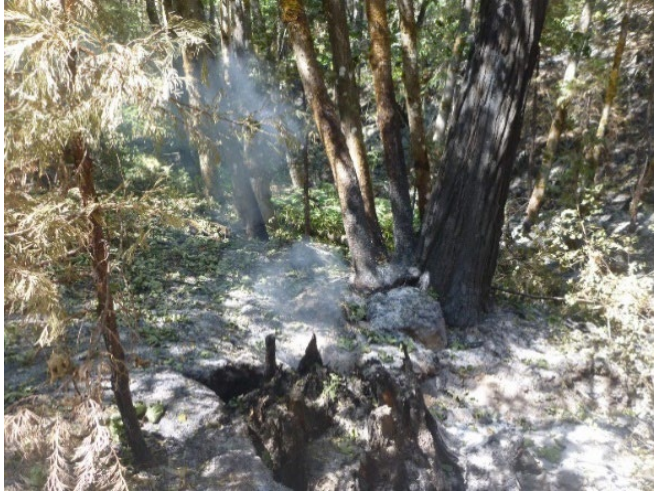
While this photo shows an upstream view of West Grider Creek from Forest Service Road 46N56 crossing.

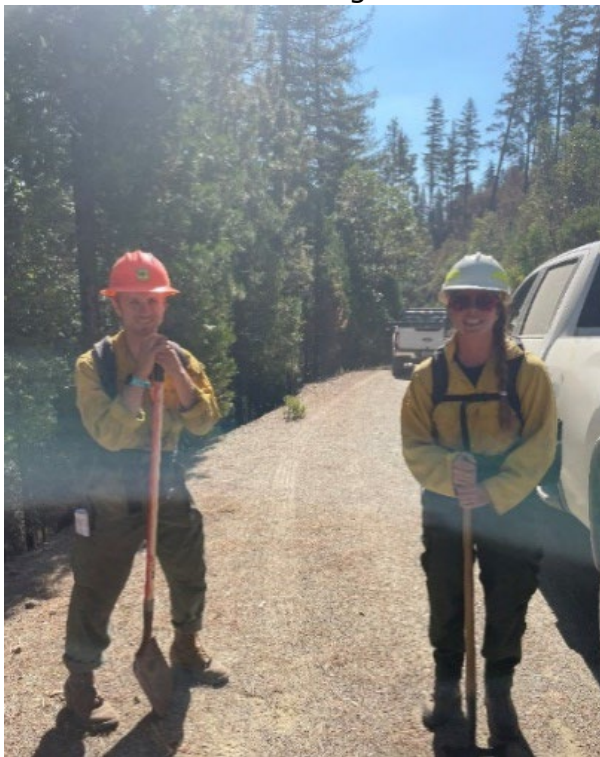
In this last photo, Forest Service Engineer Sam Marano and Forest Service Botanist Erin Lonergan are getting ready to assess dozer lines and Forest Service roads in the Yeti burned area for possible invasive weeds that could impact native plant communities and damage natural resource vegetative habitat.
