BAER Specialists Assess SR Lightning Complex fires for flooding threats

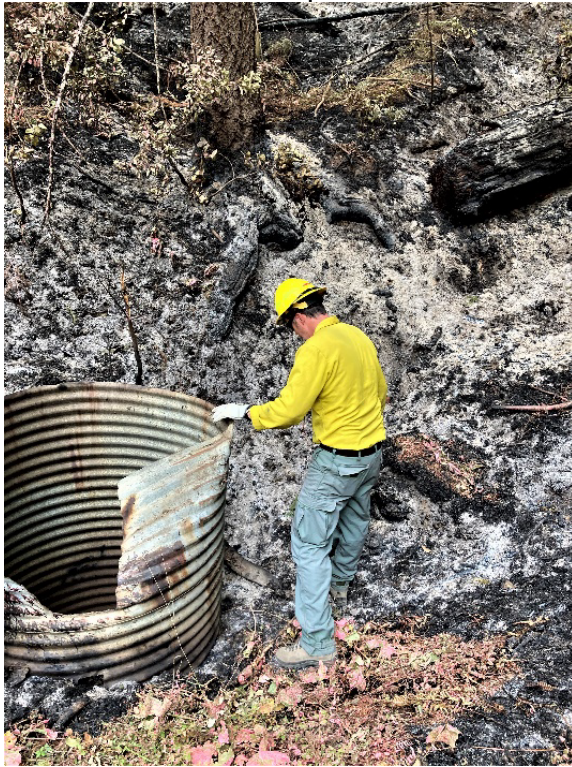
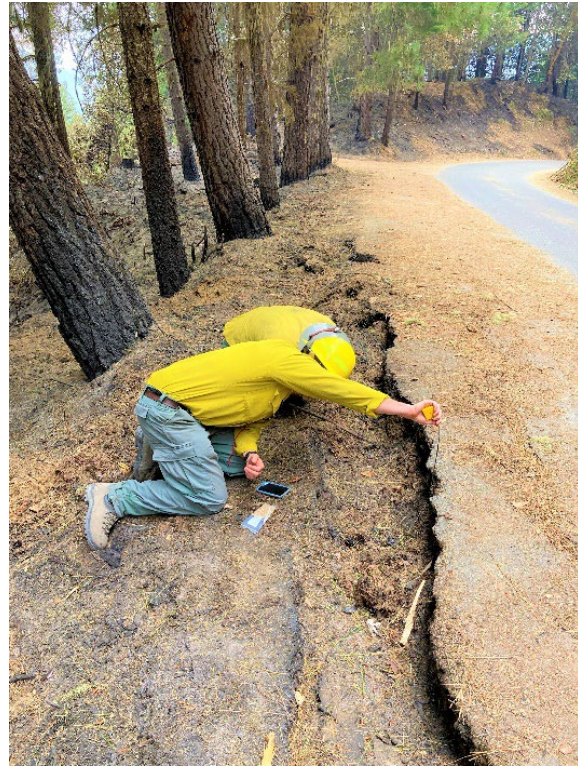
The two photos below show BAER specialists assessing road and watershed conditions in the Campbell Fire burned area on September 7, 2022. They are evaluating the condition of existing drainage structures and road conditions for their BAER assessment report.

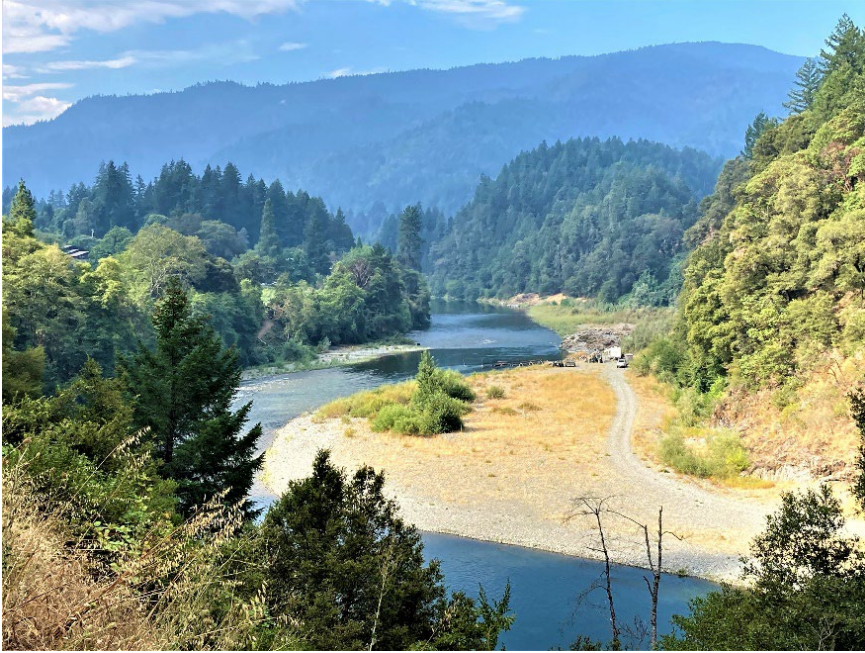
The photo below shows the mainstem of the Trinity River near Willow Creek which has been designated as a Wild and Scenic River (WSR) which is a critical natural resource value that the BAER team identified for their assessment. The outstandingly remarkable value (ORV) for this reach of the Trinity River is that it provides important habitat for salmon, steelhead, green sturgeon, and many other fish species. Some of these fish species are listed as threatened under the Endangered Species Act such as the coho salmon. The South Fork Trinity River is also a critical natural resource value with a WSR designation and ORV for its suitable habitat for salmon and steelhead.

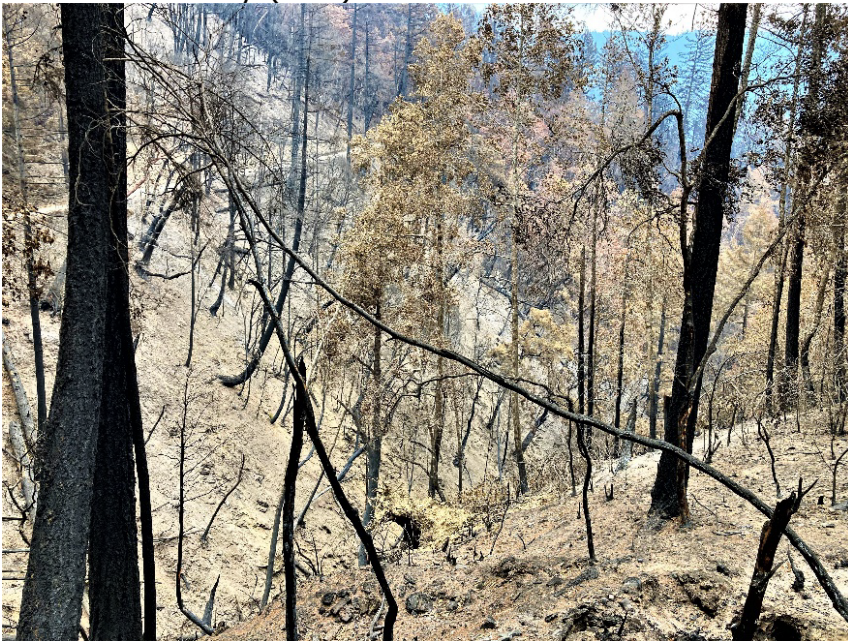
The next photo shows the condition of one of the intermittent stream channel areas in an area of the Campbell Fire that burned hot. Fortunately areas like this are an anomaly since the majority of the other burned areas burned at a low or very low soil burn severity (SBS).

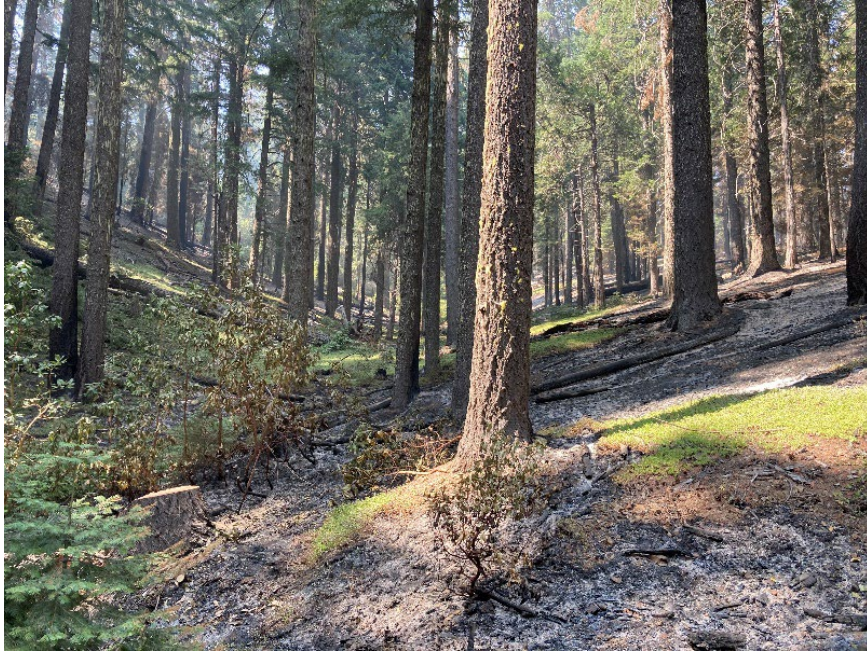
This photo below captures a low soil burn severity (SBS) in the Groves Prairie area off NFS Road 7N31.

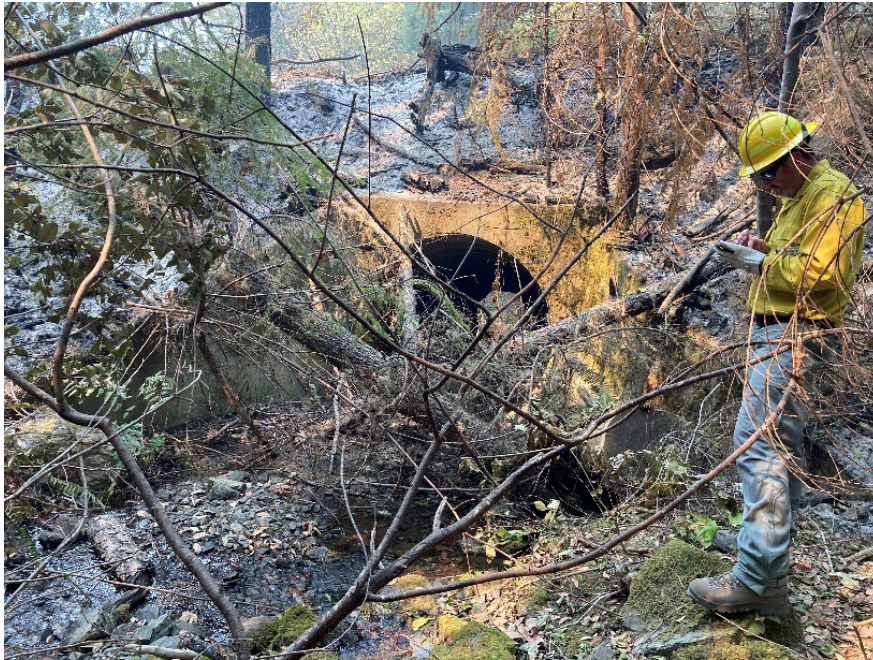
In this next photo below, Forest Service Civil Engineer Justin Nettleton evaluates a road culvert for risk of plugging during fall/winter storms on NFS Road 7N31.

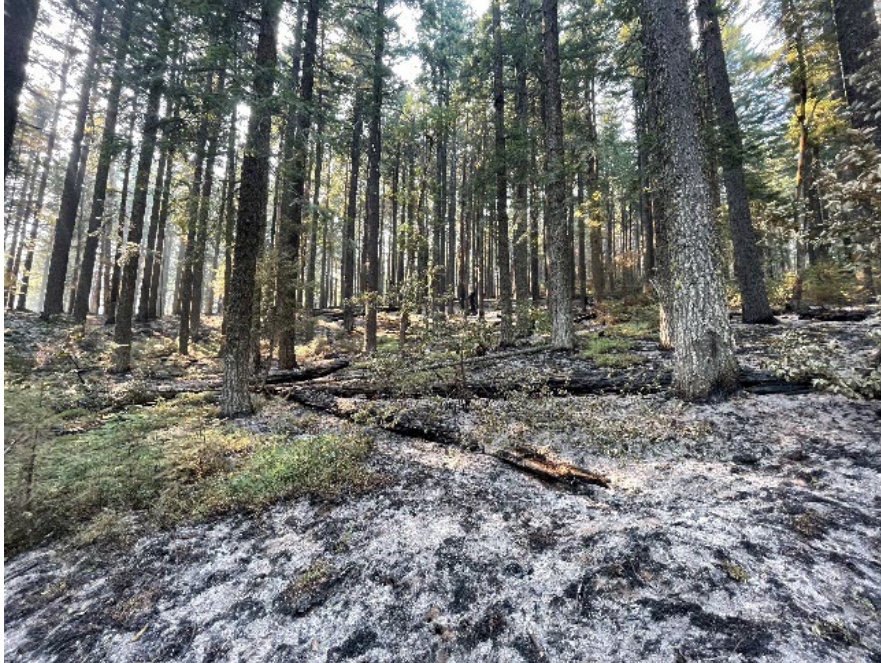
Below, is a photo of a low soil burn severity (SBS) area in the Campbell Fire.

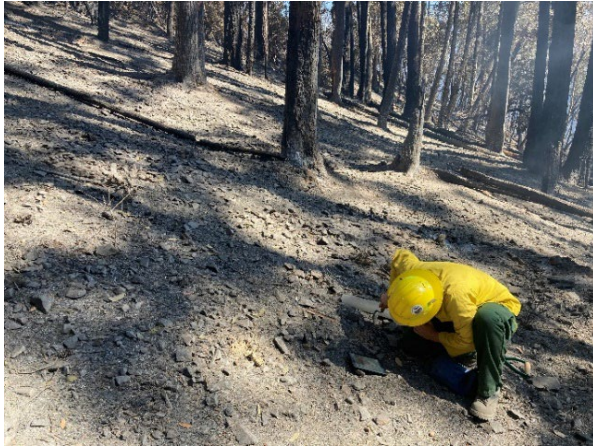
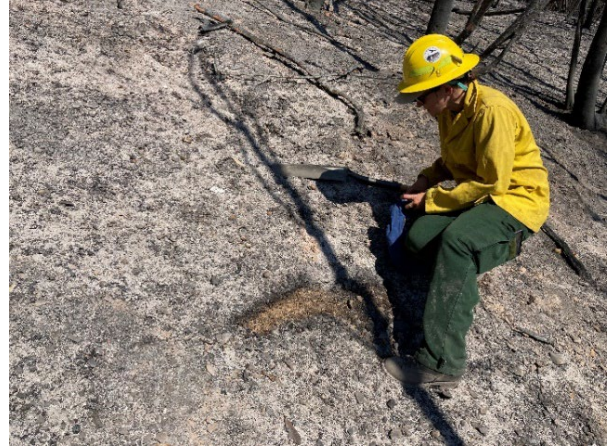
In these two photos below, Forest Service Hydrologist Emily Fudge assesses soil hydrophobicity (water repellency), changes to soil structure, and maps the soil burn severity (SBS) in Hawkins Creek burned drainage located in the Campbell burned area.

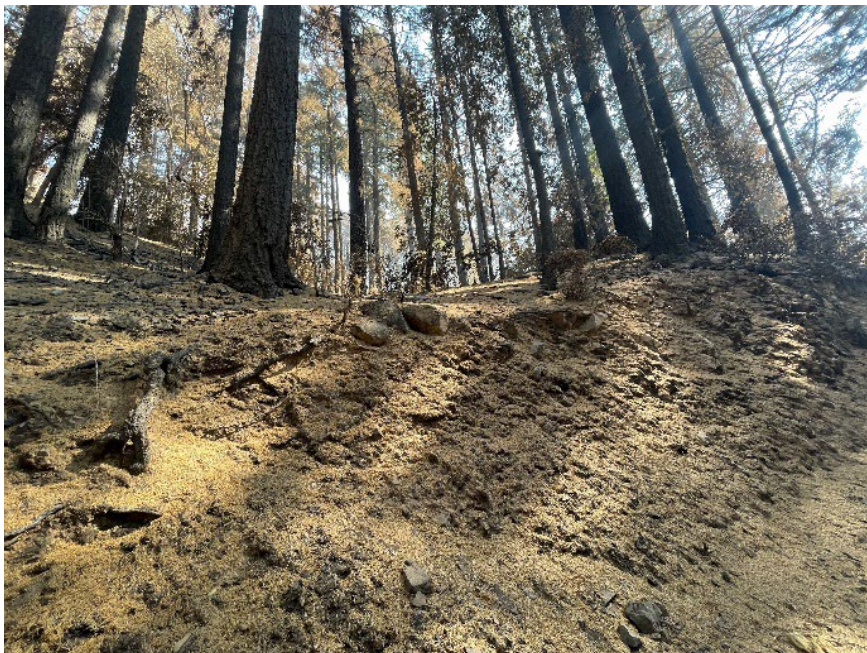
This last photo shows “needle cast” covering the soil on a slope in the Campbell Fire where ground cover no longer remains after the fire. Needle cast happens when the heated and dead needles fall to the ground from the burned and heated pine trees. The needles provide protective cover to the bare soil during rainstorms that help dissipate (block water) and spread water droplets to prevent erosion. The needles also provide a source of recycled nutrients for growth and mulch that retains soil moisture.
