BAER Specialists Assess Radford and Fairview Burned Areas

A Forest Service Burned Area Emergency Response (BAER) team is assessing federal lands burned in the Radford and Fairview Fires, with the goal of keeping visitors and employees safe while recreating and working in the San Bernardino National Forest (NF). BAER team assessments focus on emergency actions that are necessary to protect human life and safety, property, critical cultural resources, and critical natural resources such as soil productivity, hydrologic function, and water quality. Emergency actions are intended to minimize any further damage during rainstorm events.

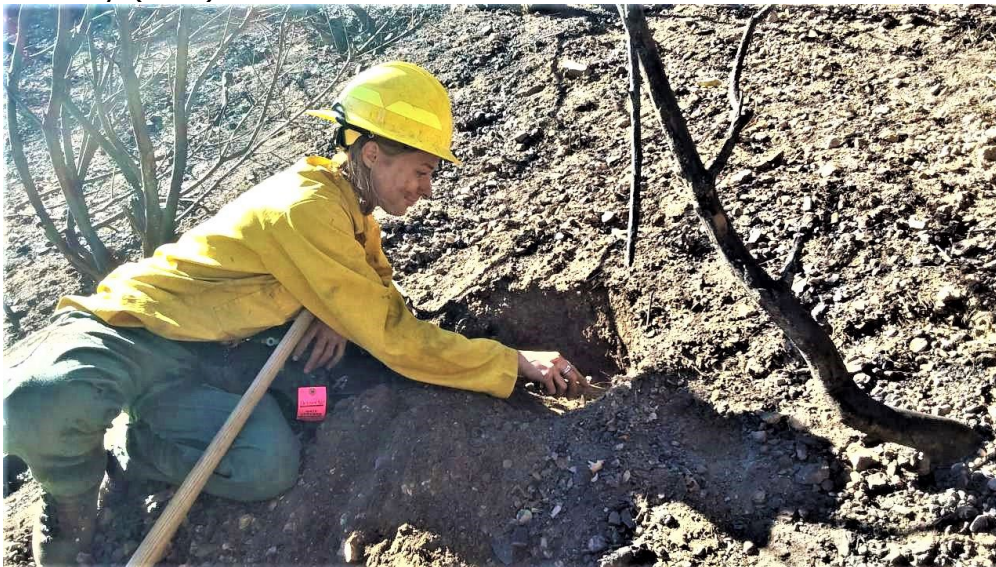
In this photo below, Forest Service Soil Scientist Serena Kuczarski assesses soil hydrophobicity (water repellency), changes to soil structure, and maps the soil burn severity (SBS) in the Radford burned area.

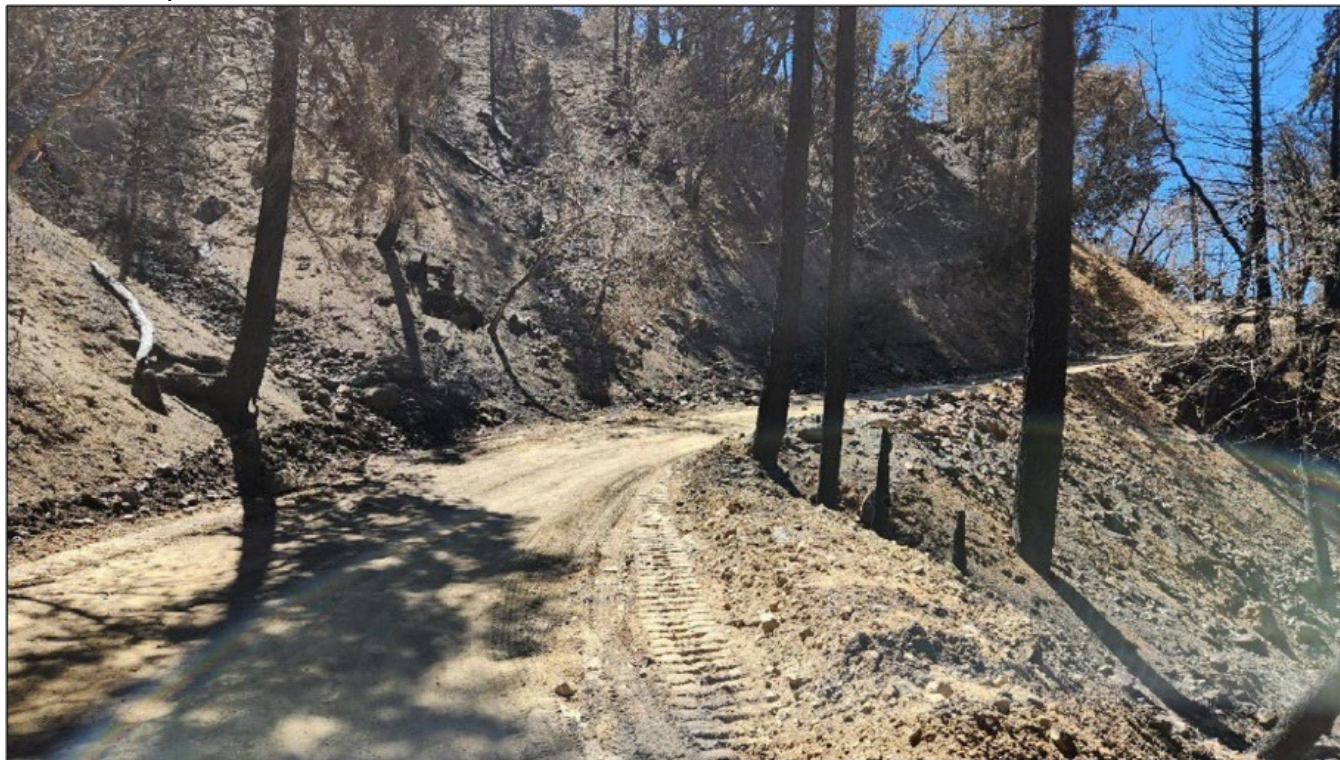
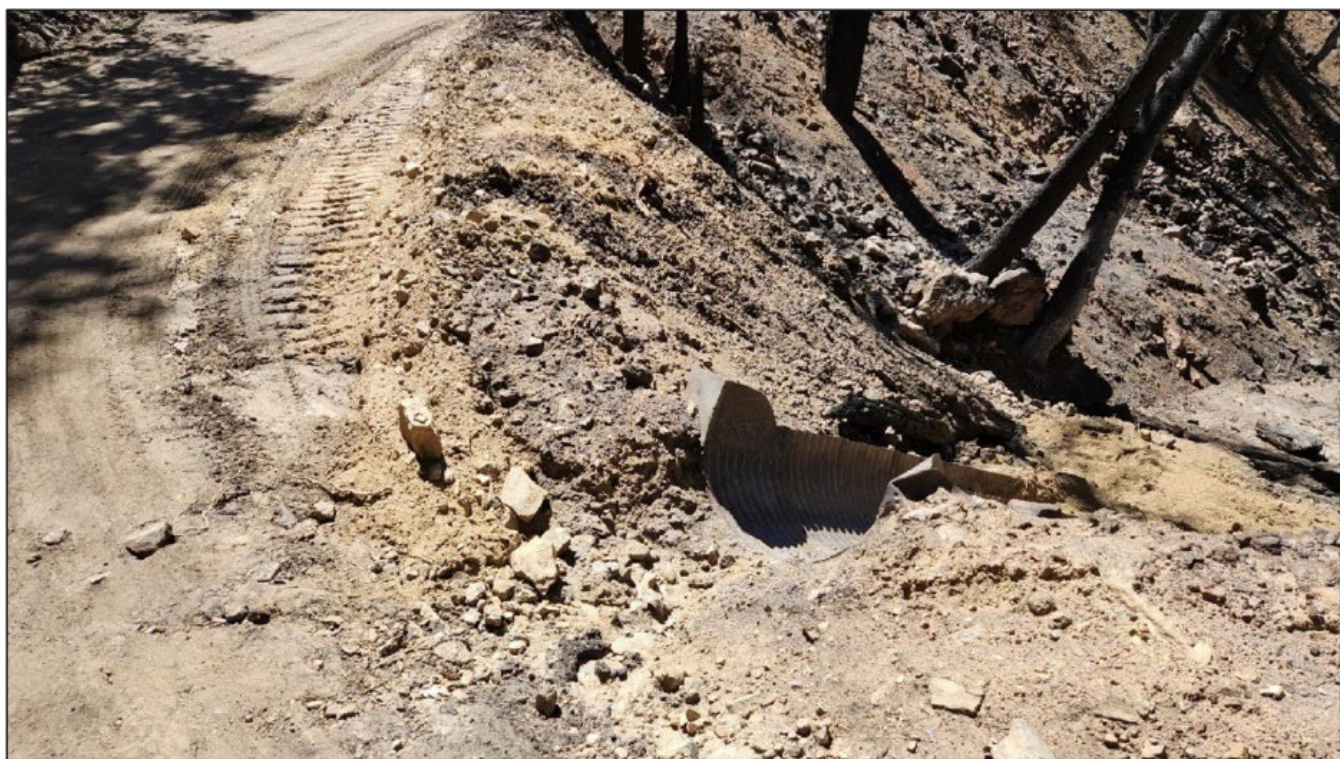
These two photos below are Forest Service 2N06 Road in the Radford burned area.

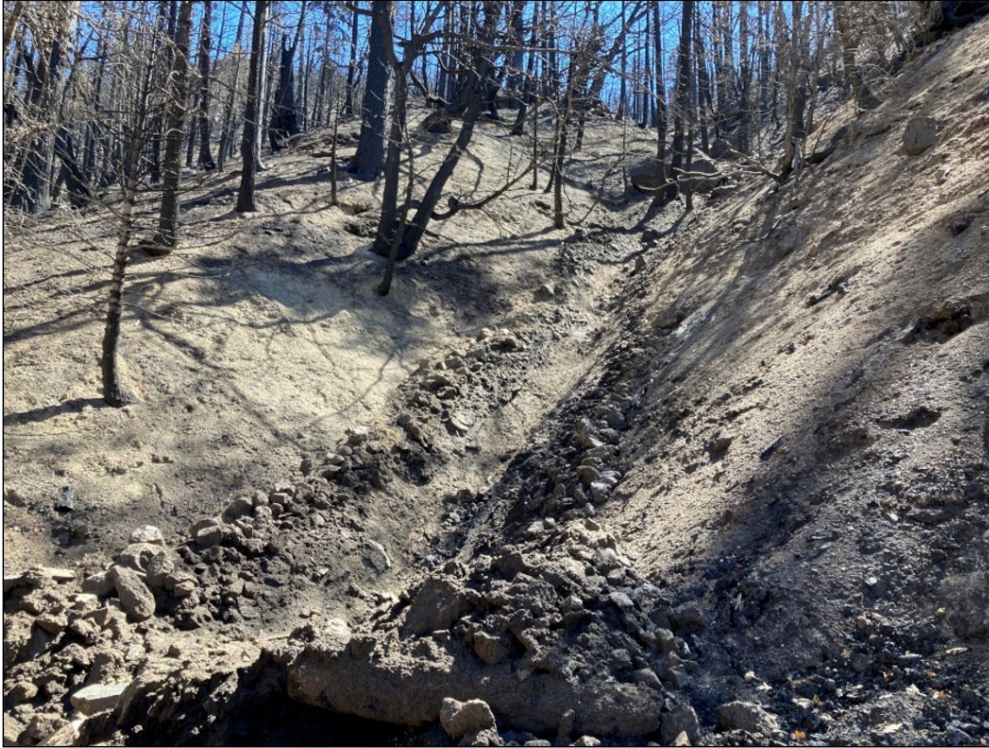
This photo shows a recent debris flow that initiated during the September 12, 2022, rainstorm event and deposited debris on the crossing of Forest Service Road 2N06 in the Radford burned area.

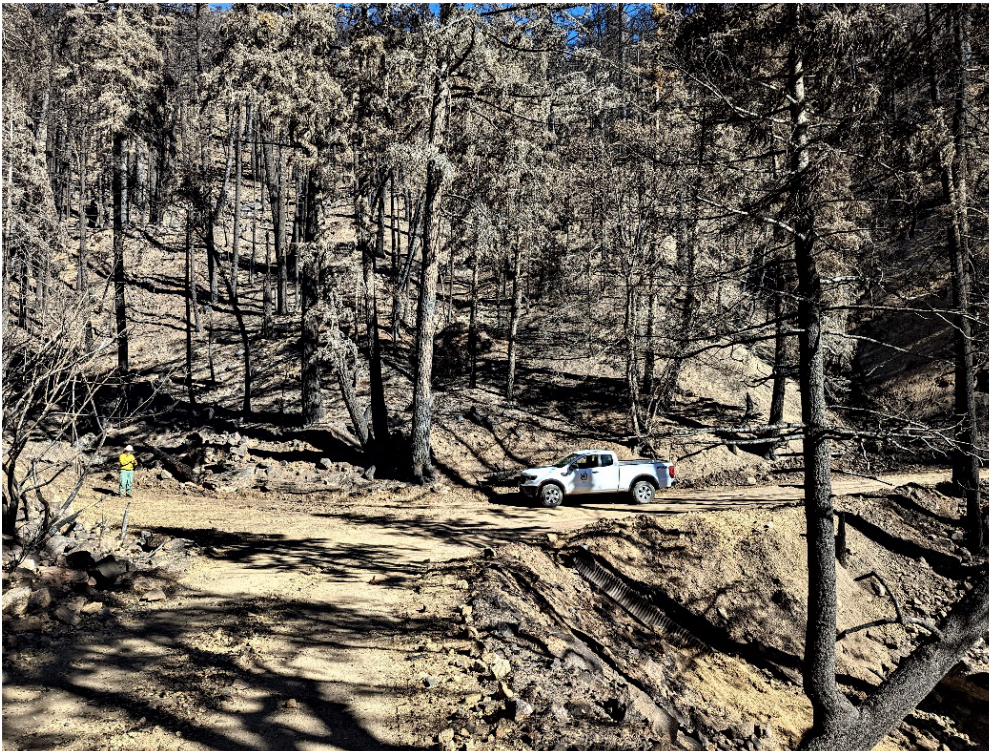
In the photo below, Forest Service hydrologist Andy Stone assesses the point where drainages cross a Forest Service Road within the Radford burned area.

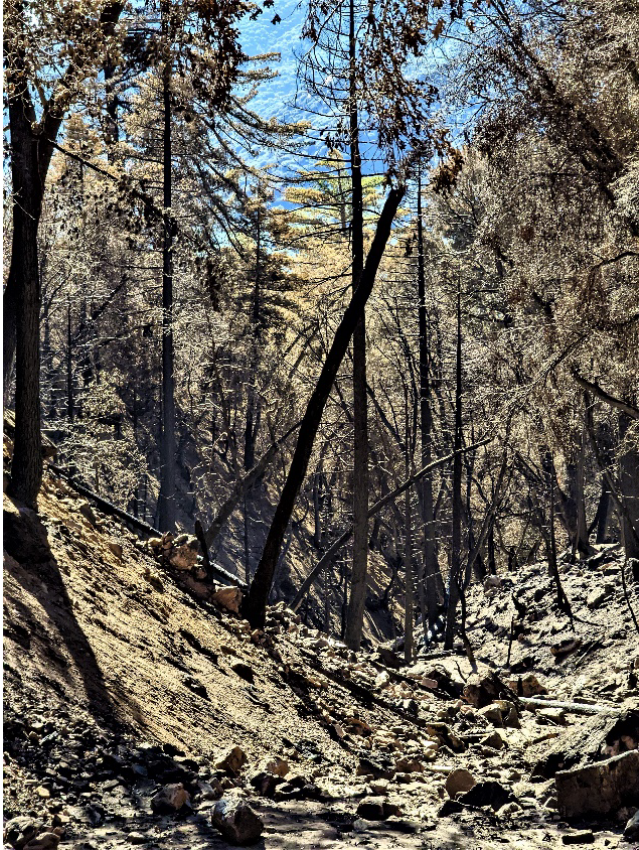
Below is a watershed drainage that crossed a road in the Radford burned area that the BAER hydrologists evaluated and included in their assessment report.

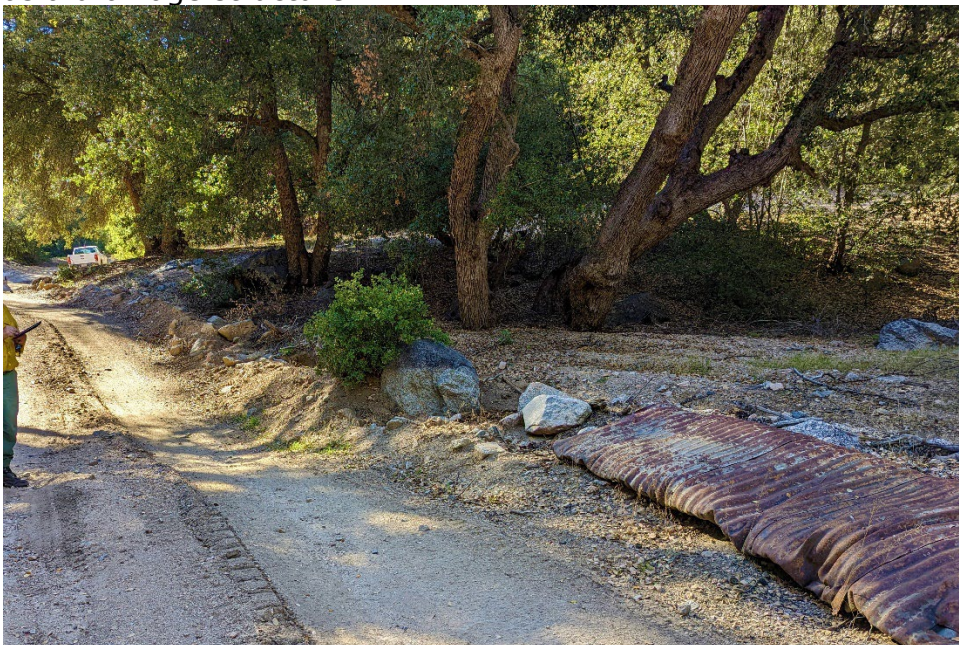
The photo below shows a road culvert that had been damaged and no longer functioned as a drainage structure.

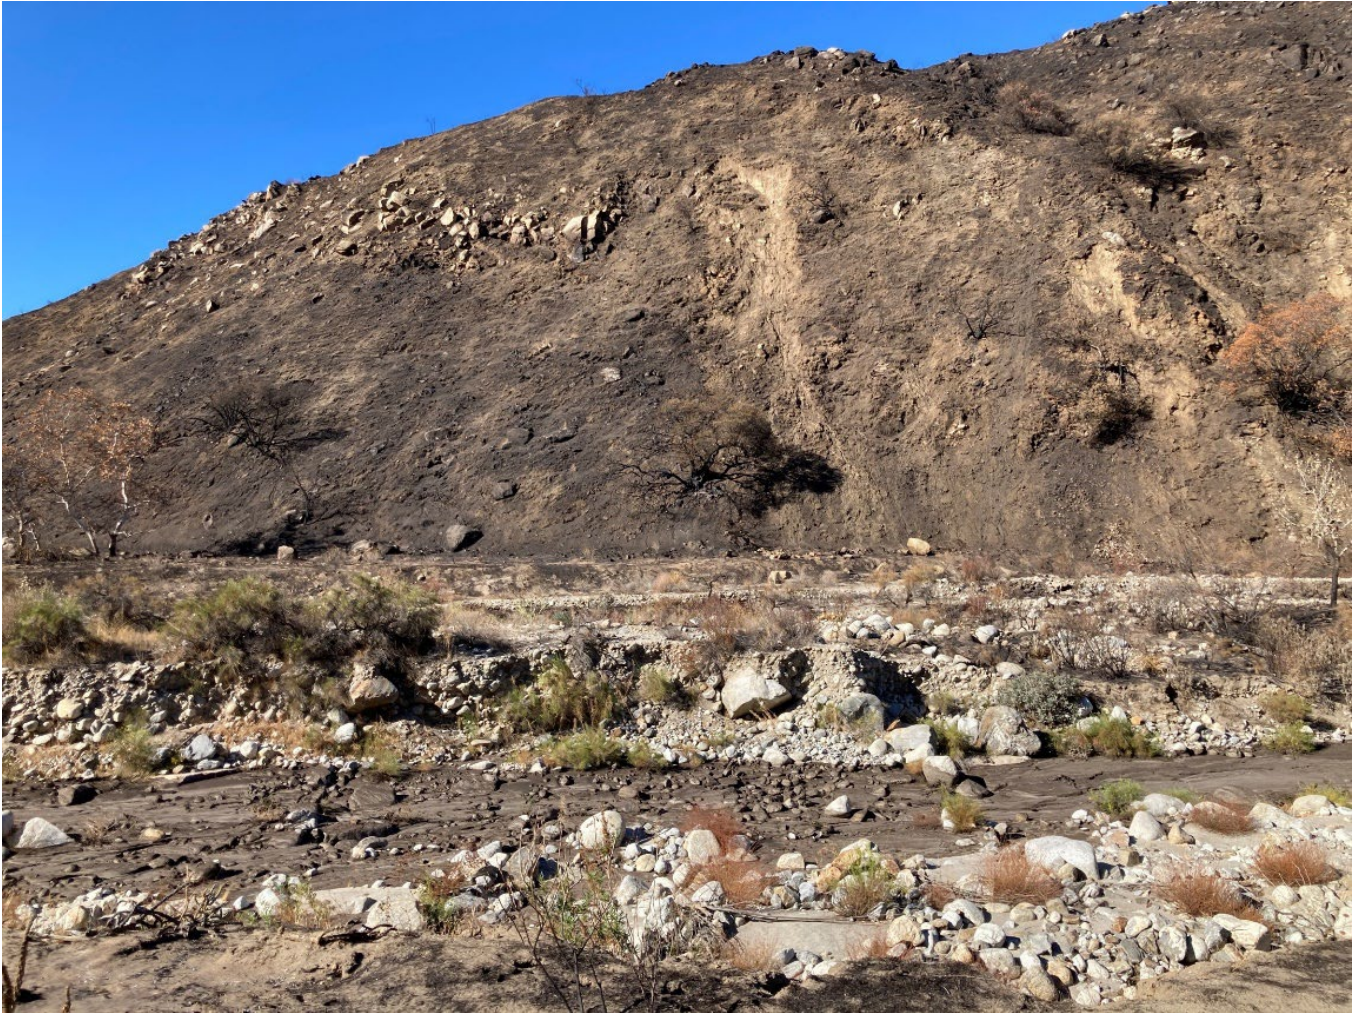
This photo shows fresh surface failures, slopes and channels loaded with un-consolidated sediments of all sizes of rocks and sediment available to be transported during rainstorms in the Fairview burned area. The photo also shows recent flows in the Bautista Creek following the September 11, 2022, rainstorm event.

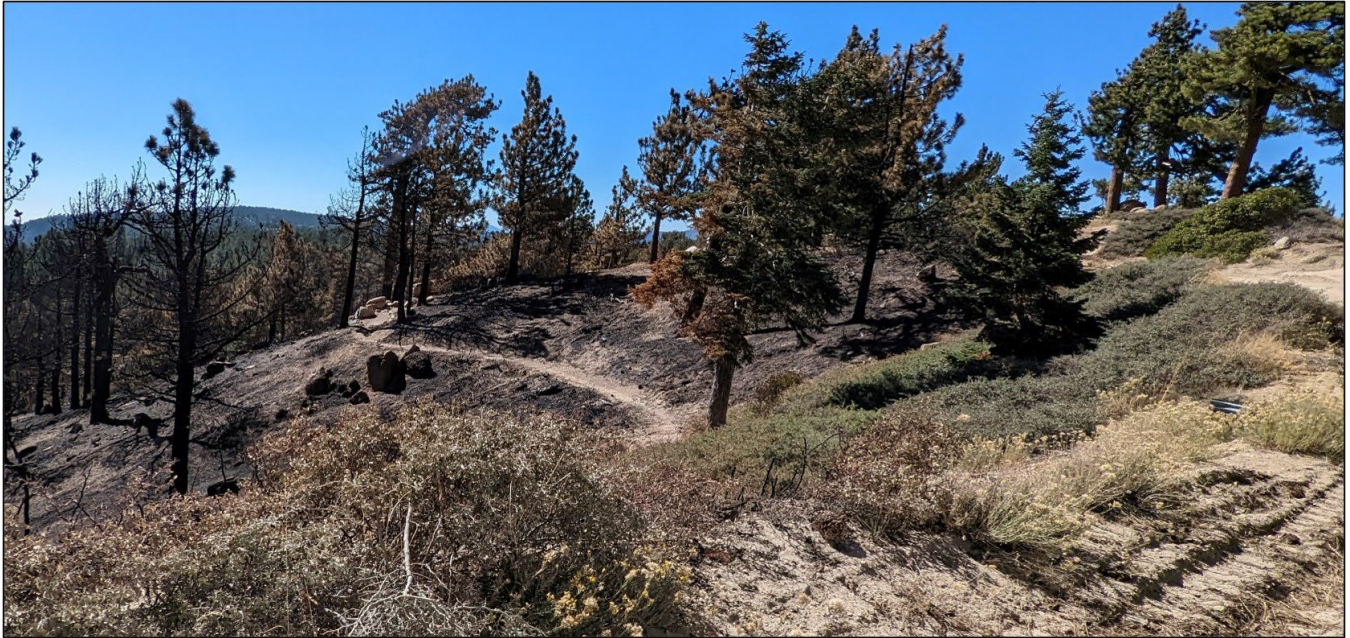
The last photo below shows a portion of Skyline trail along a ridge in the Radford burned area that was evaluated for the BAER assessment team report along with BAER emergency stabilization treatment recommendations to minimize threats from potential rainstorm threats.
