**September 29, 2023****HAPPY CAMP COMPLEX BURNED-AREA REPORT**

**PART II - BURNED-AREA DESCRIPTION****A. Fire Name:** Happy Camp Complex**B. Fire Number:** CA-KNF-007917**C. State:** CA**D. County:** Siskiyou County**E. Region:** 05 – Pacific Southwest**F. Forest:** Klamath National Forest**G. District:** Happy Camp/Oak Knoll and Scott River  
Ranger Districts**H. Fire Incident Job Code:** P5QJ7D (0505)**I. Date Fire Started:** Mid-August, 2023**J. Date Fire Contained:** 73% (as of 09/24/2023)**K. Suppression Cost:** 93.1 million (as of 9/19/2023)**L. Fire Suppression Damages Repaired with Suppression Funds (estimates):**

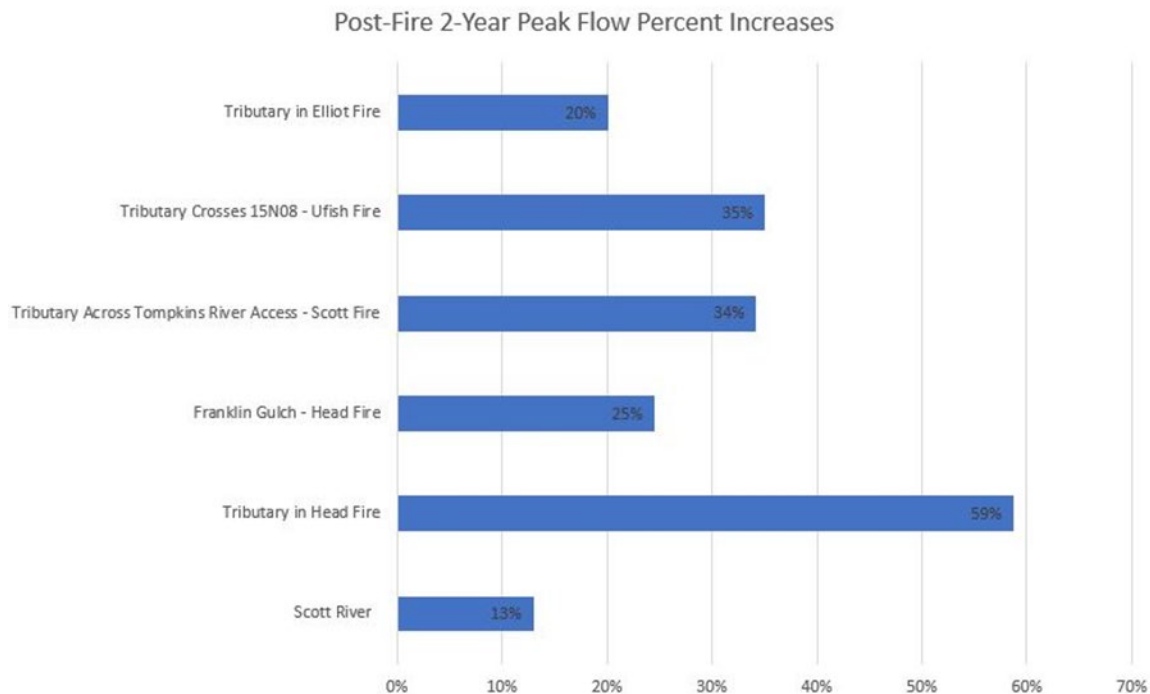
A 2-year return interval peak flow (Q2) can be used as a conservative estimate of a peak flow magnitude that could be potentially damaging and has a high likelihood of occurrence within the next 1-4 years, when the watersheds are most susceptible to elevated peak flows and erosion. A 2-year peak flow event has a 50% probability of occurrence in any given year and a 94% probability of occurring at least once over the next 4 consecutive years. Modeling pre- and post-fire peak flow involves uncertainty; modeled flows should be considered estimates of the relative expected change in post-fire hydrologic response which are used to help identify areas of concern and prioritize treatment. Design flow estimates for the Happy Camp Complex have been based on the U.S. Geological Survey regression equations developed for the North Coast region (Gotvald, et al., 2012) for Scott River pour point. The remaining 5 pour points were modeled using WildCat 5 due the size of the basins.

These elevated post-fire flows and bulking could lead to plugged culverts, damage to road infrastructure, damage to utility infrastructure, impacts to water quality, decreased soil productivity and hydrologic function.
