# Basin Fire Burned Area Summary (DRAFT)

## Burned Area Report

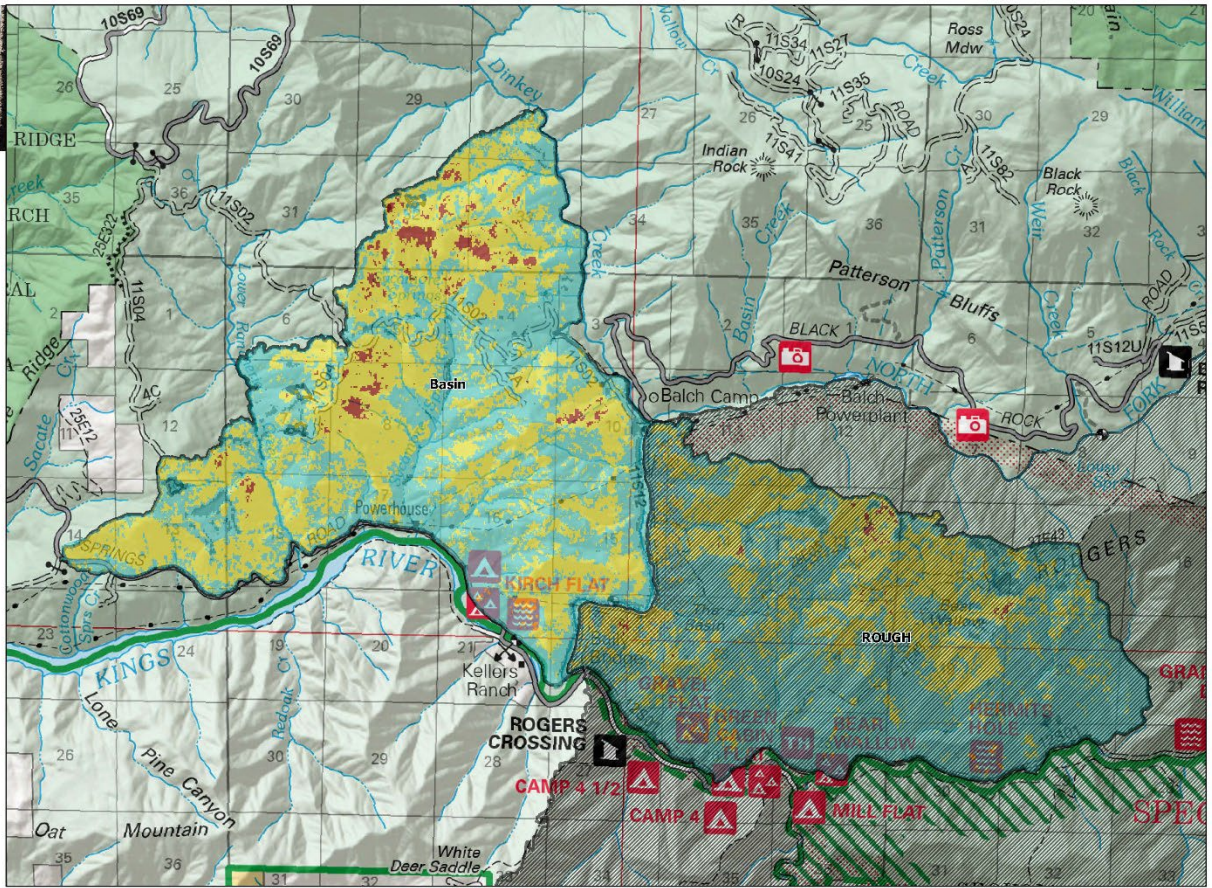
**Basin Fire Assessment  
BAER Burn Severity**

Soil Burn Severity	Acres	Percent
Unburned	420.51	2.99
Low	7419.68	52.78
Moderate	5975.87	42.54
High	242.95	1.73
<b>Grand Total</b>	<b>14,059.02</b>	<b>100</b>

This BAER mapping is based on Geomatics 2015 imagery for the 2015 fire and the 2015 fire perimeter data from the 2015 BAER assessment on July 15, 2024.
