Lake Fire Burned Area Summary

Burned Area Report

2024 Lake Fire Soil Burn Severity Burned Area Emergency Response (BAER)

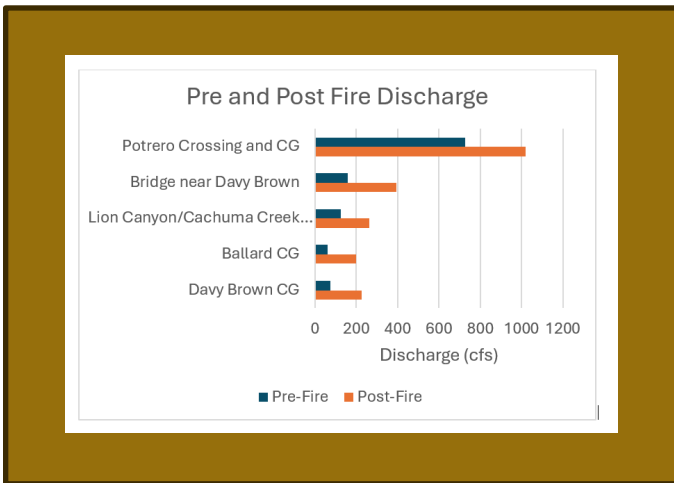
Primary watershed response is expected to include an initial flush of ash and burned materials, erosion in drainages and on steep slopes in the burned area, increased peak flows and sediment transport and deposition, flooding, sediment-laden flows, and debris flows. Watershed response is dependent on the occurrence of rainstorms and rain-on-snow events and will likely be greatest with initial storm events. Increased watershed response is most likely in areas with high to moderate soil burn severity. Disturbances will become less evident as vegetation is reestablished, providing ground cover that reduces erosion and increases surface roughness which slows flow accumulation and increases infiltration.

A rapid hydrologic assessment suggests that due to fire-induced hydrophobic soils and loss of stabilizing vegetation, BAER hydrologists anticipate increases in overland flow and flooding potential. Roads will likely be impacted due to burn

and steep slopes. Water crossings may also be impacted from increased flooding, sediment-laden flows, and debris flows. Campgrounds (Ballard, Davy Brown, Potrero, Horseshoe Bend, Coldwater) may experience flooding, especially camp sites close to creeks, streams, and rivers.
