Forest Service
U.S. DEPARTMENT OF AGRICULTURE

Pacific Southwest Region | October 2024

Burned Area Emergency Response Assessment
Technical Report
Bridge Fire (CA-ANF-243334)
October 16, 2024

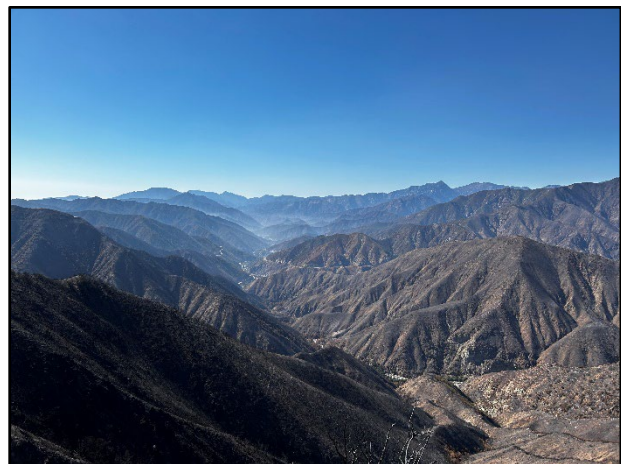
Picture 2. Overview of the Bridge Fire (USDA FS)

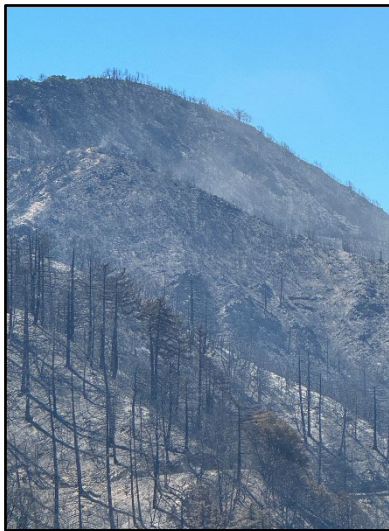
Picture 6. Post-fire wind erosion on the Bridge Fire (USDA FS)

Significant areas of moderate and high SBS had signs of wind erosion. This was observed as exposed tan subsurface soil and by exposed roots that were not consistently charred. This was likely caused by strong fire-induced inflow/outflow winds as well as the strong wind events occurring during the burn. The wind erosion removed much of the ash layer and the loose surface soil once the structure was lost (Picture 6). The loss of these materials could reduce the ash loads being deposited in the drainages during the initial rain events, but also reduces the soils water holding capacity. This reduction in water holding capacity will expedite runoff during the onset of precipitation events. This loss of the surface “A” horizon will also significantly reduce the soil productivity in these areas. Before the fire, the A horizon would have varied from chaparral to timbered ground, however it would have held rich organic matter that supported the vegetation vs the weakly developed horizons below.

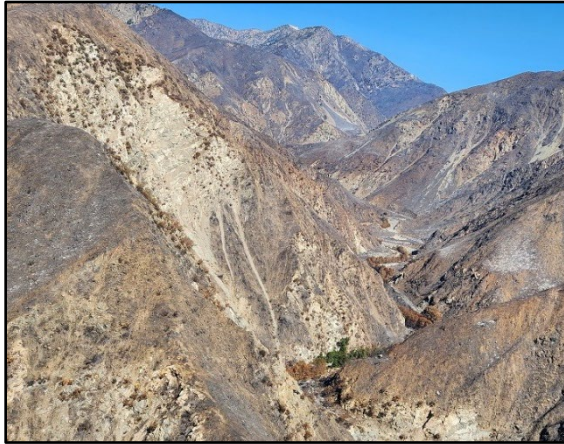
Picture 9. Steep chutes above East Fork San Gabriel River loaded with sediment (USDA FS)

From ground surveys and an aerial reconnaissance flight, it is evident that pre-fire mass wasting as rock-fall, shallow landslides, and some old debris flow deposits exists throughout major portions of the burned area. Throughout the Bridge Fire burn scar most slopes and drainages are loaded with unsorted, unconsolidated materials comprised of rocks of all sizes including boulders, cobbles, gravels, and fine sediments, available to be transported. This is related to the type of parent materials, the steep slopes and continues gravitational and hydrological mobilization of rocks and sediments down slopes and drainages. Scanning the burn scar from south to north, some of the drainages in the burn scar that present large amounts of unsorted, unconsolidated materials available to be transported included: Tanbark Creek, Hummingbird Creek, Bear Creek, Cow Canyon, Cattle Canyon, Coldwater Canyon, East Fork San Gabriel River, Fish Fork, Vincent Gulch, Prairie Fork, Sheep Canyon, Heath Canyon, Flume Canyon, Government Canyon, and Sawmill Canyon. In most of these watersheds, in addition to the fact that large amounts of sediments are present and available to be transported, major portions of these watersheds experienced moderate to high soil burn severity. From ground surveys and aerial reconnaissance, it is evident that many of the steep chutes flowing into the major creeks in the burn scar are loaded with sediments (Picture 9).
