Bridge Fire Burned Area Summary

Burned Area Report

Bridge BAER

Soil Burn Severity Map

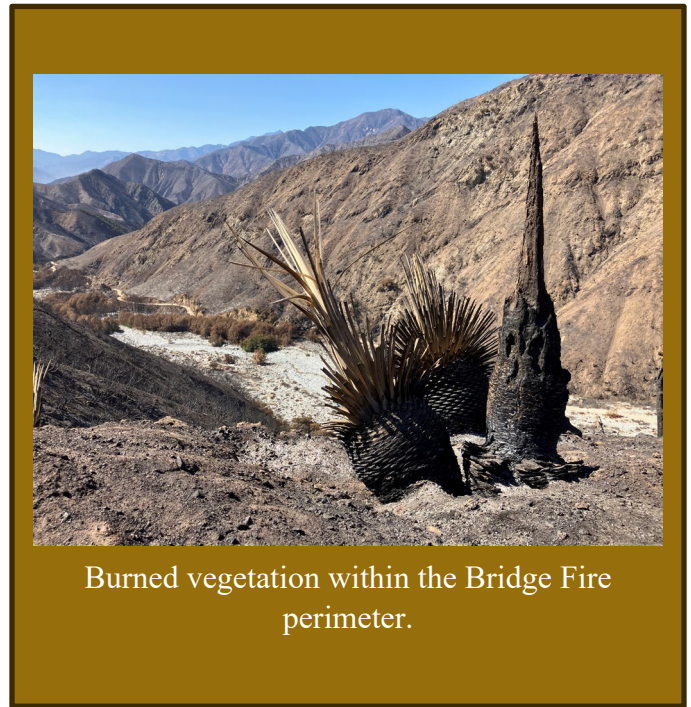
Burned vegetation within the Bridge Fire perimeter.

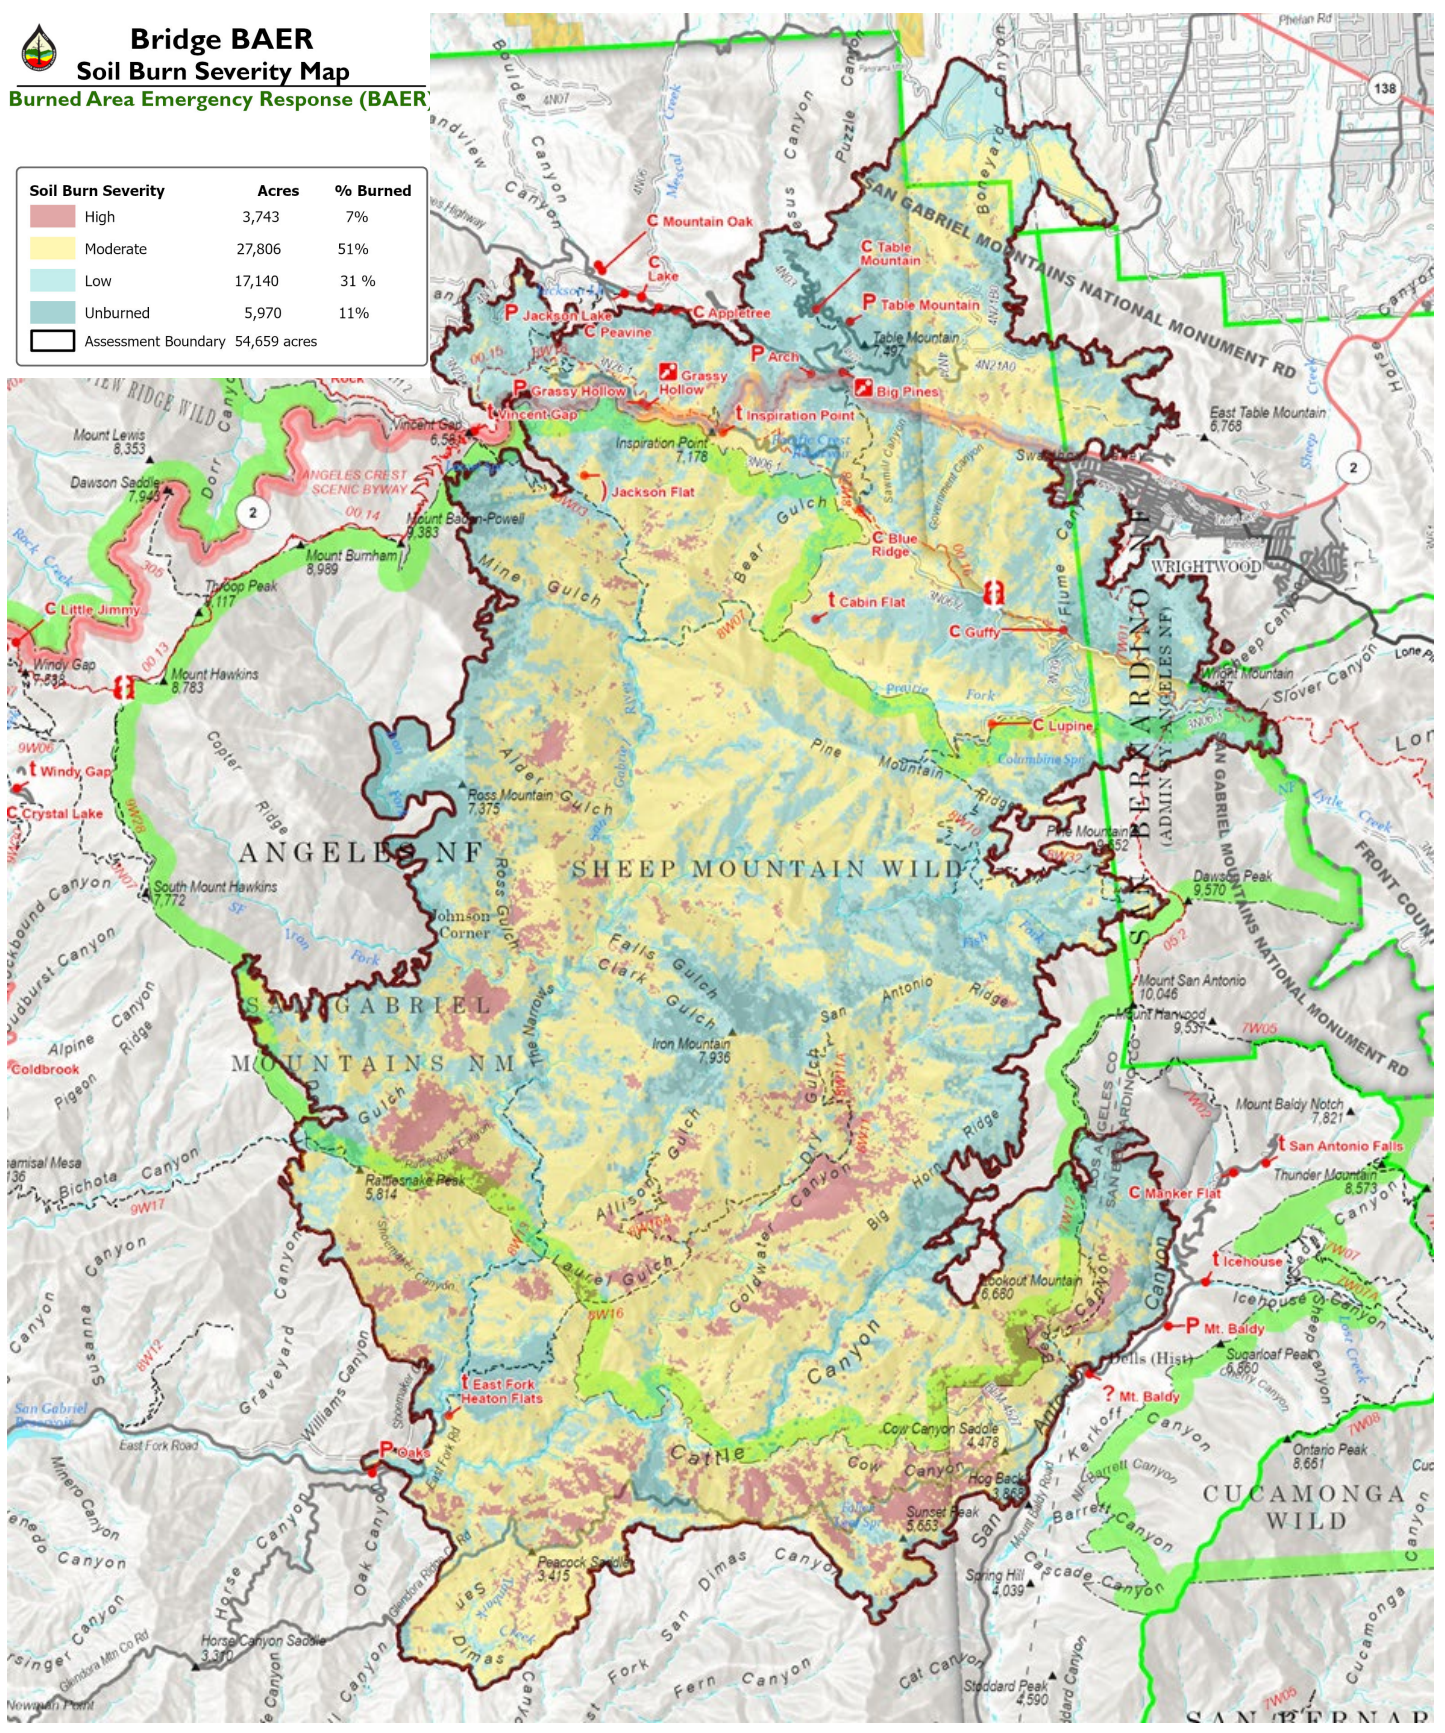
Mapped and validated SBS for the burned area is High (7%), Moderate (51%), Low (31%), and Very Low/Unburned (11%) (see map on page 7). The more severe a fire's effects are on the soil, the more likely those soils will erode in subsequent rainstorms – especially in locations with steep slopes. Erosion after fires can cause tremendous damage to homes and other structures in the years after a fire.

Soil Burn Severity	Acres	% Burned
High	3,743	7%
Moderate	27,806	51%
Low	17,140	31%
Unburned	5,970	11%
Assessment Boundary	54,659 acres
