Airport Fire Burned Area Summary

Burned Area Report

Soil Burn Severity
2024 Airport
BAER Assessment
Cleveland National Forest

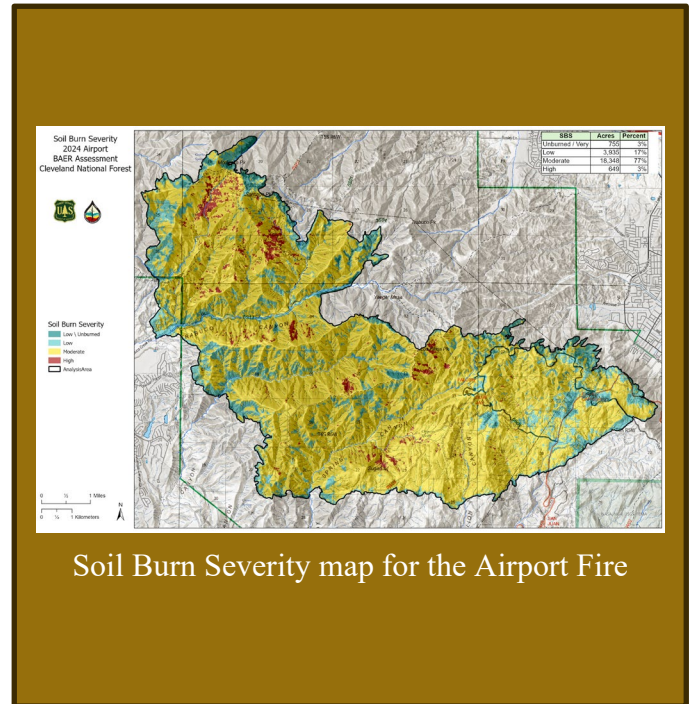
Soil Burn Severity map for the Airport Fire

Mapped and validated SBS for the burned area is High (3%), Moderate (77%), Low (17%), and Very Low/Unburned (3%) (see map on page 7). The more severe a fire's effects are on the soil, the more likely those soils will erode in subsequent rainstorms – especially in locations with steep slopes. Erosion after fires can cause tremendous damage to homes and other structures in the years after a fire.

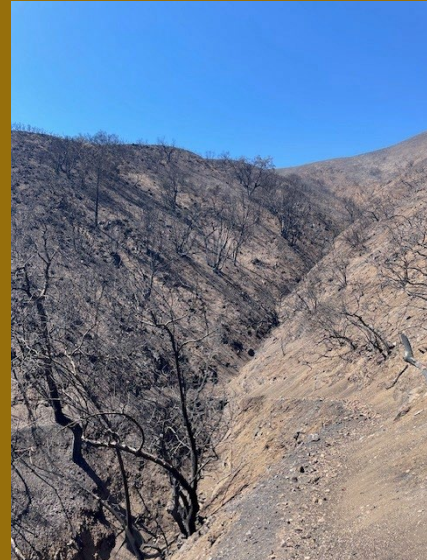
Holy Jim Trail Site 10, drainage crossing. 2

The team proposes trail drainage stabilization treatments, which include armoring and/or cleaning existing water control features and adding drainage features to provide additional capacity for elevated sediment-laden post-fire runoff.

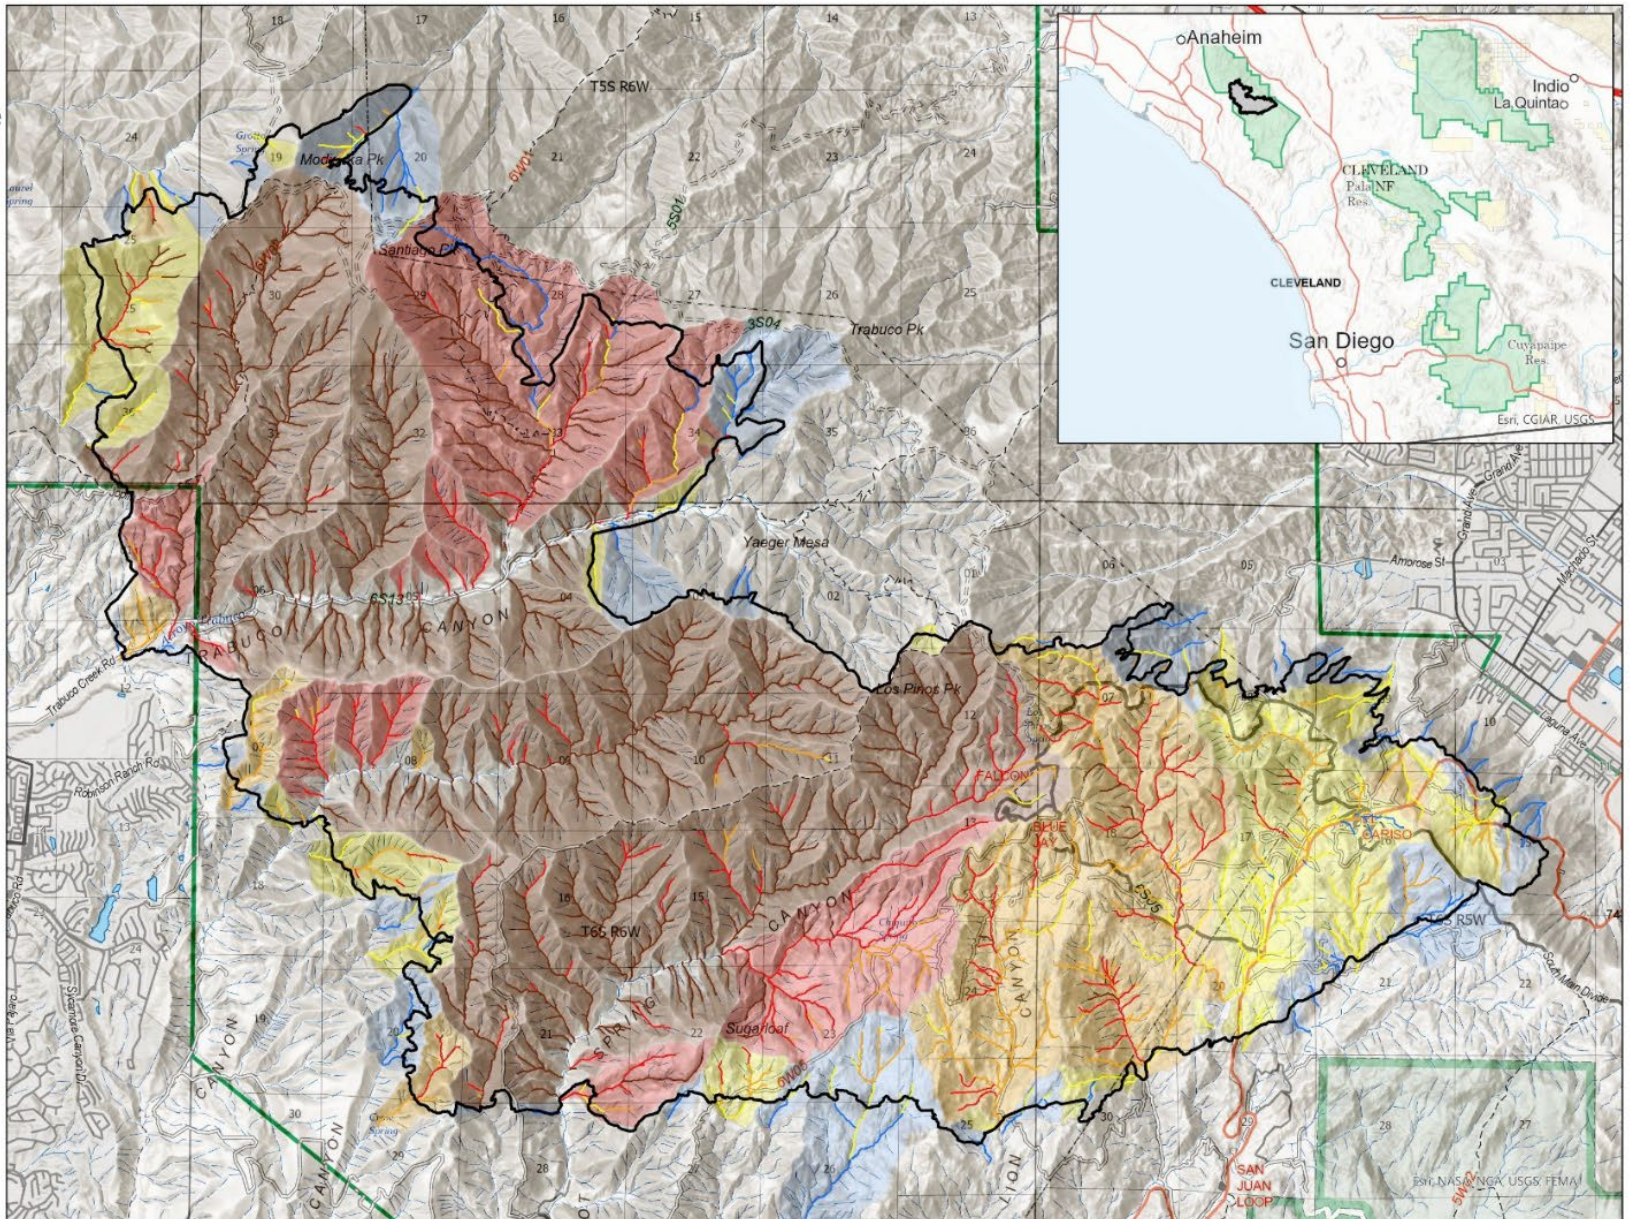
**Airport Fire
Debris Flow Probability
Peak 15 Minute Rainfall
Intensity of 24 mm/h rate
Cleveland National Forest
September 2024**

Estimated Likelihood

General risks and probabilities of debris flow, flooding and erosion hazards were evaluated by the US Forest Service BAER Team. Site specific risks were not evaluated in this assessment.

The team provided soil burn severity field data to the US Geological Survey (USGS) Landslide Hazard Program to assist in forecasting the probability, potential volumes, and hazards of debris flows through their developed empirical models. The USGS Post-fire Debris Flow Hazard Model estimates a high probability of debris flows in over 60% of the burn area. The model indicates that the largest watersheds (Santiago, Holy Jim and Trabuco, Bell, and Hot Springs Canyon) are 80-100% likely to experience debris flows. Furthermore, the model results corroborate with the flooding and debris flows that occurred in Trabuco Canyon after the 2018 Holy Fire (see map on page 8).
