**Burned Area Emergency Response Assessment
Technical Report
Airport Fire (CA-ORC-00127883)
December 2024**

Airport Fire (USDA FS)

Overview and Process

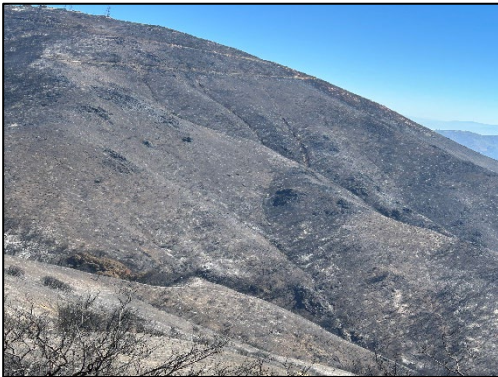
Picture 1. Burned Terrain in Modjeska Canyon Watershed (USDA FS)

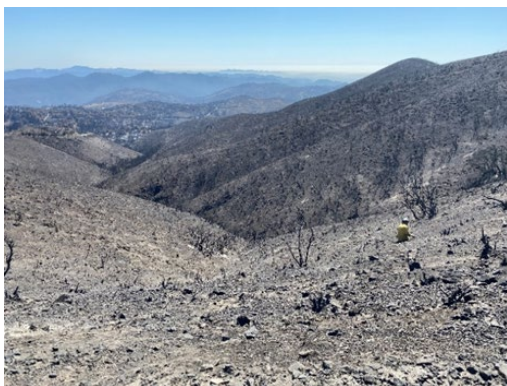
Picture 2. Hot Springs Canyon (USDA FS)

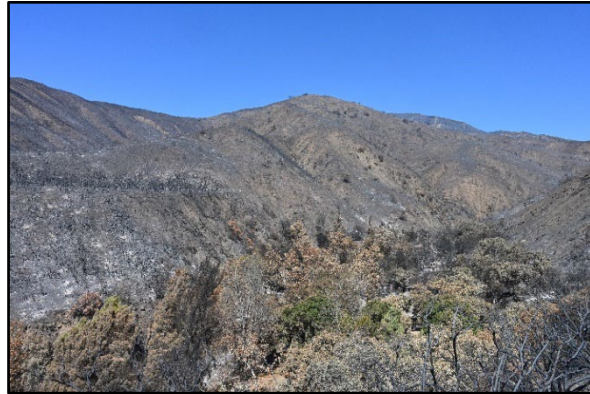
Picture 2. Overview of Airport Fire (USDA FS)

In the headwaters of Santiago, Trabuco, Bell, and Hot Springs Canyons (Picture 3), there is very little ground cover and recruitment potential from the upper canopy is mostly absent. Watershed response is expected to be higher in these canyons than those that burned patchier (e.g. Lion Canyon, drainages converging at El Cariso Campground).

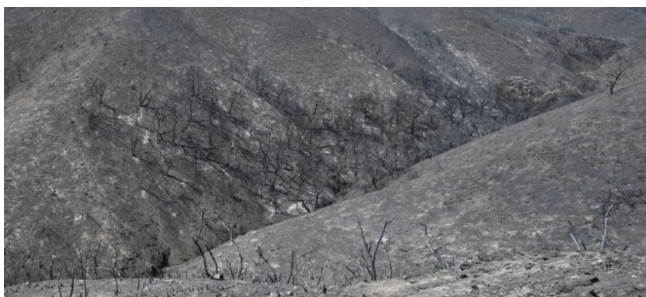
Picture 4: High burn severity in riparian oak woodland. (USDA FS)

Dense vegetation, with a deeper litter and duff layer, results in longer duration heat on the surface soils, and thus, more severe effects on soil properties. For example, deep ash after a fire usually indicates a deeper litter and duff layer prior to the fire. This results in loss of soil organic cover and organic matter, which are important for erosion resistance and the formation or exacerbation of water repellent layers at or near the soil surface. The results are increased potential for runoff and soil particle detachment, and transport by water and wind. High soil burn severity was not widespread (2.7% of the burned area), but where it occurred, effects are deep and severe. Most high burn severity had complete consumption of organic material with the surface layers of the soil resulting in a change to single-grain structure. Fine roots were commonly charred or consumed up to 3-5 cm deep. The highest-severity areas often had a loose, dusty appearance, and no longer had any cohesion or soil strength. This condition was found where forested vegetation had accumulated enough fuel on the soil surface to cause high severity, or long-duration heat impact to the soil.

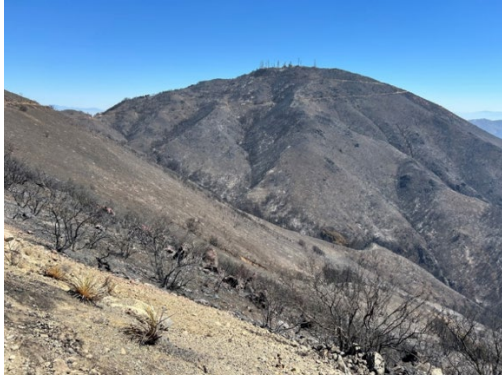
Picture 9: Santiago Peak with deep debris chutes visible dropping steeply away from the road (USDA FS).

Geologic hazards commonly exacerbated by fire are debris flow and rockfall. Rockfall is most common on steeper slopes, especially along stream banks and roadcuts. Under post-fire conditions, burned watersheds with steep slopes and first-order channels that contain significant volumes of stored sediment are likely to experience increases in runoff and erosion from a lack of protective vegetation cover, soil hydrophobicity, and loss in cohesive root strength, which can generate debris flows (Kean et al., 2011; Parise and Cannon, 2012; and Kean et al., 2019). Post-fire debris flows initiate as result of progressive bulking or accumulation of slurry in stream channels (Cannon, 2000, 2001; Cannon et al., 2001a). Runoff generated slurry typically has high sediment concentrations (40–65 percent) and can scour colluvial and fluvial stream deposits. The flow can then progressively grow as it moves downstream by recruiting boulders and woody debris, resulting in destructive debris flows (Iverson, 1997). Hydrologic processes such as debris flows and hyper-concentrated flows threaten life, property, and infrastructure. They can destroy houses, block, or erode roads and cause transportation impacts, sever pipelines, damage utilities and add large quantities of sediment to stream channels that impact water resources (Schwartz et al., 2021).

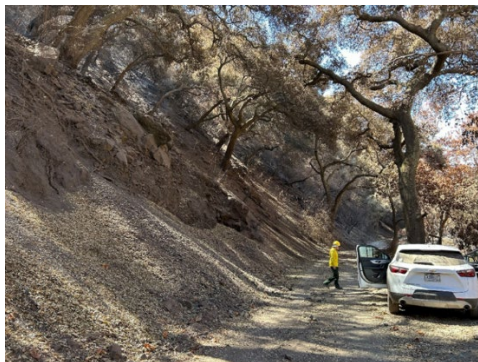
Picture 10: Large dry ravel cones forming along lower Trabuco road due to high rates of erosion (USDA FS).

As a result of the fire and the removal of supportive vegetation, post-fire dry ravel and rockfall was observed on slopes, impacting roads, and further loading channels with fine sediments and rocks (Picture 10). In addition to the fact that many of these drainages impacted by the fire experienced a moderate to high soil burn severity, many of the slopes in the burn area are steep (40-60%) or very steep (60+%) slopes.

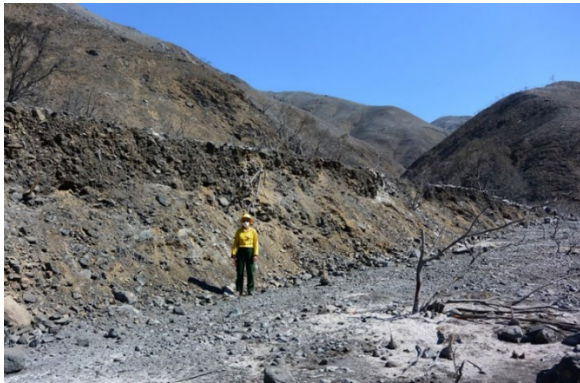
Picture 11. Large debris fan deposit in Trabuco Canyon, taken after the Holy Fire of 2018. Similar size and aged deposits are mapped at the headwaters of Bell and Hot Springs Canyon (USDA FS).

Within the Airport Fire burn scar, widespread evidence of debris flow deposits was identified in many watersheds, and creek bottoms (Picture 11). For the most case, these debris flow deposits were mobilized during storms under pre-fire conditions. Since that the Airport Fire burned such a high percentage of the landscape at the headwaters of watersheds and on steep slopes, debris flow initiation and mobilization is expected to dramatically increase due to post-fire conditions.

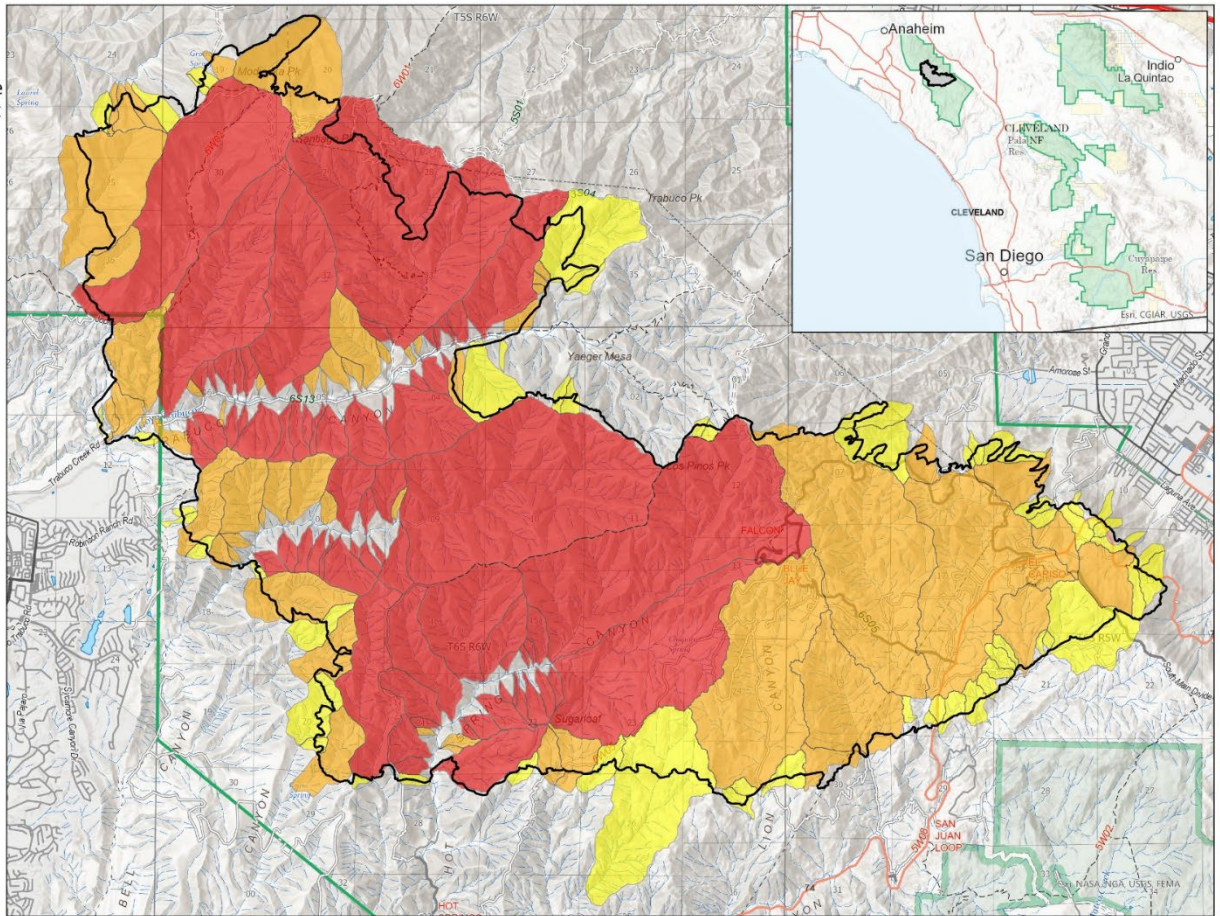
Airport Fire
 Combined Hazard
 Peak 15 Minute Rainfall
 Intensity of 24 mm/h rate
 Cleveland National Forest
 September 2024

Debris Flow Combined Hazard
 24mmh
 Low
 Moderate
 High
 <call other values>
 AnalysisArea

General risks and probabilities of debris flow, flooding and erosion hazards were evaluated by the US Forest Service BAER Team. Site specific risks were not evaluated in this assessment.

The USGS debris flow model estimates high probabilities of debris flows forming in over 60% of the Airport burn area. The largest watersheds within the burn (Santiago, Holy Jim and Trabuco, Bell, Hot Springs Canyon) have modeled debris flow likelihoods of 80-100% in a 1-year recurrence interval (RI) storm. Model results are supported by observations of significant flooding and debris flow responses at the outlet of Trabuco Canyon following the 2018 Holy Fire and at the base of the burned tributary following the 2016 Holy Fire.
