Forest Service
U.S. DEPARTMENT OF AGRICULTURE

Pacific Southwest Region | February 2025

**Burned Area Emergency Response Assessment
(BAER)
Technical Report
Eaton Fire (CA-LAC-009087)
February 7, 2025**

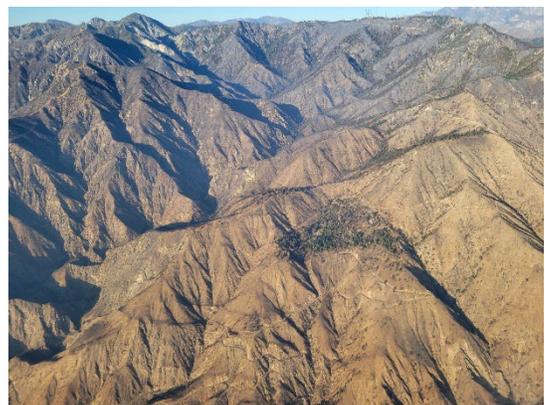
Picture 2. View looking up Eaton Canyon towards Mount Wilson displaying wind eroded tan foreground and darker un-eroded background. (USDA FS)

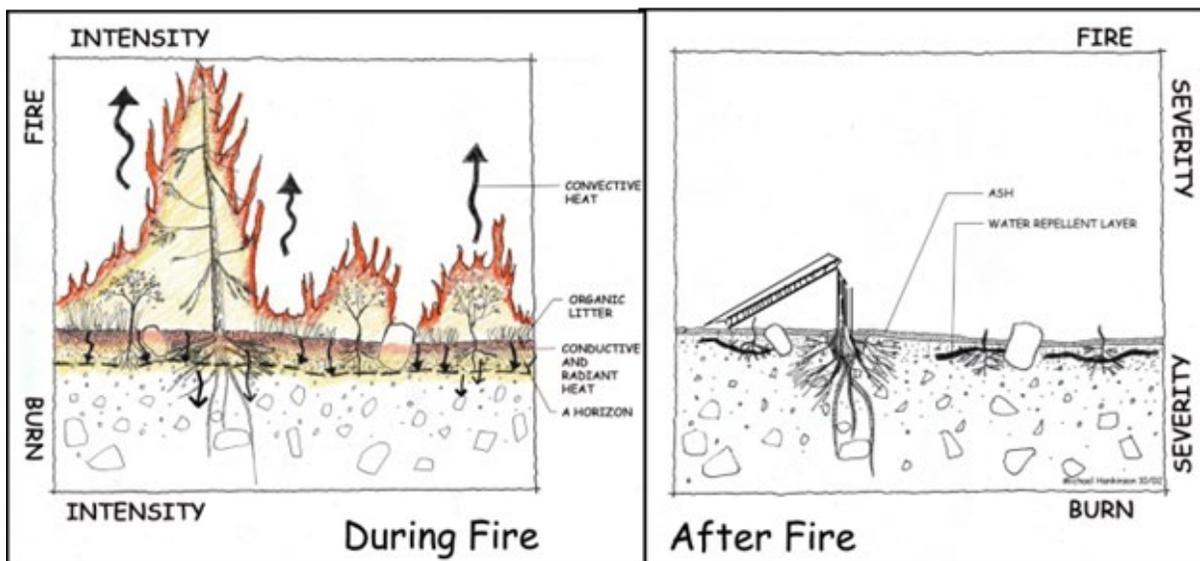
It must be understood that **soil burn severity is NOT vegetative burn severity or mortality** as illustrated in Figure 1 below. Vegetative burn severity is but one component taken into consideration – soil burn severity goes beyond aboveground vegetation impacts to belowground soil heating effects and associated impacts to soil hydrologic function, runoff and erosion potential, and vegetative recovery. Such additional factors include amount and condition of residual ground cover, viability of native seed banks, condition of residual fine roots, degree of fire-induced water-repellency, soil physical factors (structural stability, porosity, restricted drainage), soil chemical factors (oxidation, altered nutrient status), and topography (slope gradient, length, and profile). While above-ground burn severity is more related to peak temperatures and fire behavior during the fire, below-ground soil burn severity is related strongly to the length of time the heat is in contact with the soil (residence time).

Figure 1. A graphical representation of burn severity vs. fire intensity. Residence time is not represented in the drawing but is a key factor in resulting severity (*Effects of Fire-GTR WO-7*).

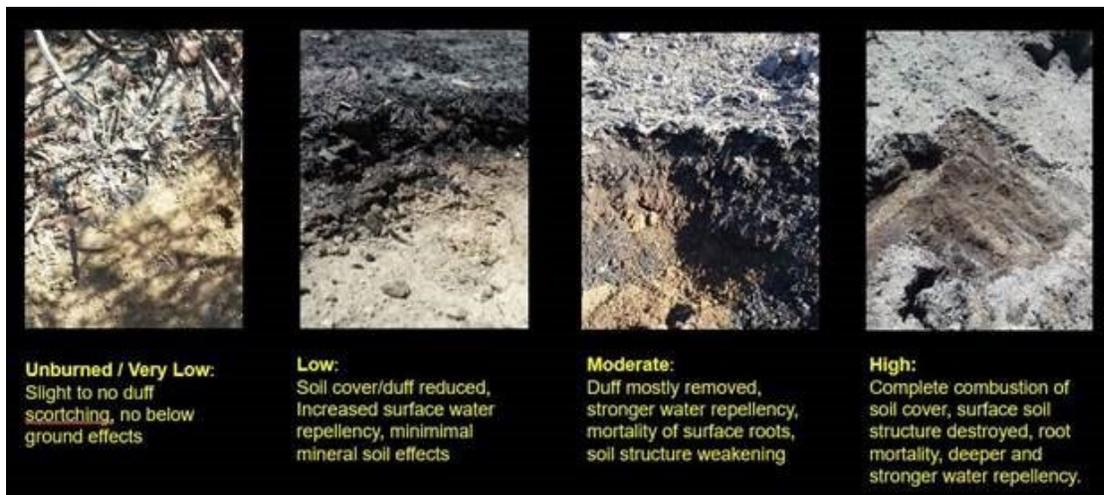
High soil burn severity: All or nearly all the pre-fire ground cover and surface organic matter (litter, duff, and fine roots) is generally consumed, and charring may be visible on larger roots. The prevailing color of the site is often “black” due to extensive charring. Bare soil or ash is exposed and susceptible to erosion, and aggregate structure may be less stable. White or gray ash (up to several centimeters in depth) indicates that considerable ground cover or fuels were consumed. Sometimes very large tree roots (> 3 inches or 8 cm diameter) are entirely burned extending from a charred stump hole. Soil is often gray, orange, or reddish at the ground surface where large fuels were concentrated and consumed. Figure 2 are visual examples of different soil burn severities.

Figure 2. Visual examples of different soil burn severities

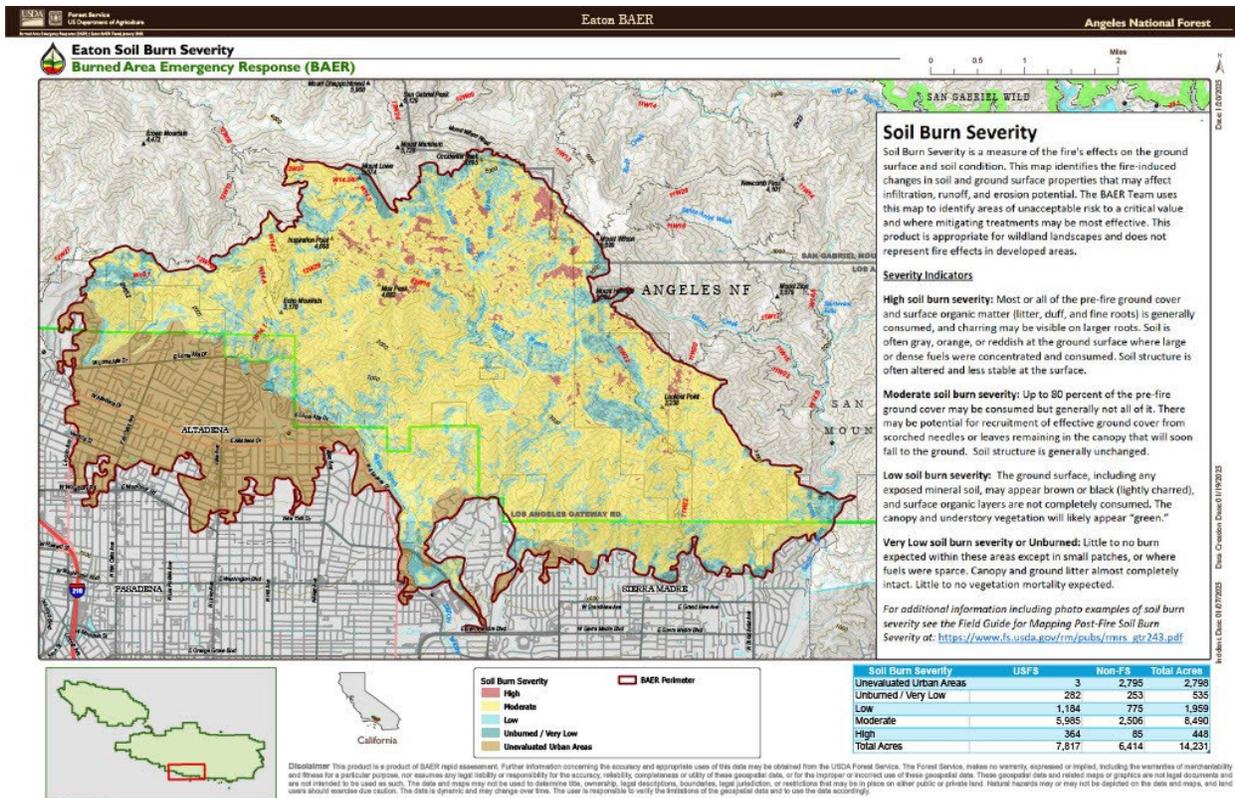
This fire produced a large amount of moderate SBS due to the fire’s rapid movement through the chaparral-dominated landscape. SBS was assessed for the entire fire perimeter excluding the urban landscape. The SBS breakdown is as follows: 535 acres (5%) unburned/very low, 1,959 acres (17%) low, 8,490 acres (74%) moderate and 448 acres (4%) high. Soil water repellency was very strong and widespread across the burn perimeter, with an estimated 90% of moderate and high SBS areas exhibiting strong water repellency.

Figure 3. Soil burn severity map for the Eaton Fire.

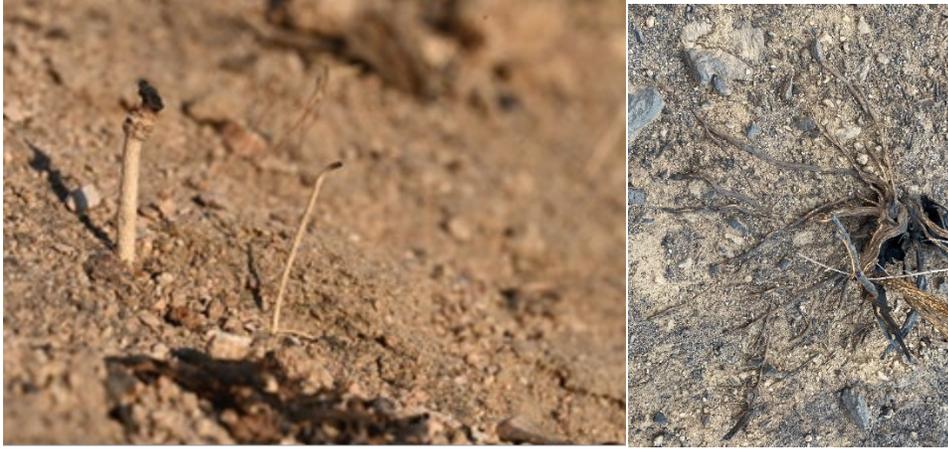
Picture 4: Exposed graminoids following loss of surface soil horizon.

Picture 5: Exposed shrub root system following loss of surface soil horizon.

Picture 5 shows the exposure of the root mass of a chaparral shrub. In the lower country, the soils are shallow, and roots tend to establish on top of the rock or consolidated soil. According to Esther Lewis, the BAER team botanist, we are not likely to see resprouting due to the roots being exposed and overheating. Shrub roots experiencing this excessive wind erosion and exposure are likely to perish.

Picture 4 similarly shows the exposure of that portion of graminoid species that were insulated by soil during the soil and subsequently exposed when soil properties that stabilize soils are removed by wind.

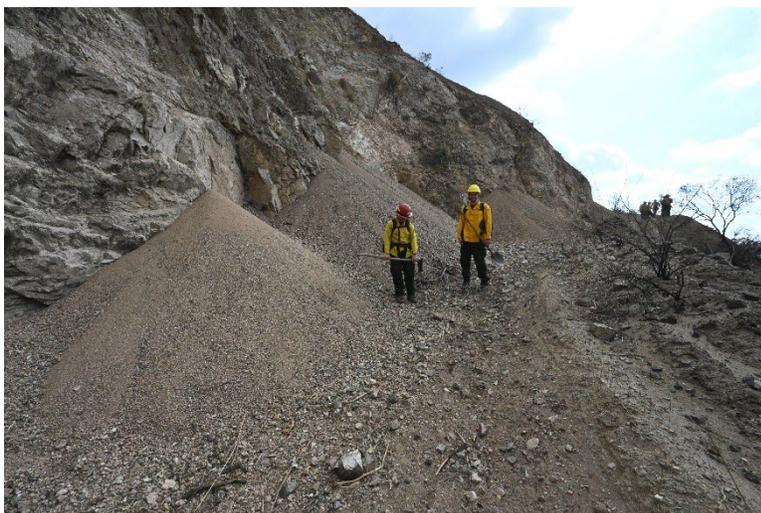
The figures below demonstrate the extreme dry ravel that can clearly be seen on the Wilson Toll Road. Similar deposits are common in channels throughout the fire area. These dry ravel deposits will immediately mobilize during a hydrologic event dramatically increasing bulk flow. This bulk flow will increase flow elevation and buoyancy that will help mobilize large rock in debris flows.

Picture 6: Large dry-ravel deposits observed on Mt. Wilson toll road

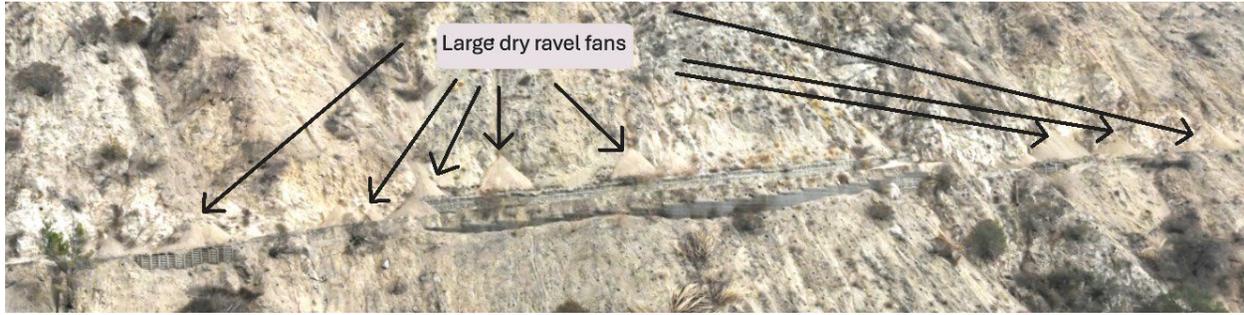
Picture 7 (below): Dry-ravel deposits on Mt. Wilson toll road.

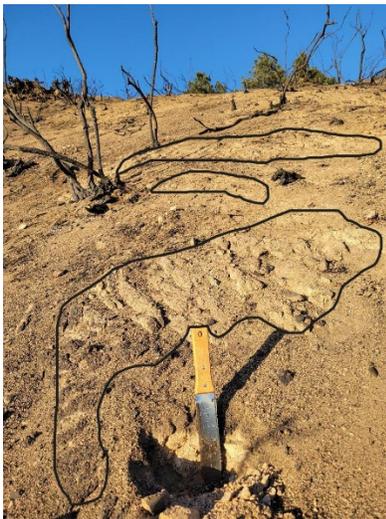
Picture 8: Evidence of exposed bedrock following loss of mineral surface soil due to wind erosion.

Lastly, the wind erosion was so extreme that weathered bedrock was exposed in areas. These areas likely supported shrubs, forbs and grasses and will not support this vegetation in the foreseeable future. This represents a significant loss in soil productivity and will not recover if the shrub canopy does not recover. A 4-8 cm of soil loss represents approximately a 2 cm loss of water holding capacity and a significant increase in hydrologic response. The black polygons in Figure 8 delineate areas where igneous bedrock has been exposed by surface mineral soil removal.

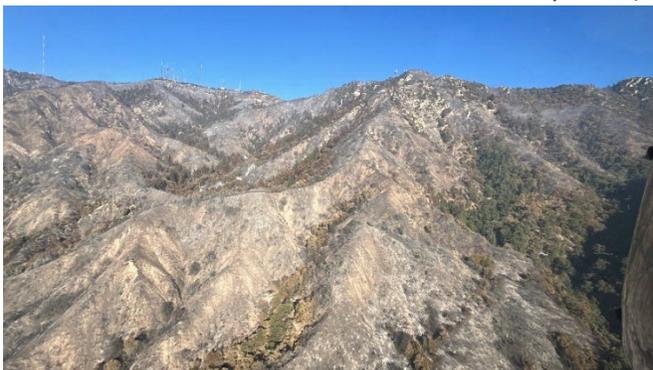
Picture 9 Eaton Canyon

As shown in the Soil Burn Severity (SBS) map (Appendix A), the landscape has large continuous areas of moderate SBS, which will affect watershed response (Pictures 9 and 10).

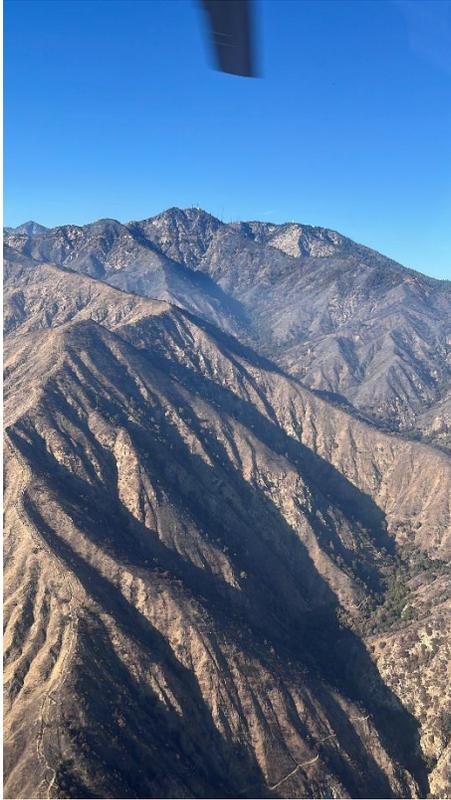
Picture 10. (left) Little Santa Anita Canyon (Mt. Wilson Trail near bottom)

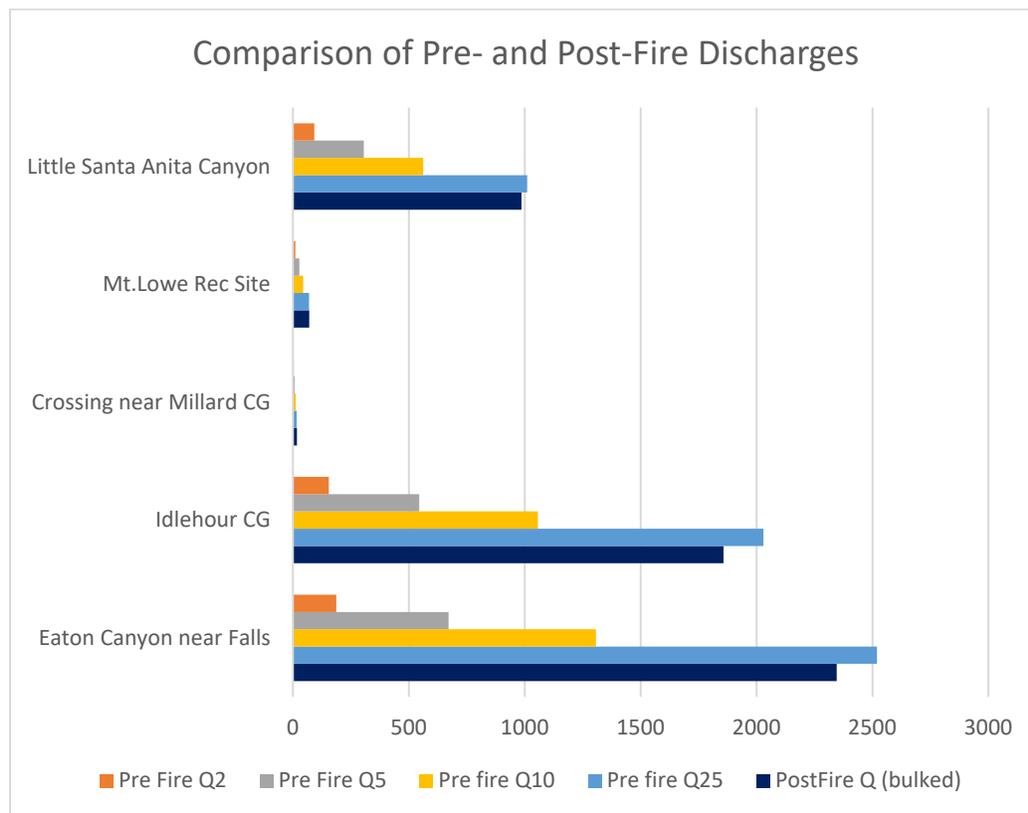
Modeling Results: Post-fire bulked flows are expected to be 4.5 to over 12 times that of non-bulked, pre-fire peak flows. Some of these values represent significant increases in runoff justifying the need for emergency response treatments. Post-fire modeling results are most applicable during the first year of recovery; hydrologic response will decrease in subsequent years. Most of the results hover at or just below the normal 25-year flood event. That is, in the post fire environment with a 2-year winter storm, flows will act like a 25-year flood. A storm greater than the 2-year will produce an even higher flood event.

Figure 4. Post fire discharges in relation pre-fire return intervals for Eaton Fire.

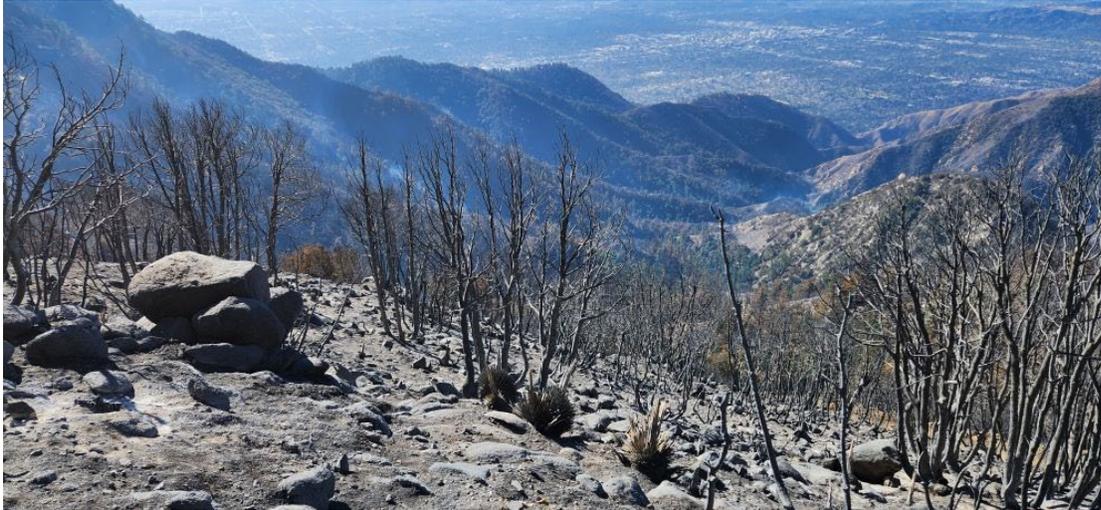
Picture 10: Extension of the Eaton Fire, from Mount Wilson down to neighborhoods of Altadena

The two major watersheds that were burned by the Eaton Fire are the Eaton Canyon and Little Santa Anita canyon watersheds. In addition to these two major watersheds, numerous smaller, named and un-named watersheds were burned, which include (from west to east): Millard Canyon, Chiquita Canyon, Las Flores Canyon, Rubio Canyon, Pasadena Glen, Hastings Canyon, and Bailey Canyon. Most of these drainages flow directly into neighborhoods and private back-yard properties.

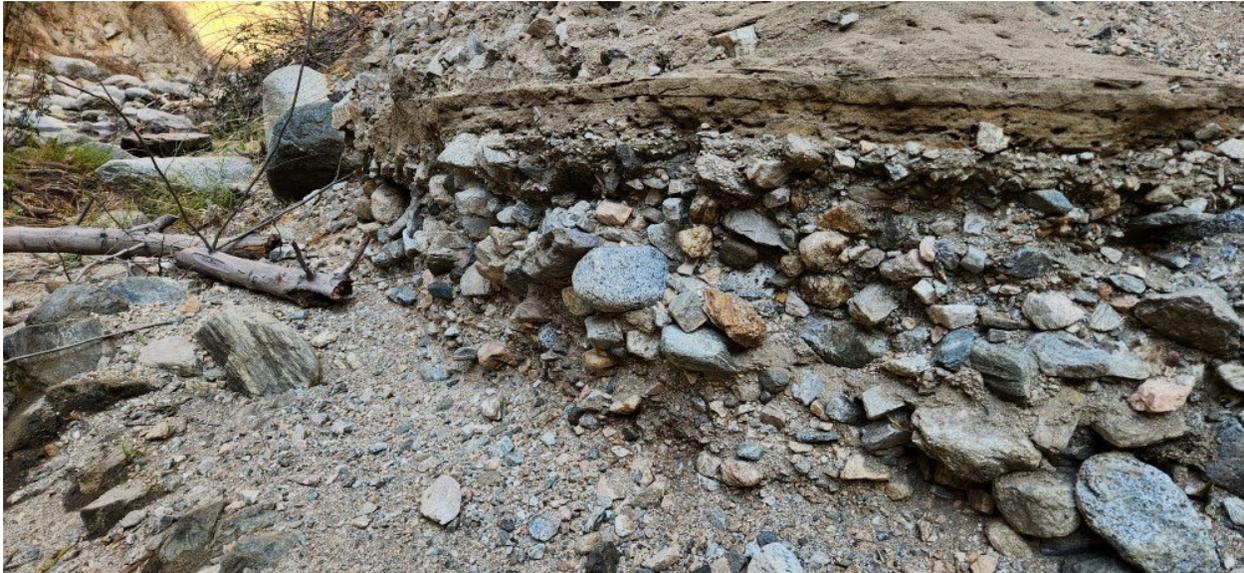
Picture 11: Lateral bank erosion, exposing unsorted, non-stratified, matrix-supported, paleo debris flow deposits – Eaton Canyon

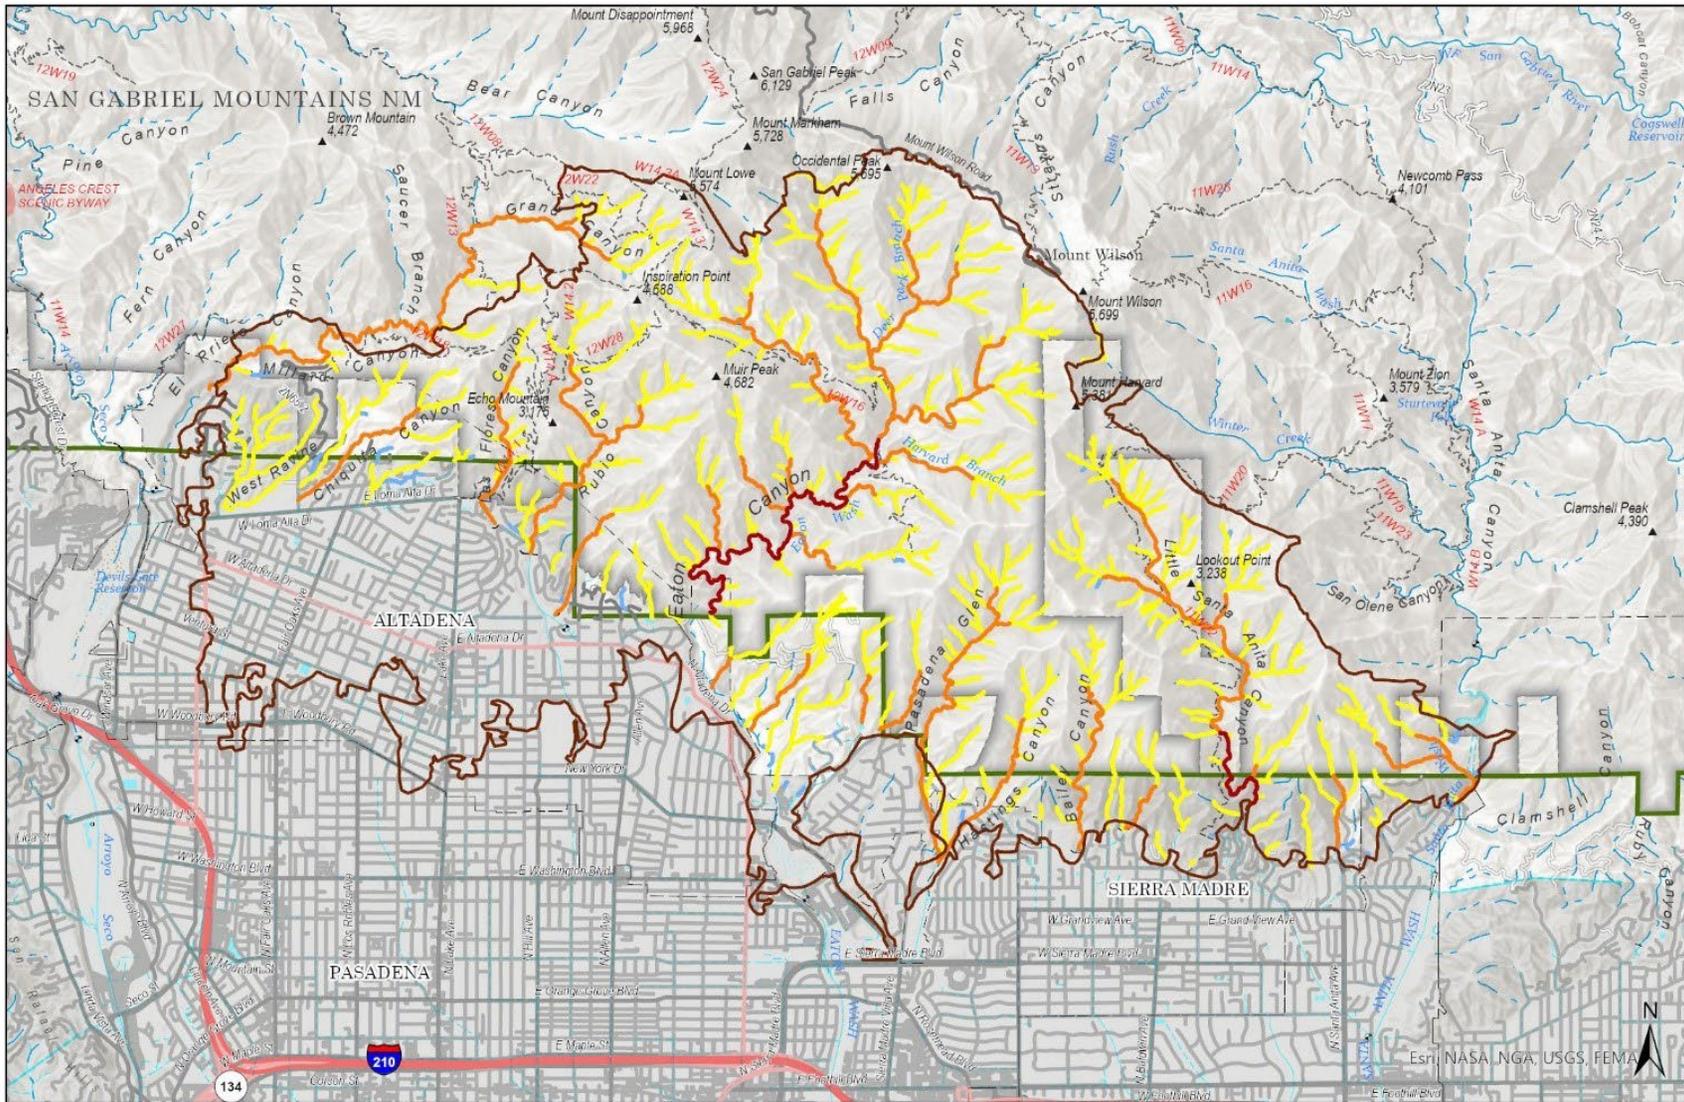
Debris Flow Volume Prediction
 Eaton Fire - Angeles National Forest
 January 2025

Peak 15 Minute Rainfall Intensity 40 mm/h rate

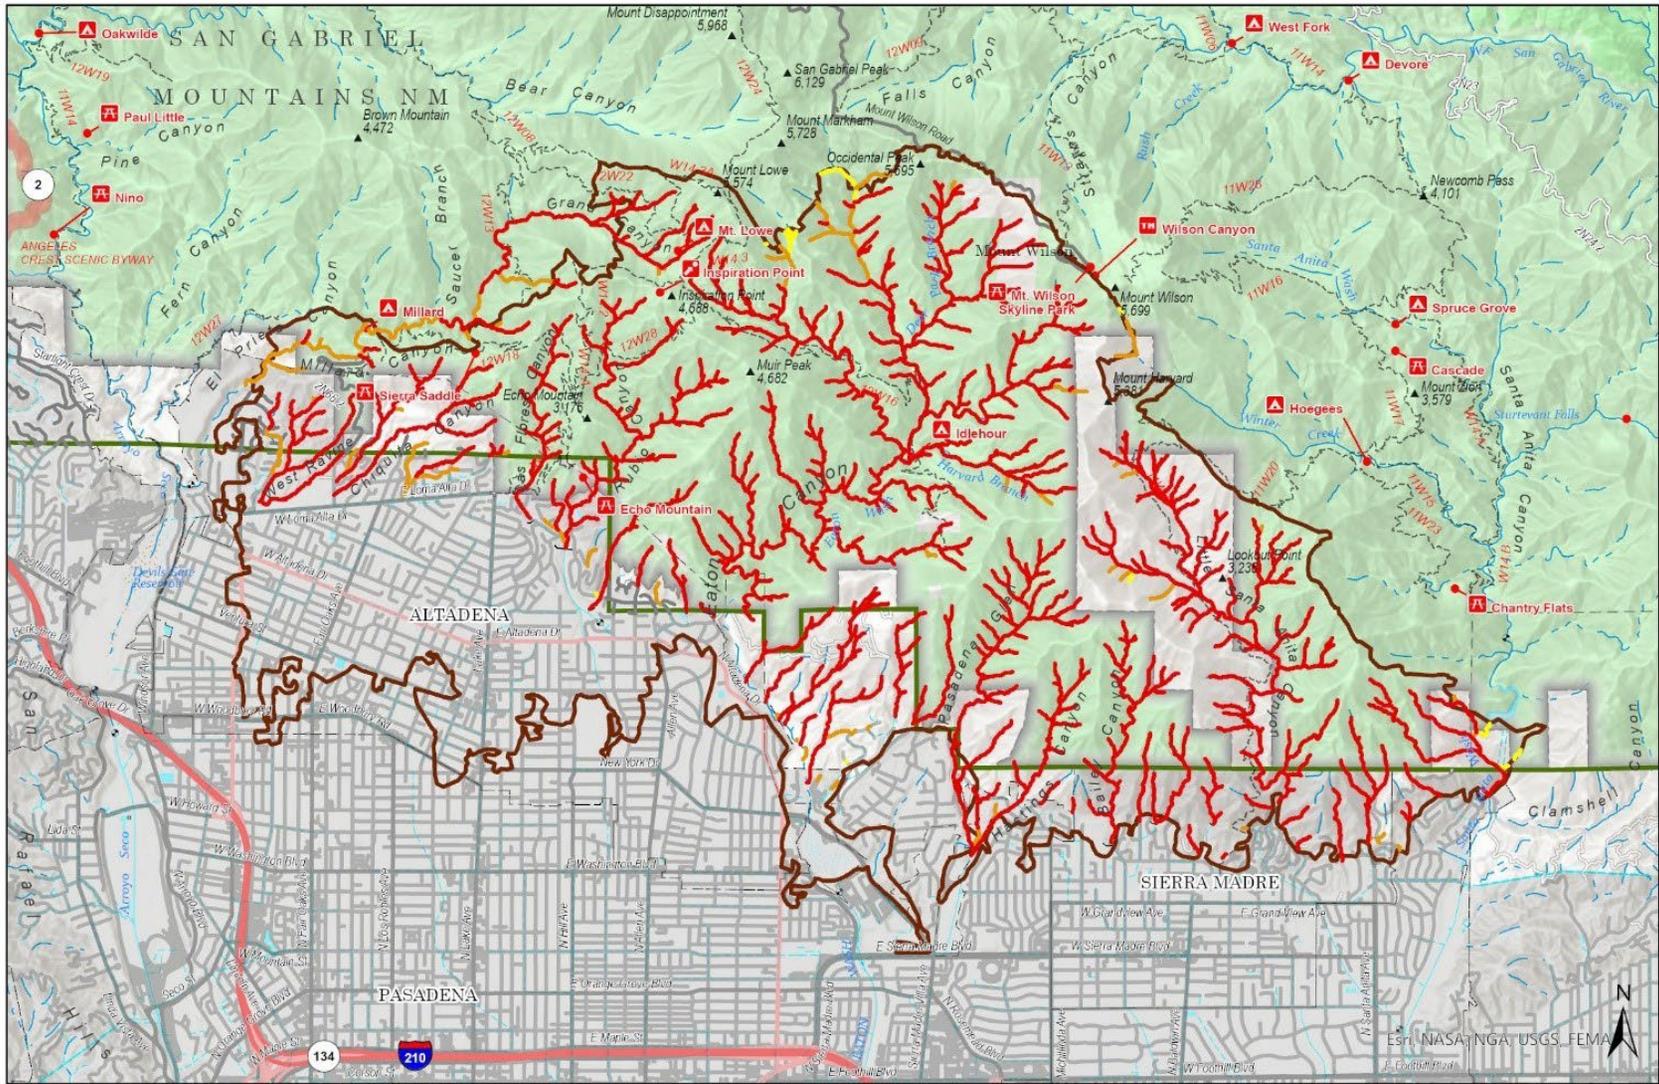
Debris Flow Combined Hazard
 Eaton Fire - Angeles National Forest
 January 2025

Peak 15 Minute Rainfall Intensity 40 mm/h rate

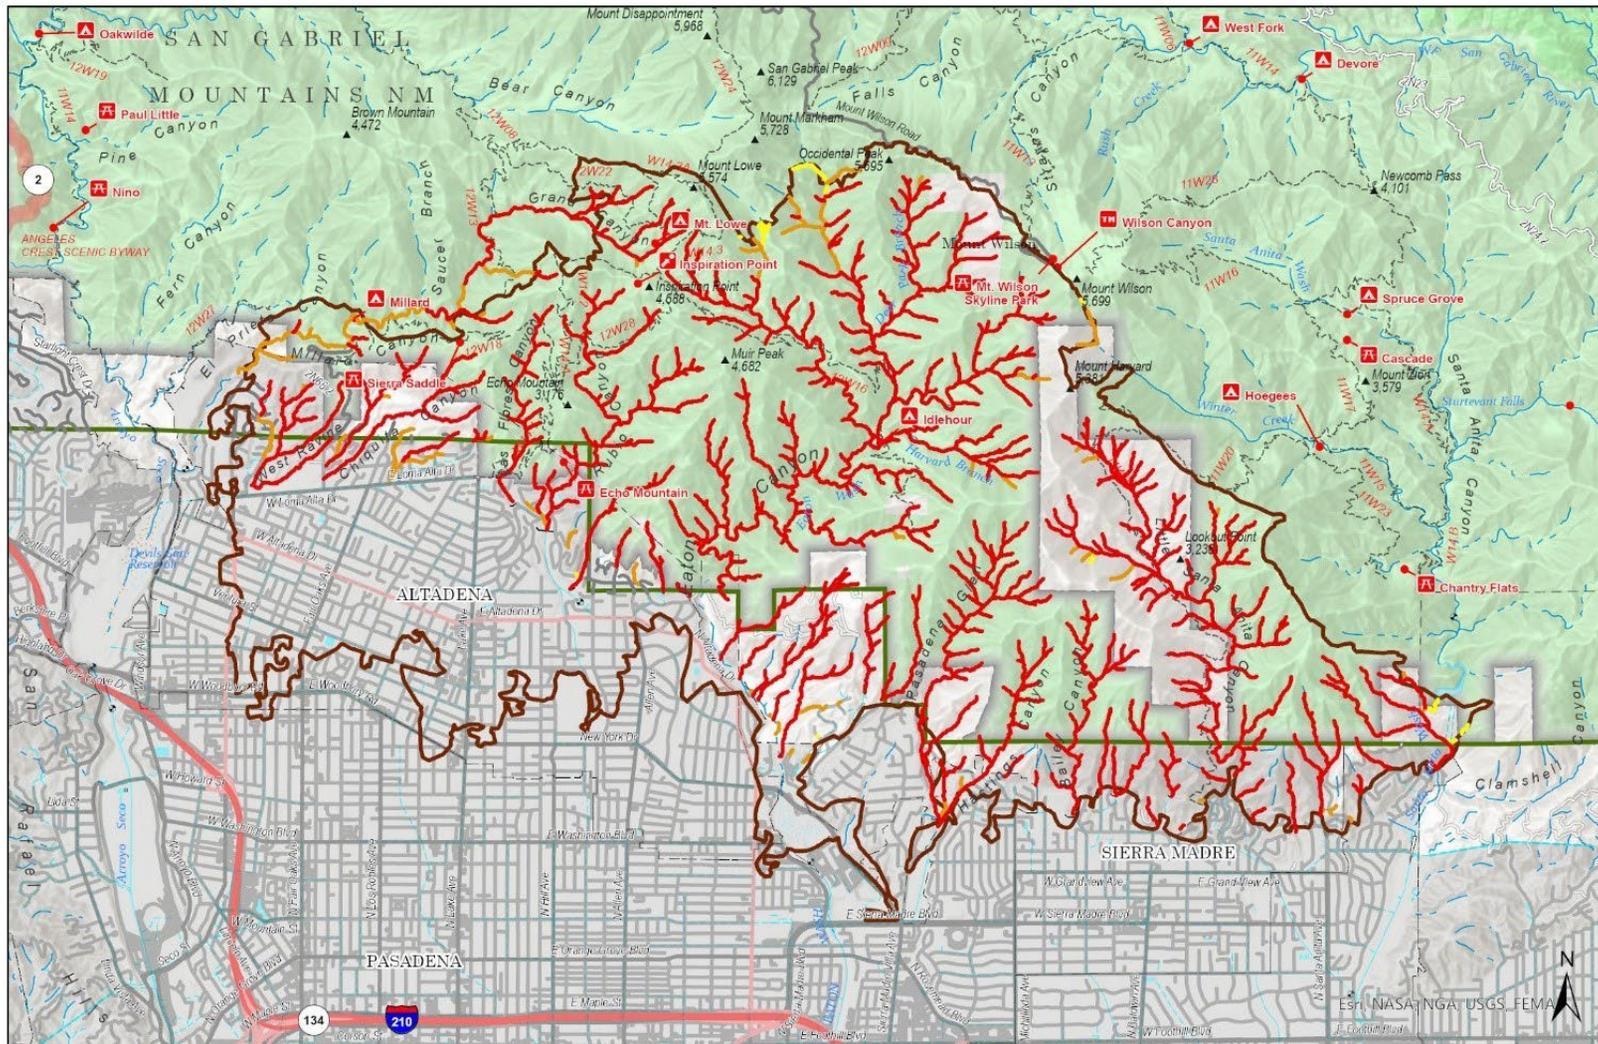
Debris Flow Combined Hazard
 Eaton Fire - Angeles National Forest
 January 2025

Peak 15 Minute Rainfall Intensity 40 mm/h rate
