Hermits Peak-Calf Canyon Burned Area Emergency Response Phase 1 Assessment Report Summary

Phase 1 Soil Burn Severity - Headwaters Gallinas River and Tecolote Creek Watersheds

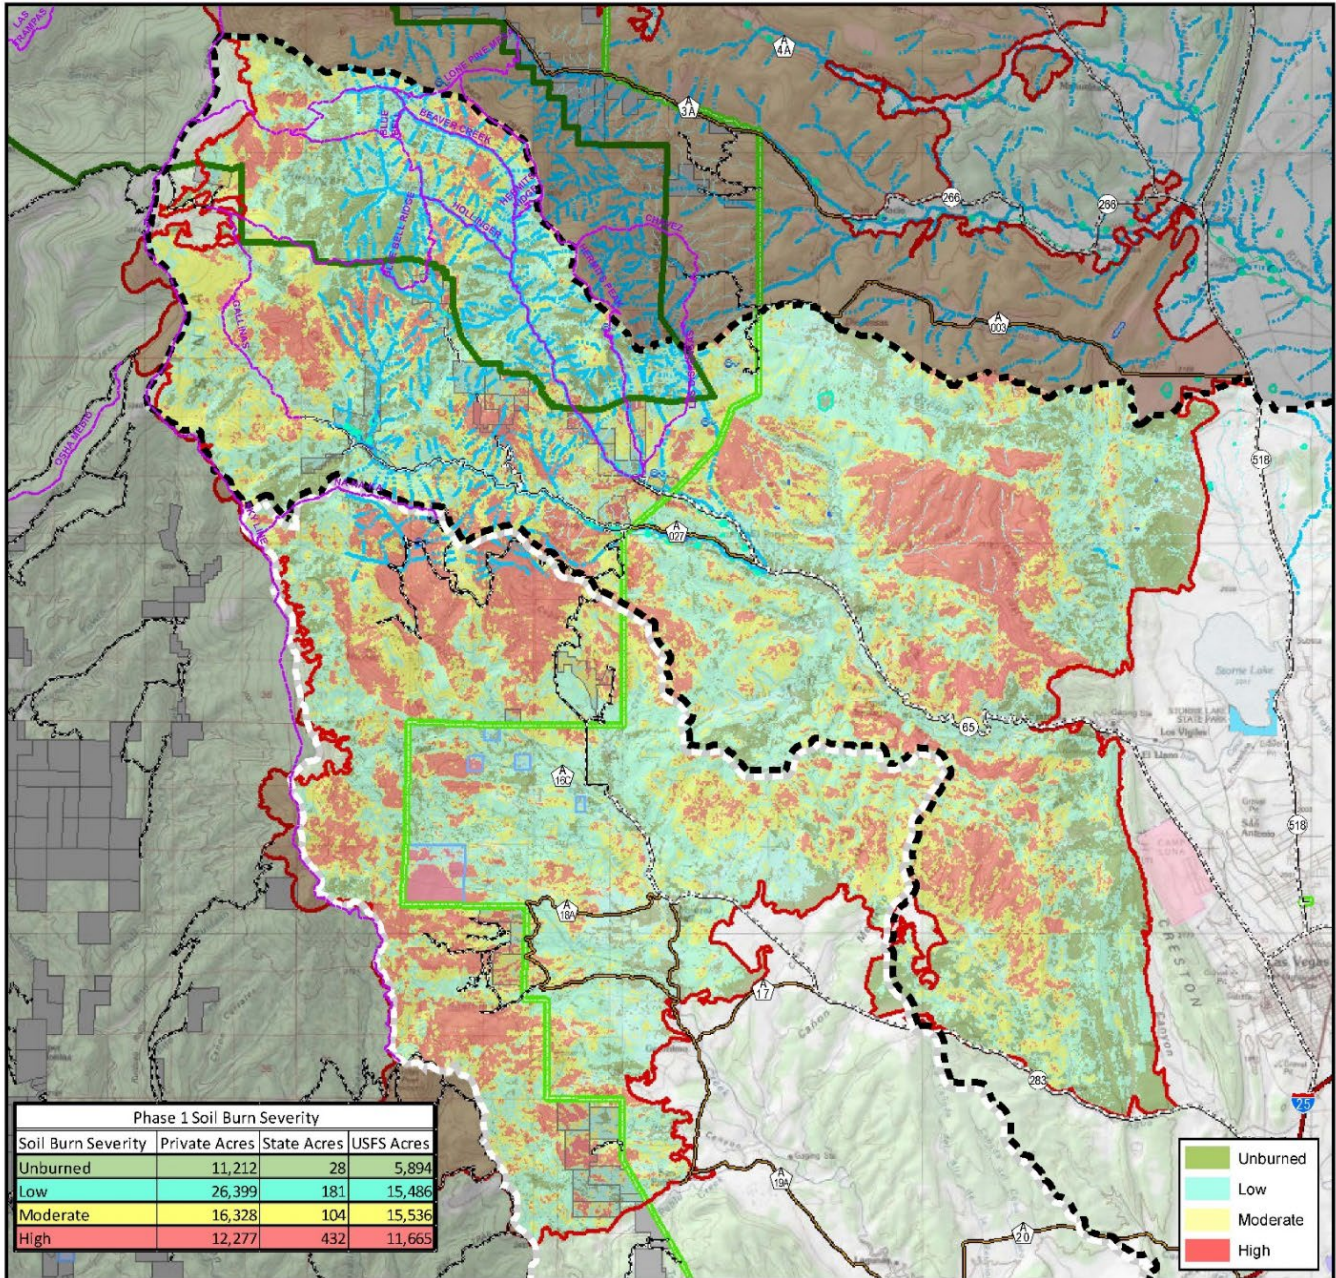
Figure 1. Soil Burn Severity map for the southern area (BAER Phase 1) of the Hermits Peak/Calf Canyon Fire.

Overall, about 49% of the BAER Phase 1 area of the HPCC fires burned in moderate and high SBS classes. The large contiguous areas of moderate and high SBS are contributing to the elevated watershed response. This analysis includes the Canovas Canyon – Gallinas Creek, Porvenir Canyon, and Cabo Lucero Creek – Tecolote Creek 6th code watersheds. All modeled subbasins and catchments show an extreme post-fire clear

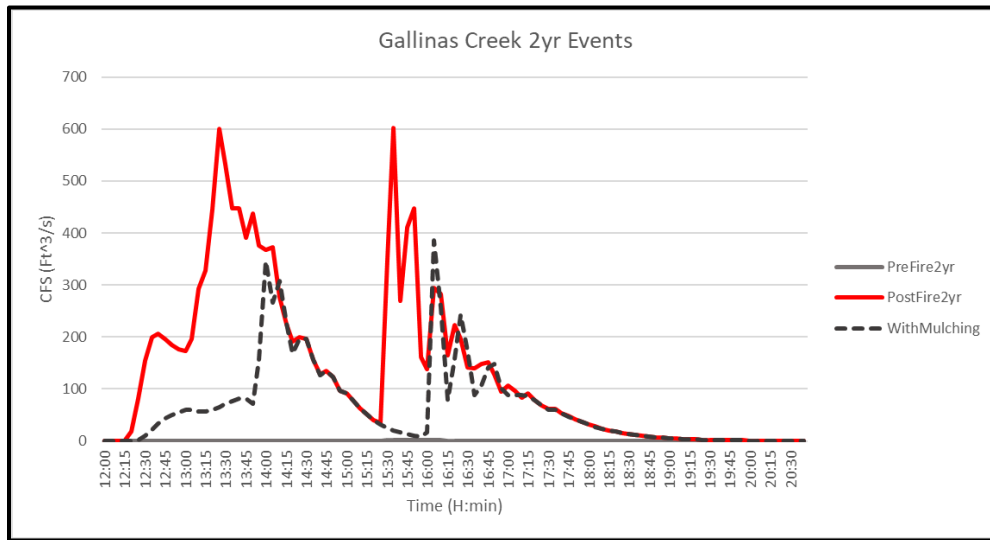
water flow increase for annual and 2-year storm events. Canovas Canyon – Gallinas Creek HUC12, modeled to the forest boundary, shows that what would typically have been a 2-year storm now produces what would be a 100-year event at the outlet. Figure 4 shows modelled water flows in Gallinas Creek in response to a 2-year storm event.

Figure 4. Modelled change in clear water flow in the Gallinas watershed in response to a 2-year storm event. The grey line (completely flat in this example) shows that water flow did not increase much over base flow in response to a monsoonal 2-year storm with pre-fire conditions. The red line shows water flow after the fire if no treatments occur. Note that the maximum flow rate is more than 600 CFS. The dashed black line shows water flow after the fire if high soil burn severity areas of the Gallinas watershed are treated with mulch. The mulching treatment reduces the peak flows produced by a 2-year summer convective storm event by 45%.
