Forest Service  
U.S. DEPARTMENT OF AGRICULTURE

Santa Fe National Forest | June 2022

# Cerro Pelado Burned Area Emergency Response (BAER) Assessment Report

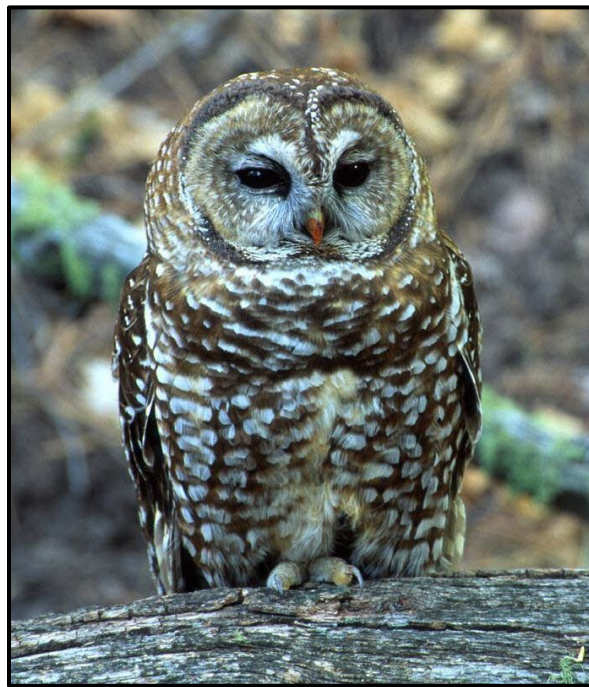
Figure 6. Mexican Spotted Owl

Mexican spotted owl (MSO) Critical Habitat: MSO habitat is not readily impacted by flooding events. Second order fire effects such as tree regeneration, plant succession, and changes in site productivity can be anticipated primarily for moderate to high SBS. An increase in pest susceptibility may also occur including invasion of noxious and invasive species. Unaffected MSO Protected Activity Centers (PACs) habitat could subsequently be impacted by pest outbreak originating from within the Cerro Pelado Fire. Using the BAER Risk Assessment Matrix (Table 1) for natural resource critical values, we estimate the probability of loss for Mexican spotted owl PACs and Recovery Nest Roost to be “possible” and the magnitude of consequences to be “minor”.
