OAK FIRE

Burned Area Emergency Response Assessment

August
2022

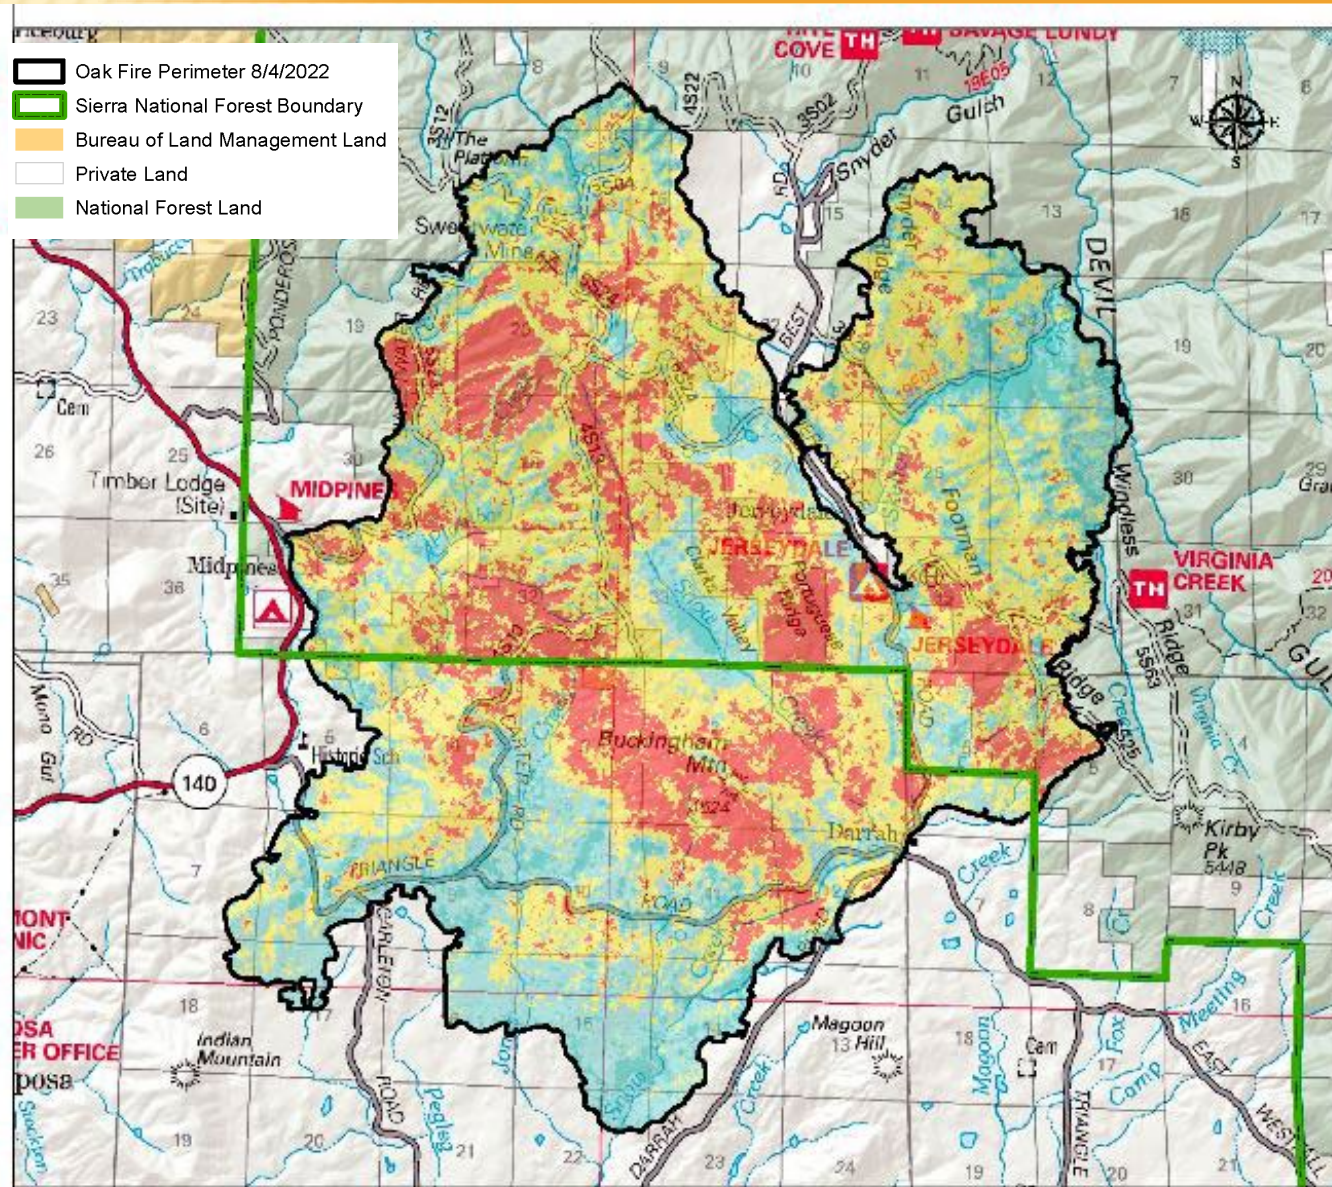
SOILS- SOIL BURN SEVERITY (SBS)

Acres of Soil Burn Severity by Land Ownership		
USDA Forest Service	Bureau of Land Management	Private
2,324.07	23.46	1,655.88
4,569.92	17.05	4,213.19
1,763.29	12.50	3,503.50
546.97	1.83	848.62
9,204.26	54.84	10,221.20

Soil Burn Severity	%	Total Acres (Approx.)
High	21	4,003.41
Moderate	45	8,800.17
Low	27	5,279.29
Unburned	7	1,397.42
Grand Total	100	*19,480.29

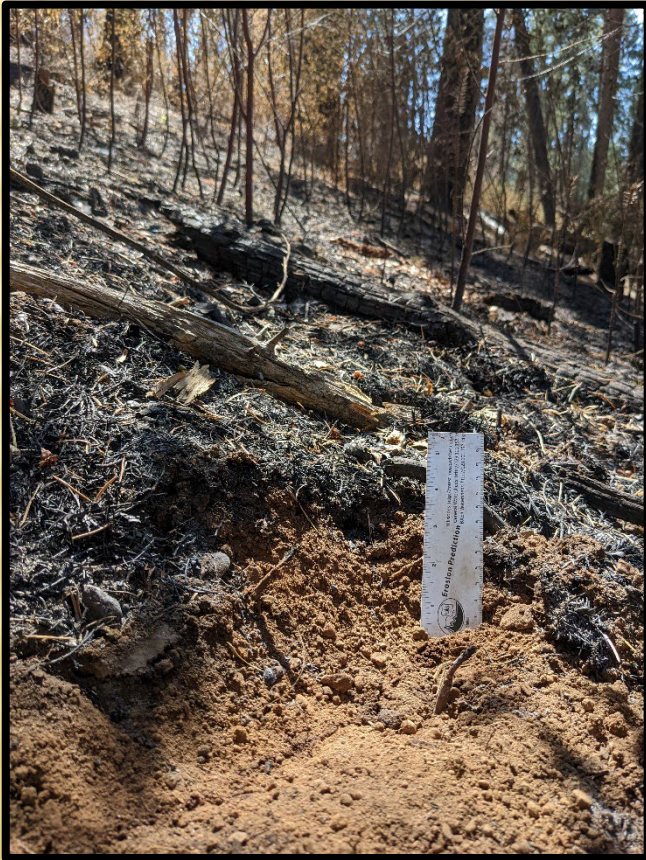
Mixed Conifer

LOW SOIL BURN SEVERITY

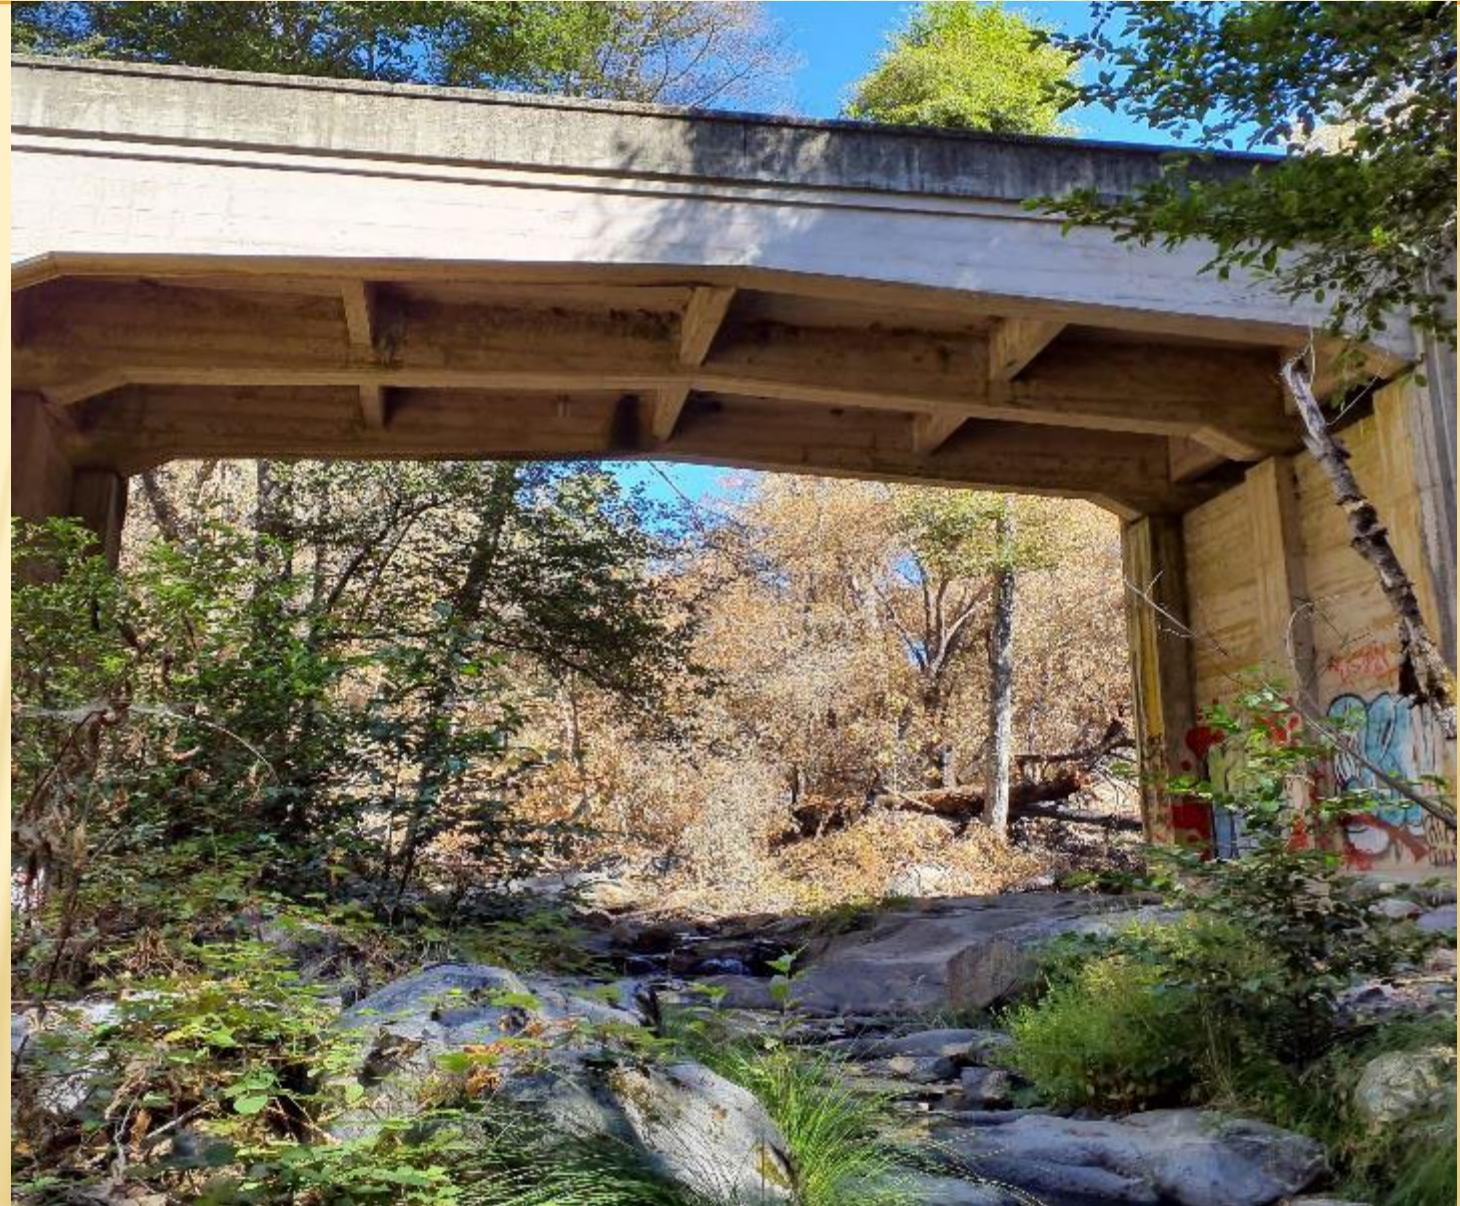
WATERSHED OBSERVATIONS & FINDINGS – HYDROLOGY

- ✘ Hydrologic modeling was completed to determine post fire watershed response. Much of the watersheds were burned severely.
- ✘ High watershed response with runoff and sediment is expected from the fire area watersheds, up to 400 percent increase from primary drainages.
- ✘ Forest Roads and Trails could be impacted and damaged as a result of a 2-year design storm or larger, with possible flooding and sedimentation to roads at drainage crossings.
- ✘ Burned watershed channels have existing sediment exposed and ready to be mobilized downstream.

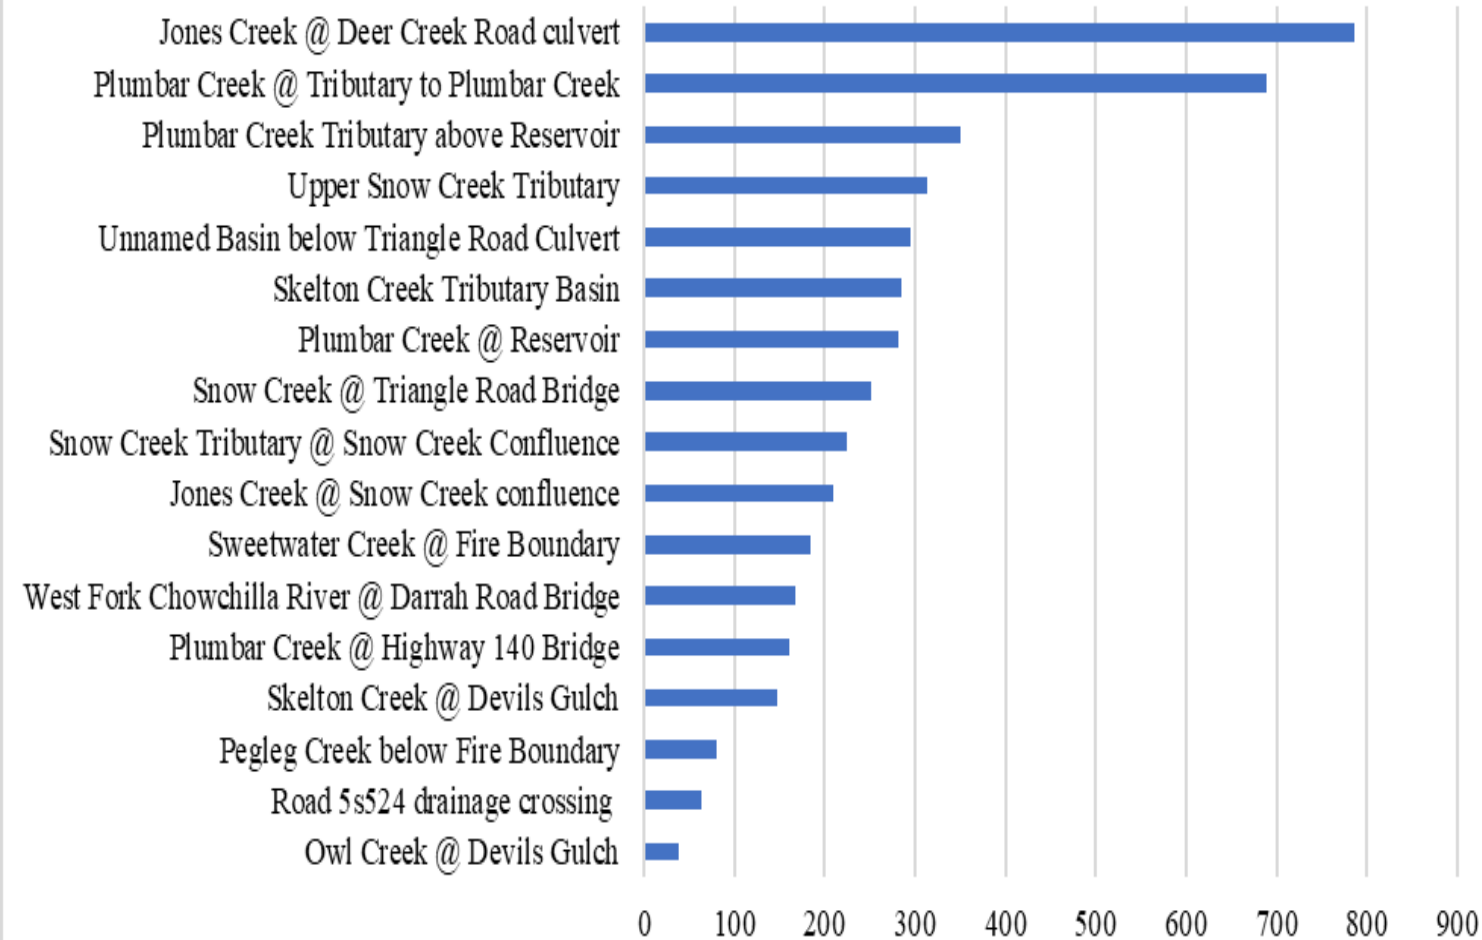
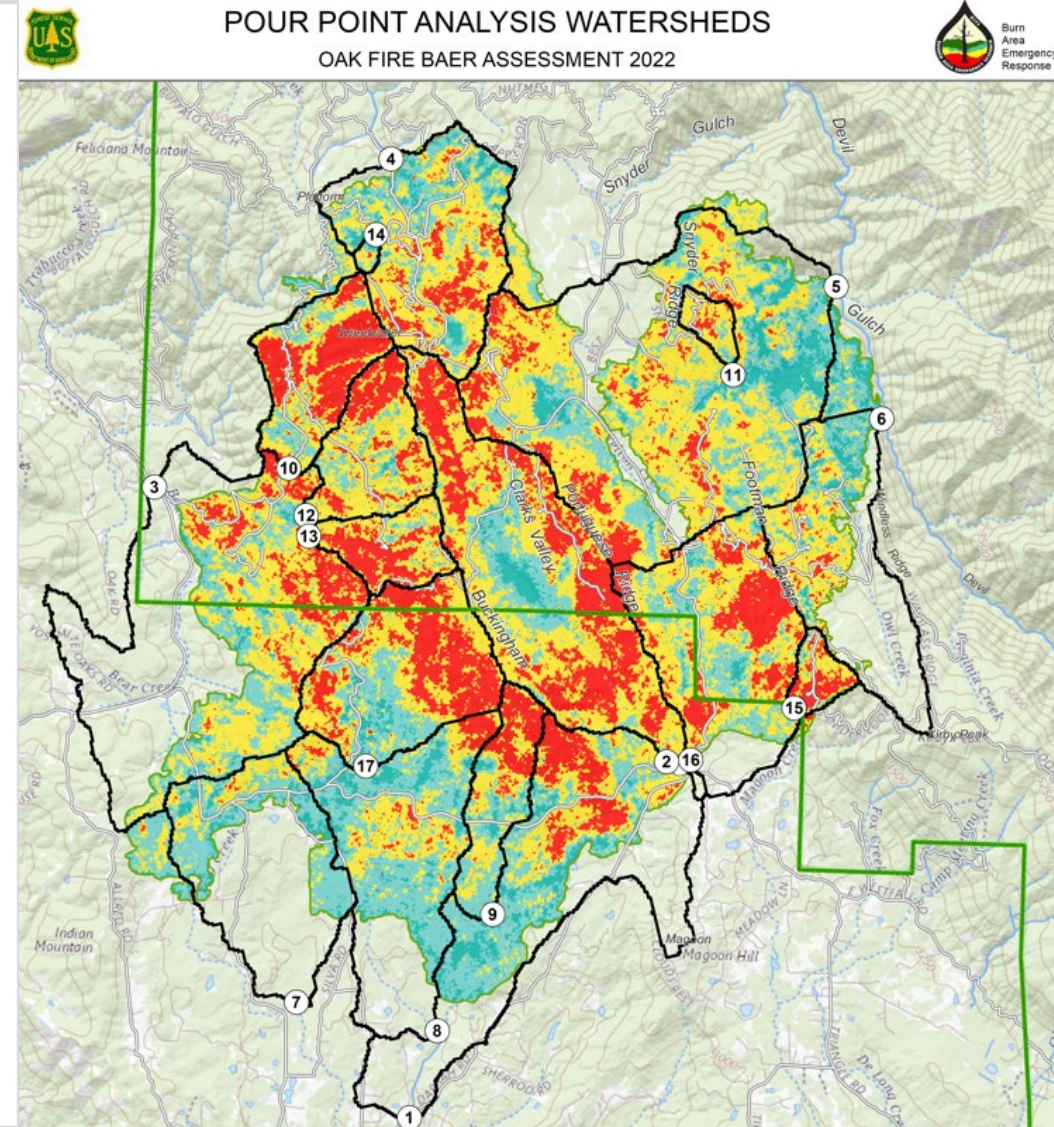
WATERSHED OBSERVATIONS & FINDINGS – HYDROLOGIC MODELING RESULTS

Post Fire 2-year design storm peak flows (Q2) in Percent above Pre-Fire Q2 flows

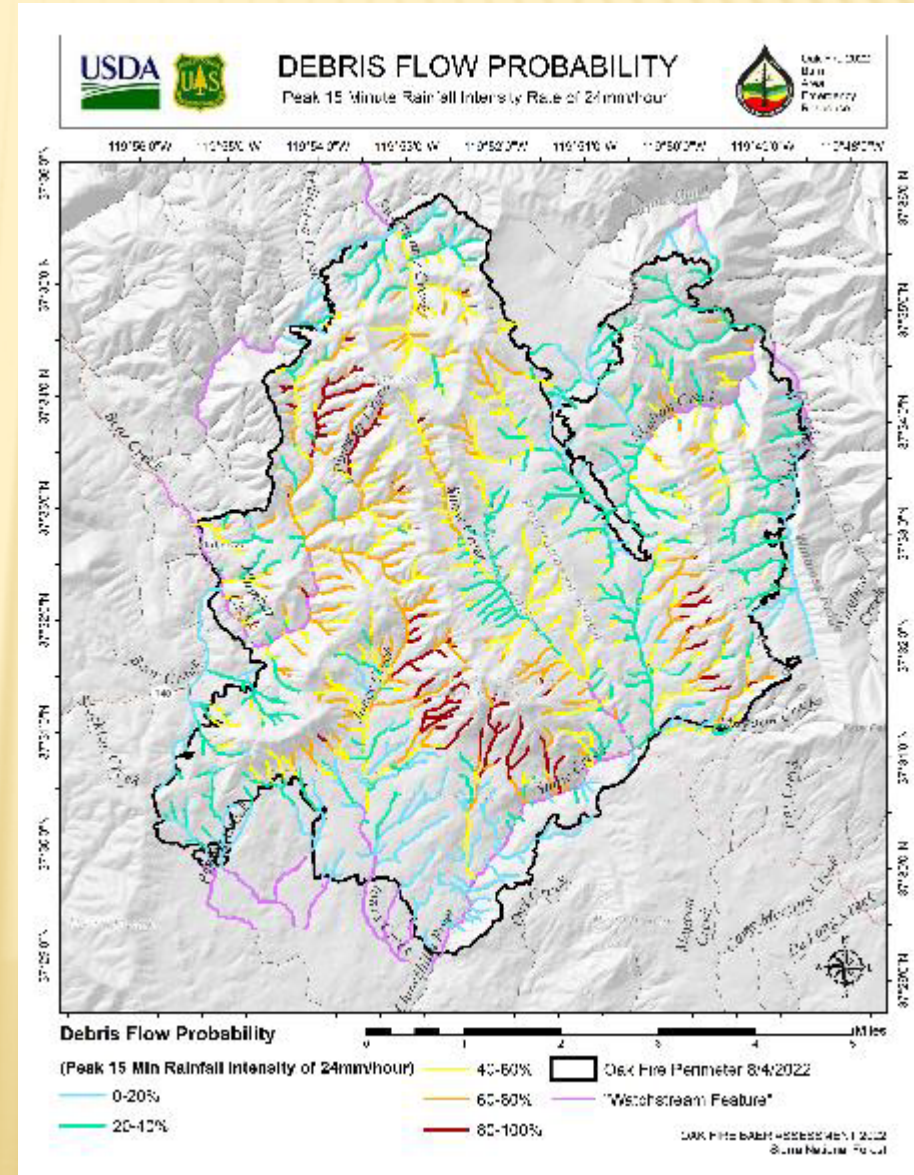
GEOLOGY HAZARDS ASSESSMENT

- Rock-fall
- Debris flows
- Sediment laden flooding
- Sediment bulking, and
- Channel flushing along some slopes and drainages in and below the burn areas

- Post warning signs and enforce administrative closures along some FS roads & trails
- Road storm proofing and storm patrols
- Coordinate warning notifications with the National Weather Service

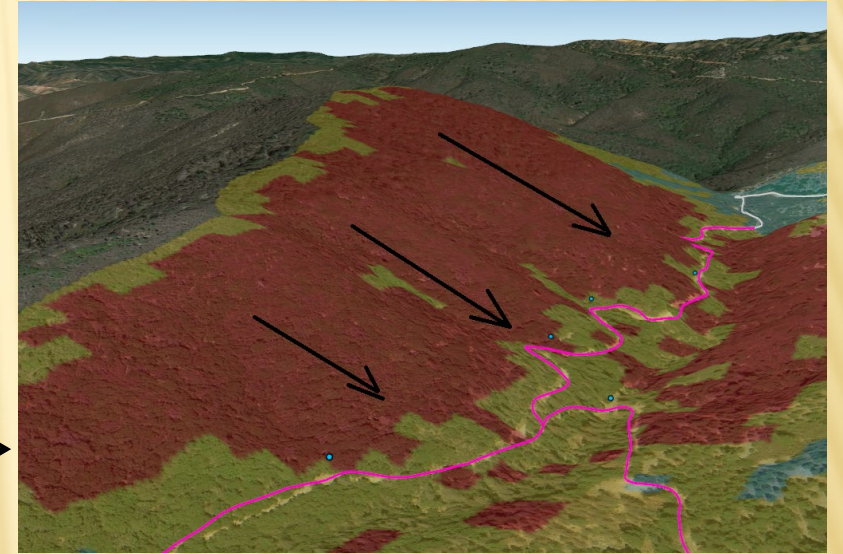
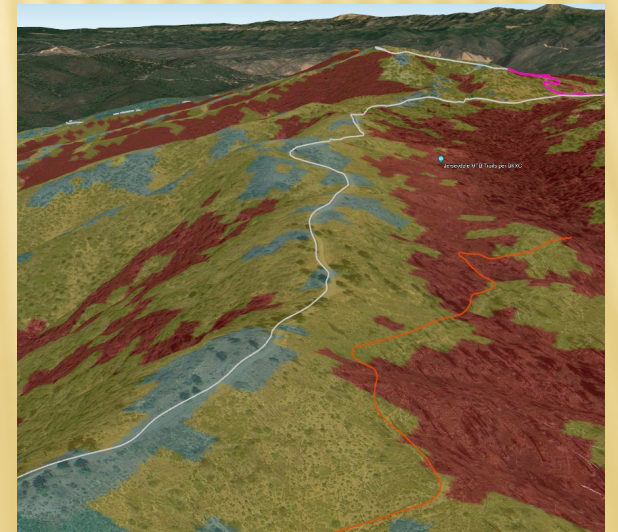
ENGINEERING - FINDINGS

- 45.57 miles are within the Oak Fire footprint
- Approximately 30 miles were evaluated for assessment
 - 28.88 miles of roads were assessed to have **Likely** Probability of Damage and will have a **Major** Magnitude of Consequence leading to a **High Risk**.
 - Roads located on moderate/high burn severity upslope, steep drainages, and roads with steep grades —————→
 - 13.29 miles of roads were assessed to have **Unlikely** Probability of Damage but will have a **Moderate** Magnitude of Consequence leading to a **Low Risk**.
 - Roads located on ridgetops, in locations with low to unburned upslope, or in flat terrain —————→

- **Restore Drainage**
 - Includes road grading, cleaning culverts, and ditch cleaning to allow water to drain off the road during storm events.
- **Armor Drainage Crossings**
 - Armor existing crossings to reduce road failure and reduce impacts downslope of road to protect fish habitat and water quality.
- **Gates**
 - • Install gates for public safety especially during periods of expected moderate to high rainfall events .
- **Storm Inspection and Response**
 - Allows the forest to inspect roads after storm events and repair any road damage found during inspection.
- **Warning Sign**
 - Alert drivers and recreational users of existing or potentially hazardous conditions created by the wildfire.

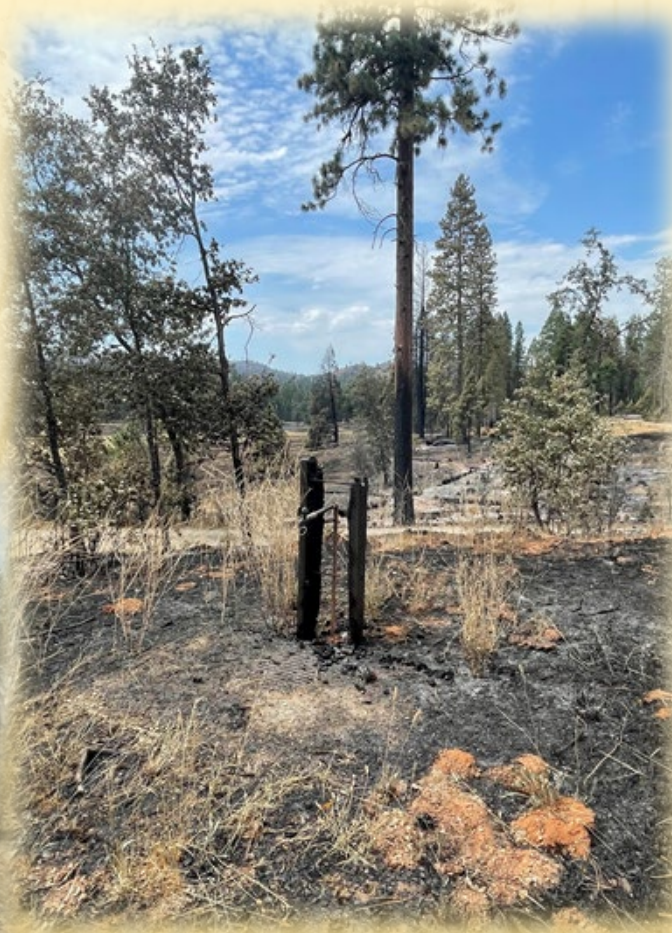
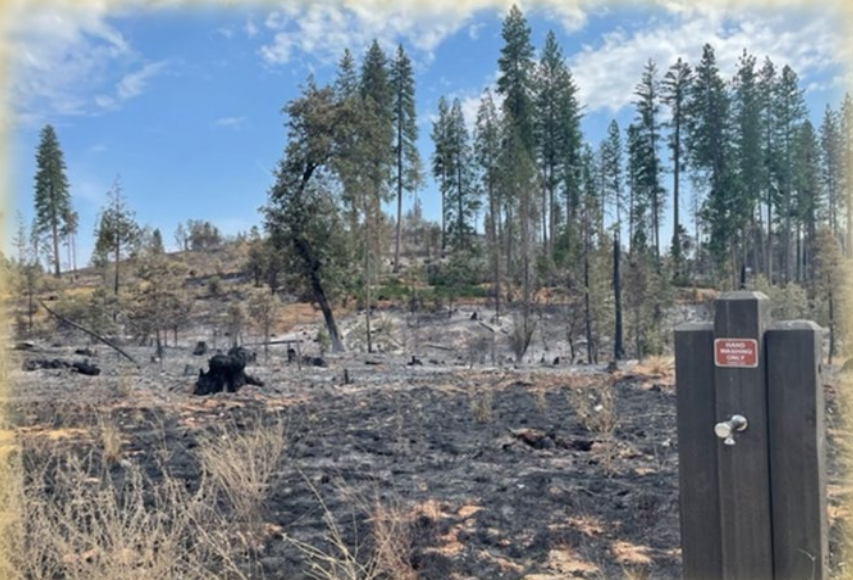
Jerseydale Campground

- New Renovations
 - Substantial Recent Investment
- Threats to Infrastructure
 - Hazard Trees

- Storm-proofing treatments
- Warning signs
- Focused hazard tree removal (trail crew safety and Forest Service property protection)
- Another Treatment
 - Trail Temporary Closure
 - Closure Signs

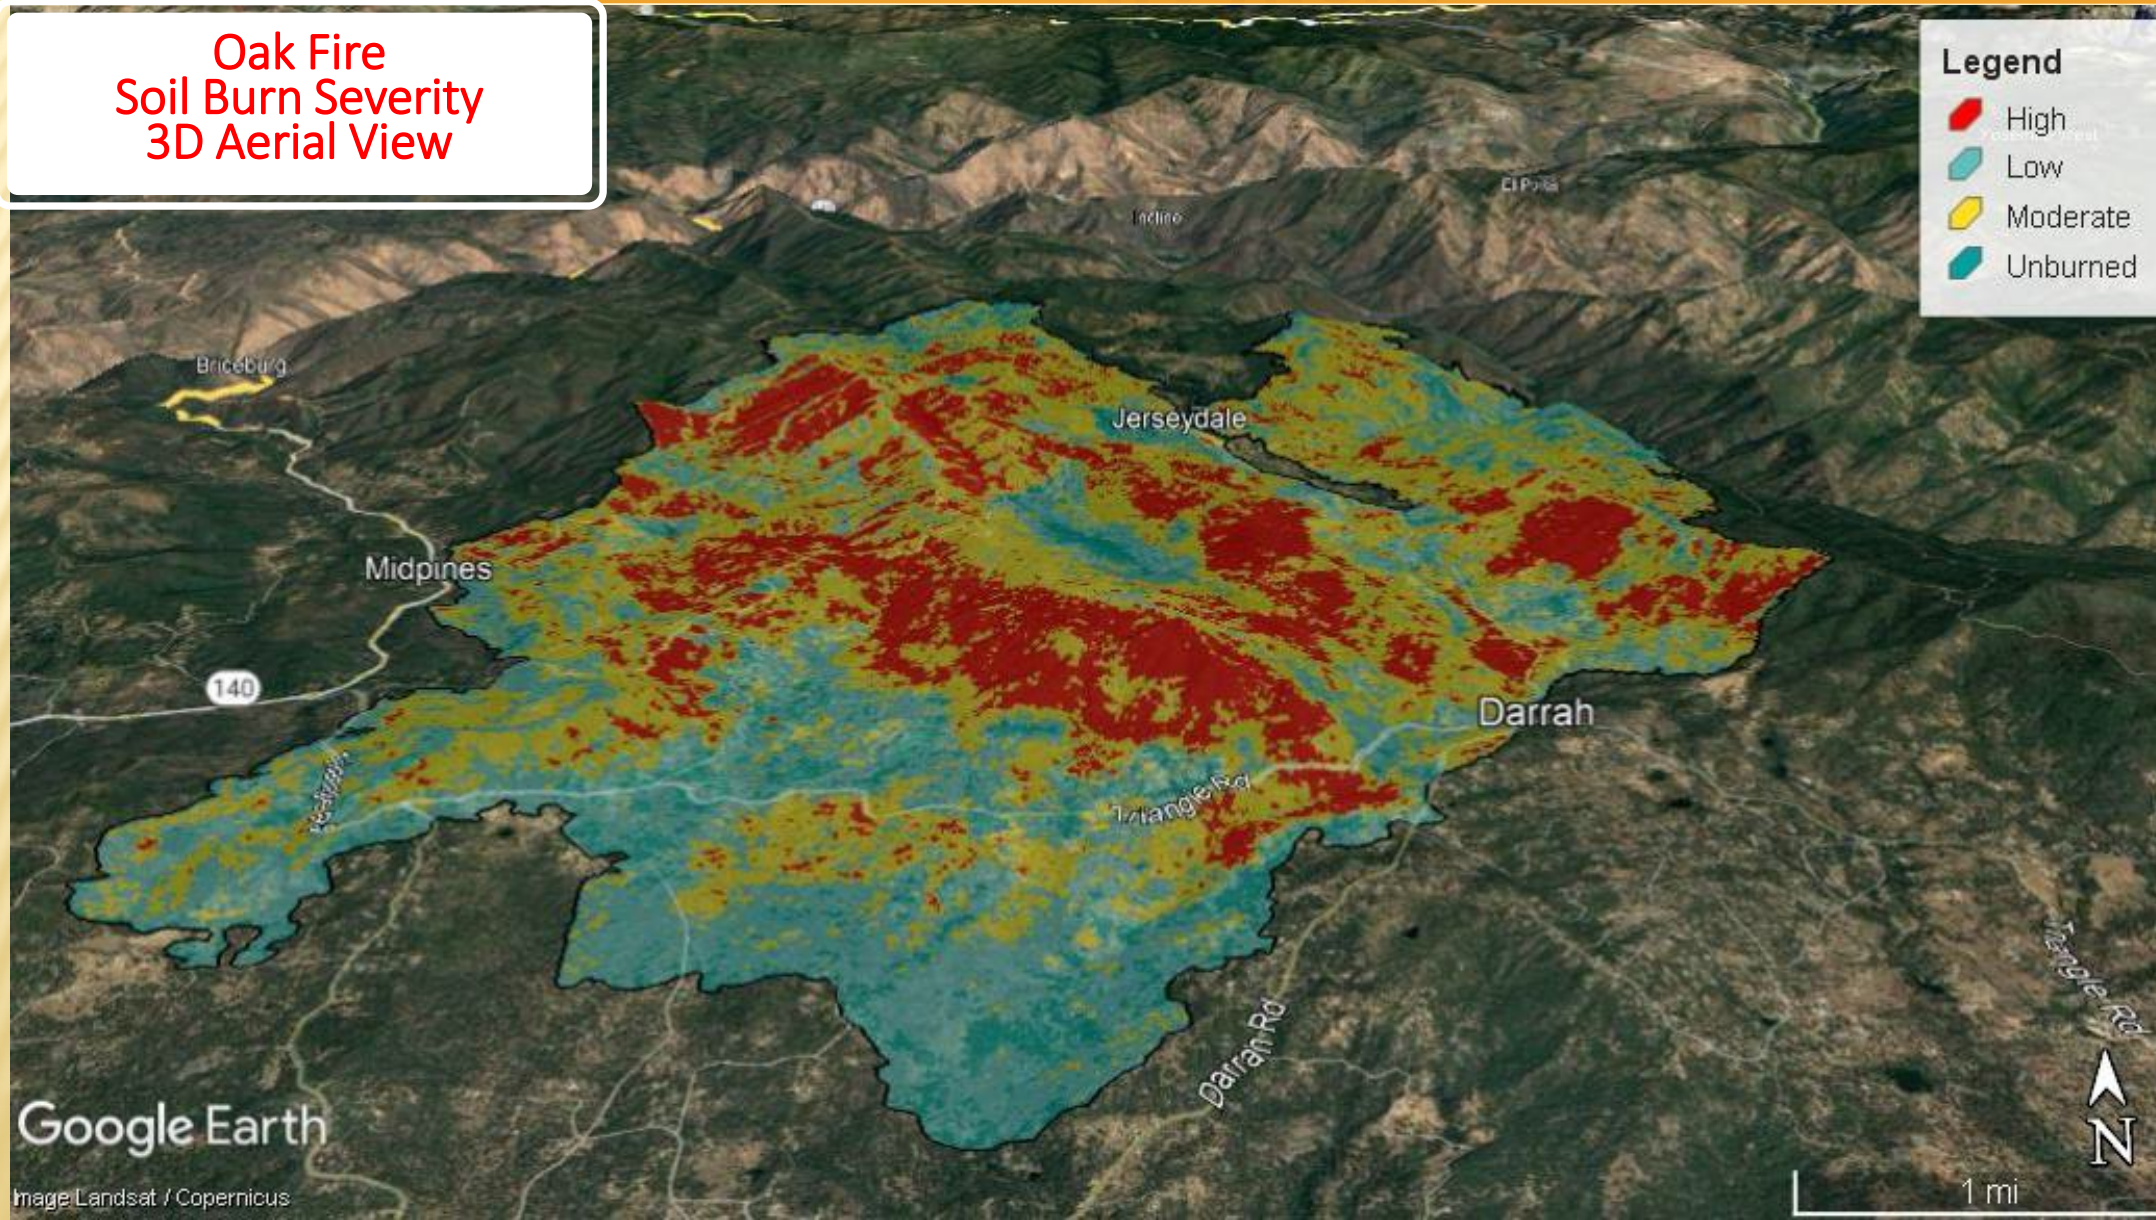
3D View

Oak Fire
Soil Burn Severity
3D Aerial View
