BAER Specialists Assess Mosquito Burned Area

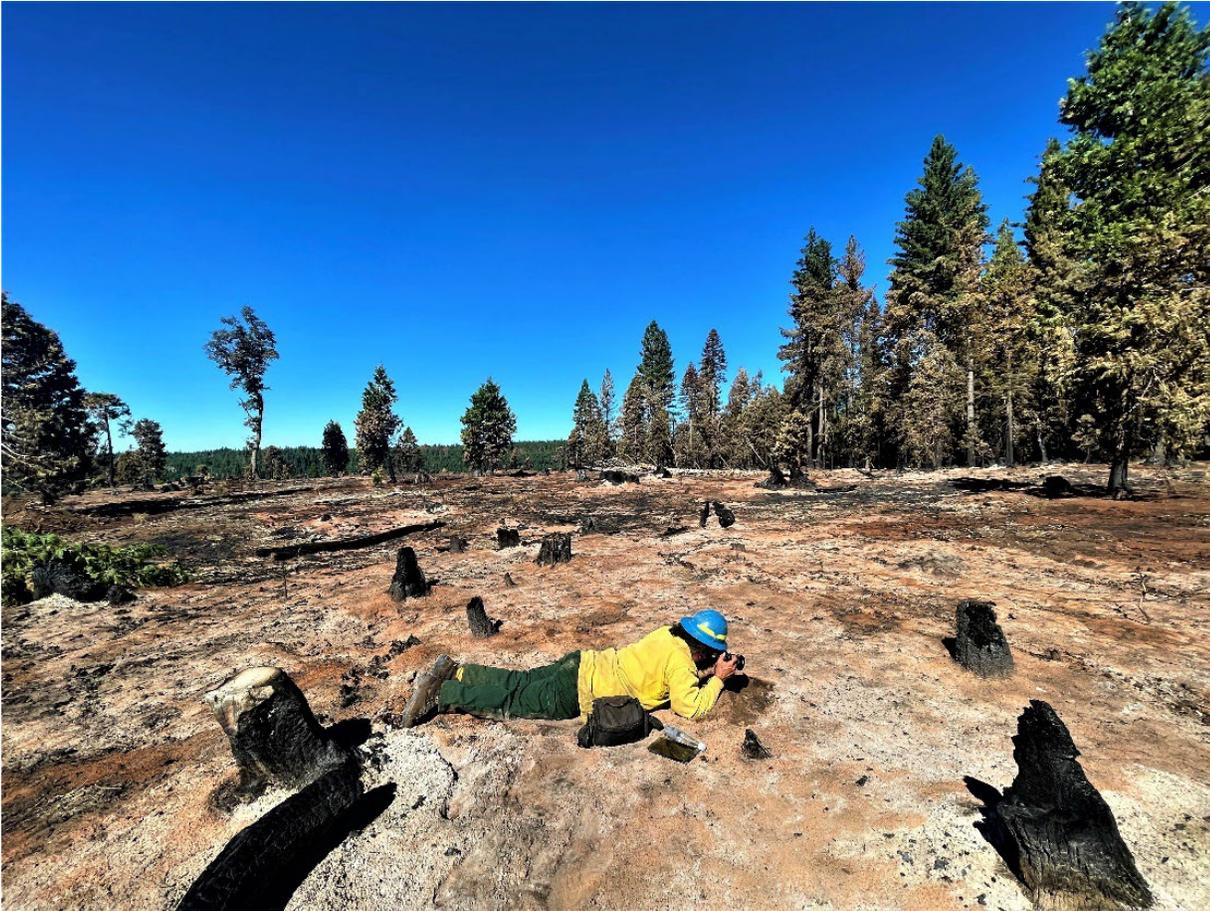
In this photo below, Forest Service Soil Scientist Eric Nicita assesses soil hydrophobicity (water repellency), changes to soil structure, and maps the soil burn severity (SBS) in the Mosquito burned area.

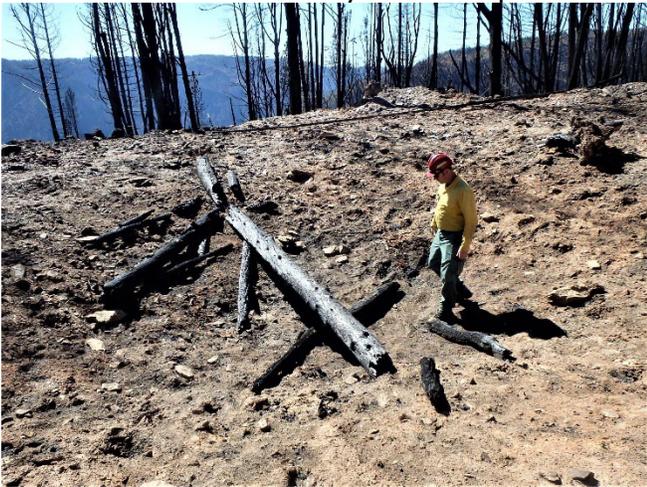
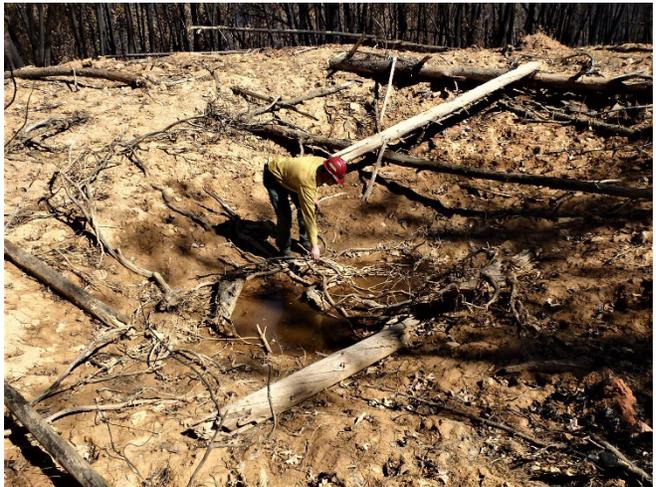
These two photos show Dan Teater, assessing California red legged frog critical habitat that was burned over by the Mosquito Fire.

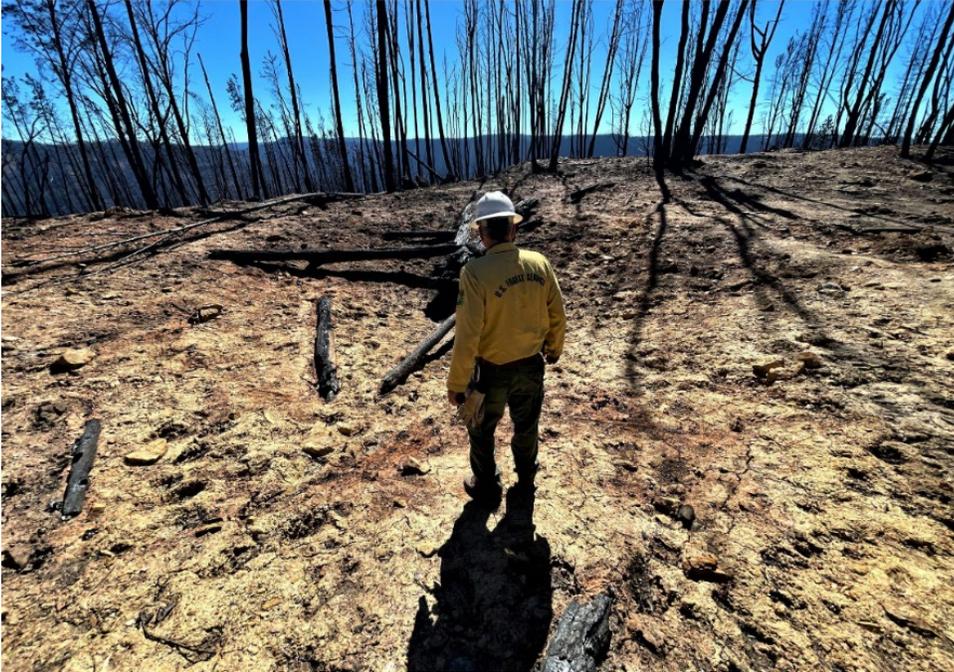
This next photo shows Forest Service Environmental Geologist Rick Weaver assessing the California red legged frog habitat near Big Gun Diggings Hydraulic Mine located on the American River Ranger District on the Tahoe NF.

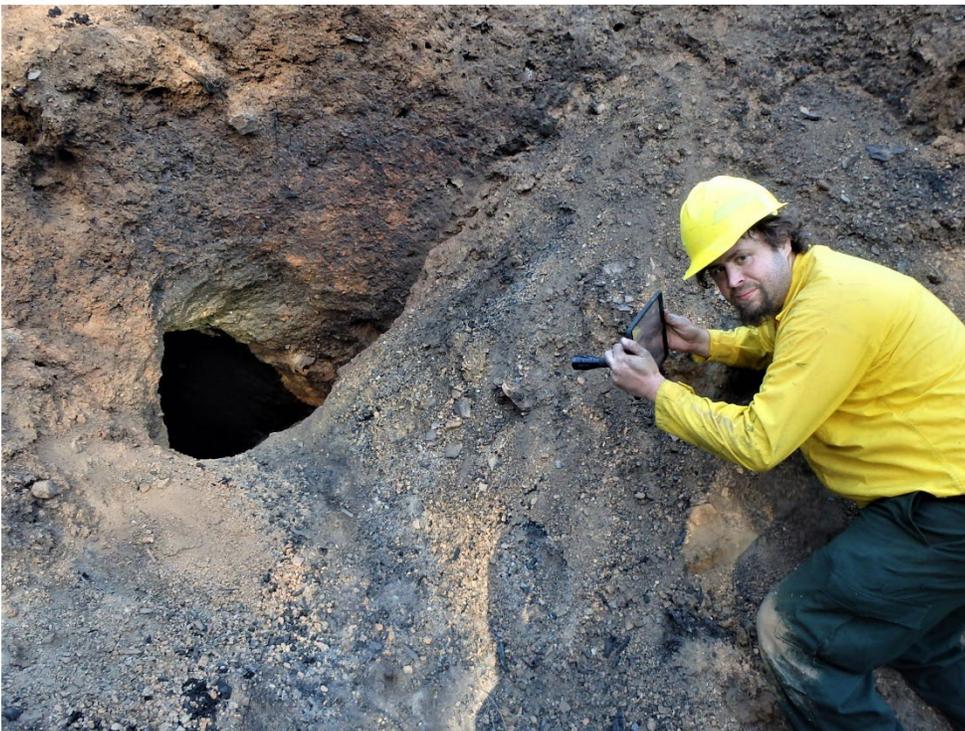
In this photo below, Forest Service Abandoned Mine Specialist Jeremy Olson is recording information at a hazardous mine opening near the Western States Trail in the Mosquito burned area.

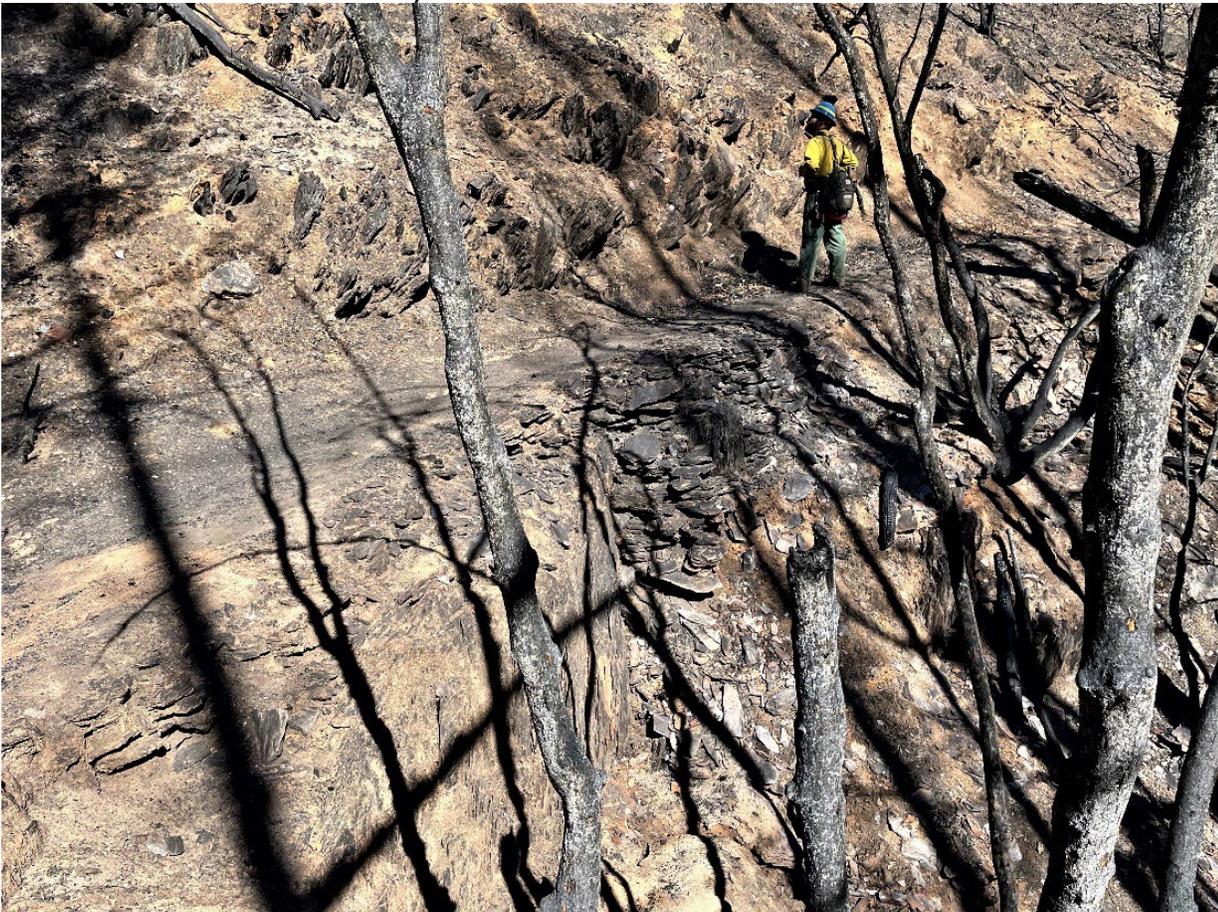
This photo below shows BAER Trails Specialist James Wood assessing the burned Western States Trail in Eldorado Canyon.

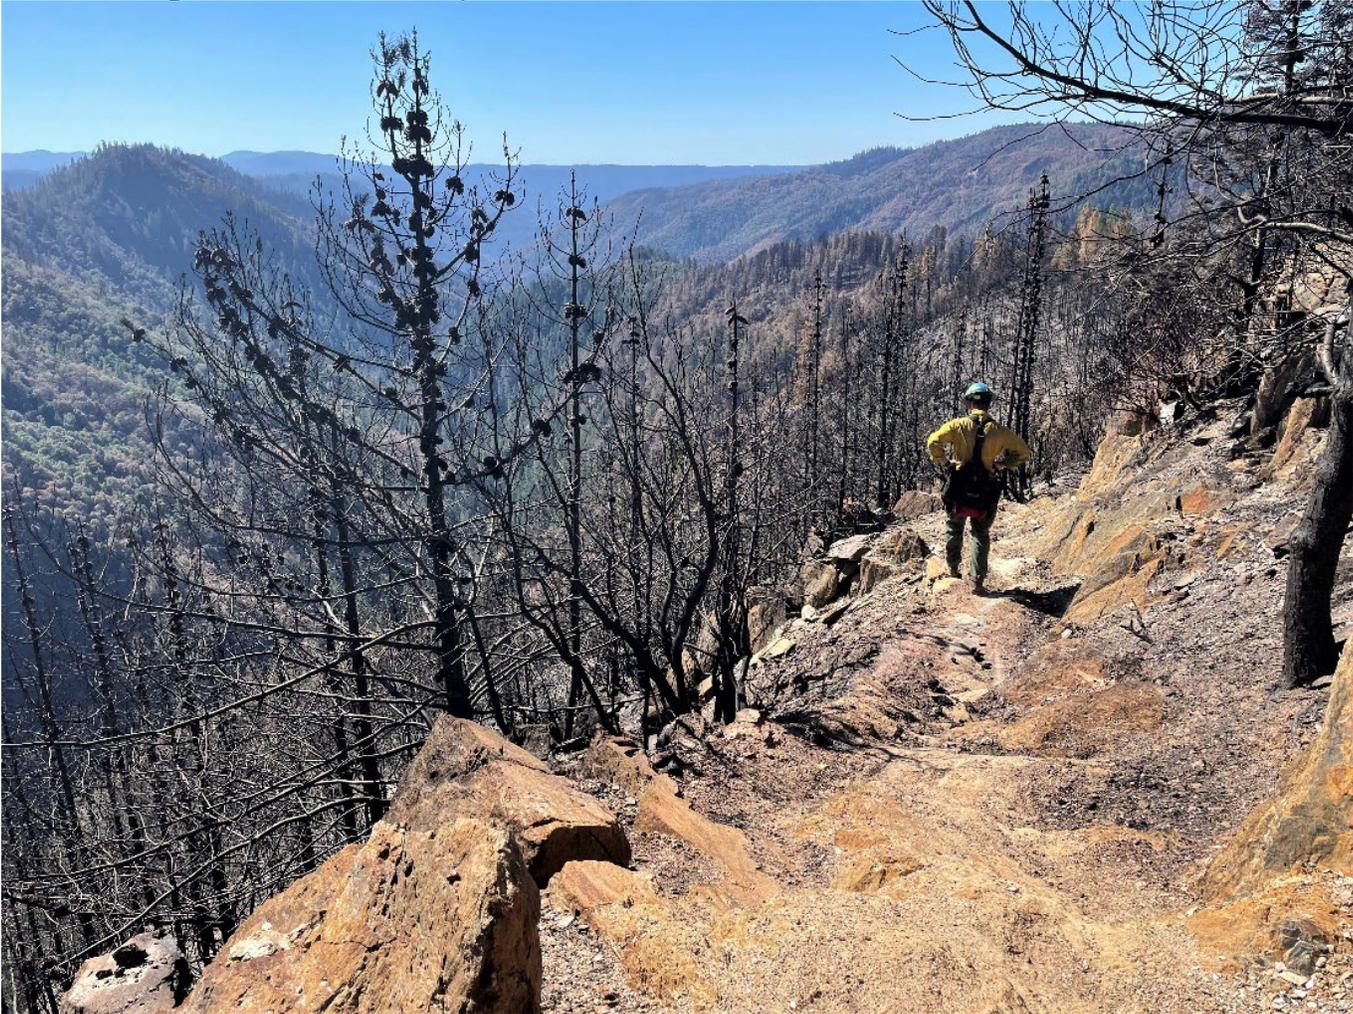
Here BAER Archeology Tech Jacob Batsky is assessing the Loop 6 motorcycle trail on Codfish Ridge as shown in this photo below.

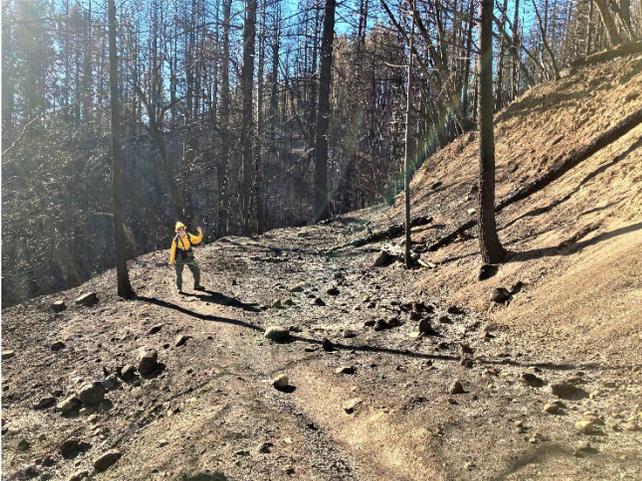
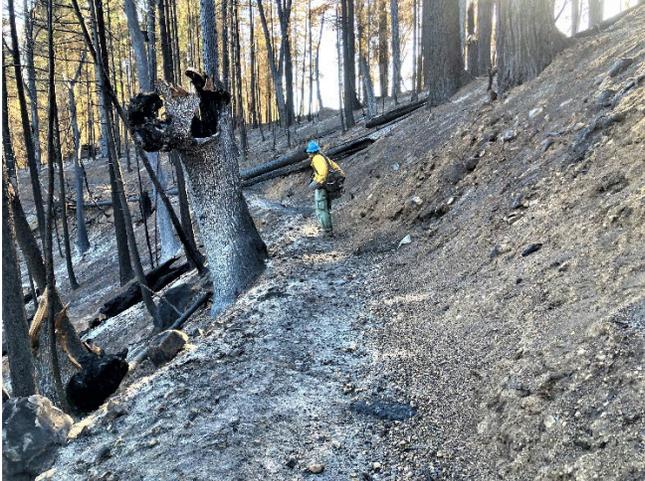
The next two photos BAER Hydrologist Tori Stempniewicz (left photo) and Jacob Batsky (right photo) assess the Loop 6 motorcycle trail in the Mosquito burned area.
