HAPPY CAMP COMPLEX FIRES

Burned Area Emergency Response Assessment

September
2023

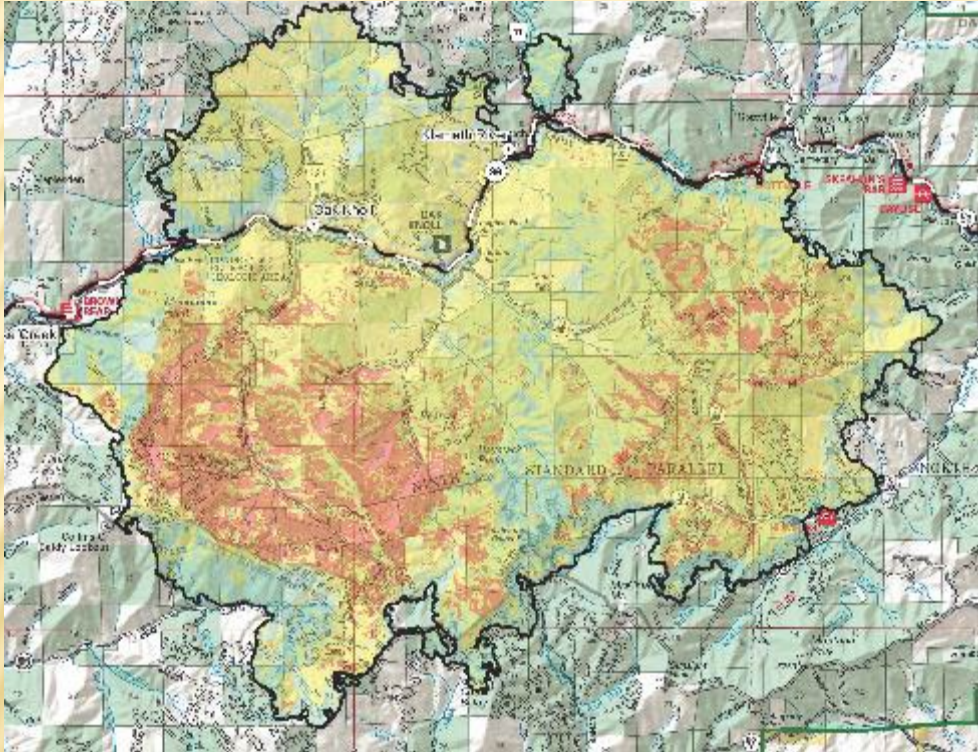
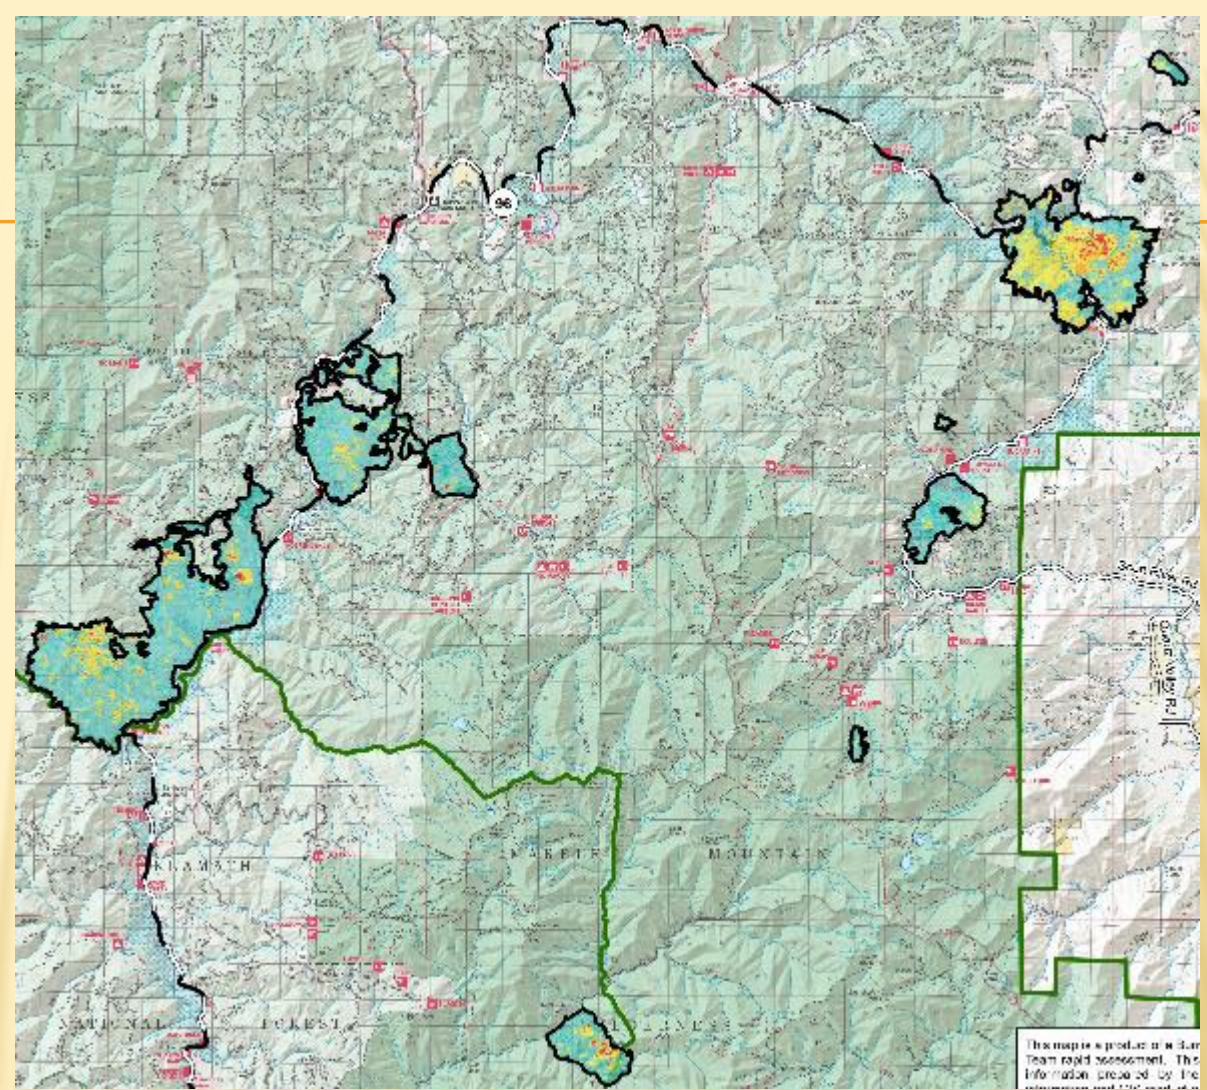
2022 McKinney Fire

~80% High and Moderate Soil Burn Severity
~20% Low and Unburned Soil Burn Severity

2023 Happy Camp Complex Fires

~20% High and Moderate Soil Burn Severity
~80% Low and Unburned Soil Burn Severity

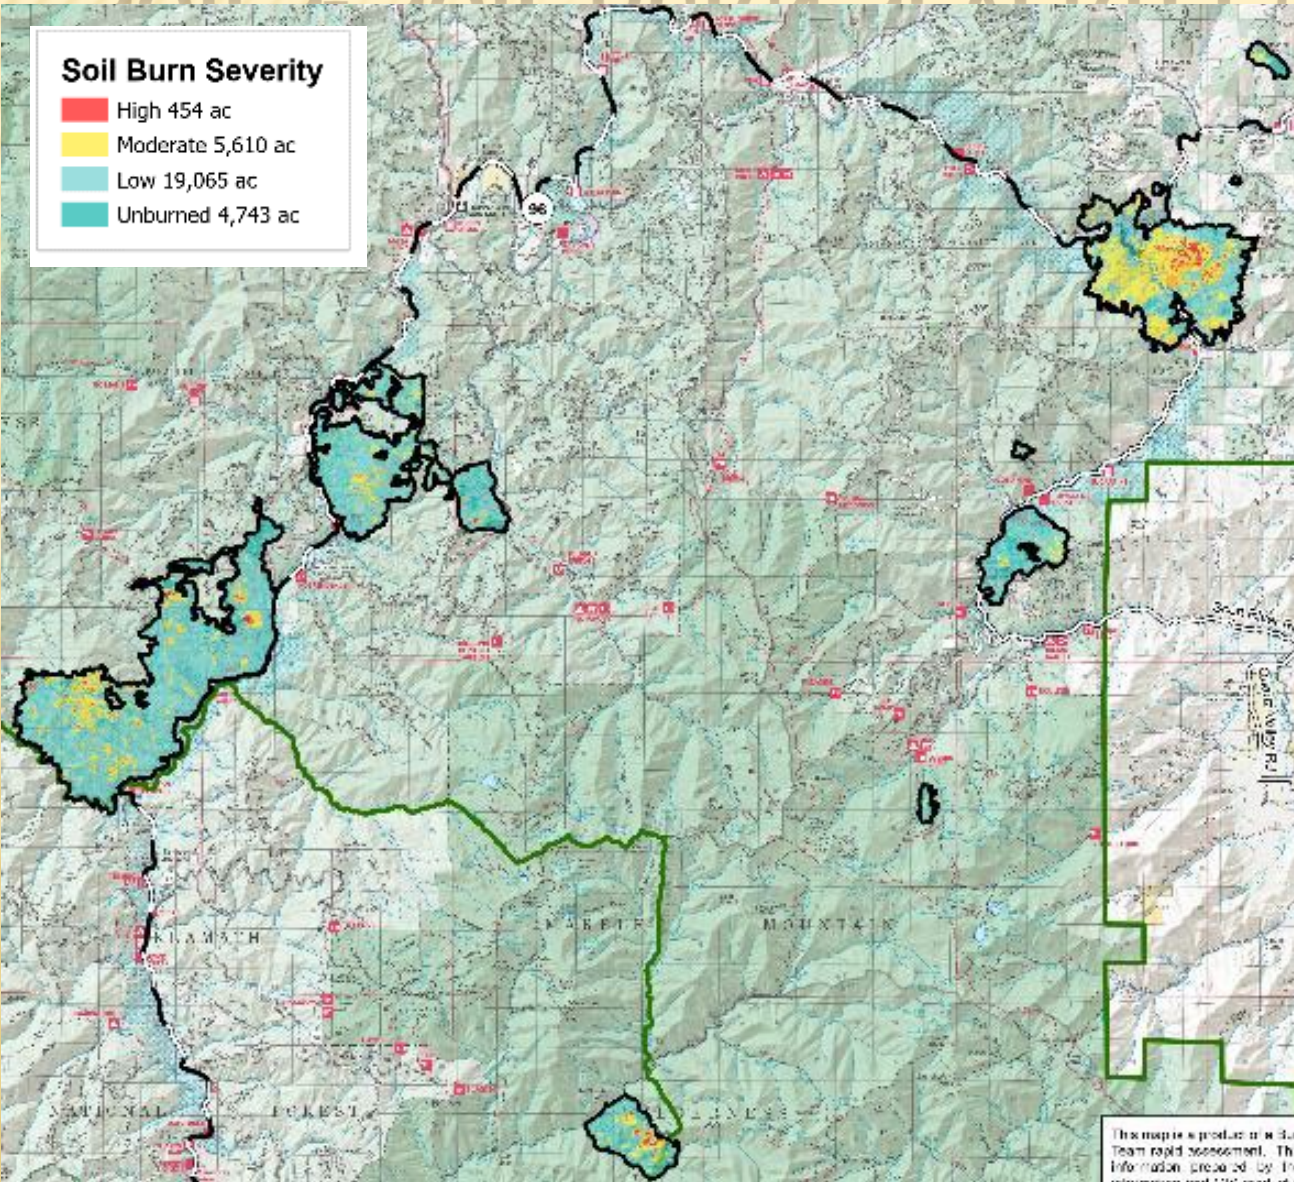
SOILS- SOIL BURN SEVERITY (SBS)

Total Acres	Percent
Unburned	4,742	16%
Low	19,065	64%
Moderate	5,610	18%
High	454	2%
TOTAL	29,872	100%

- Significantly higher erosion, runoff and debris flows are associated with high and moderate SBS.
- Combined moderate and high was 20% which is relatively low compared to recent fires/years.
- Low SBS was the prevalent burn severity and achieves the same fuel reduction as successful prescribed fire.
- High SBS is most prevalent on steep canyon walls; too steep to consider effective land treatments.

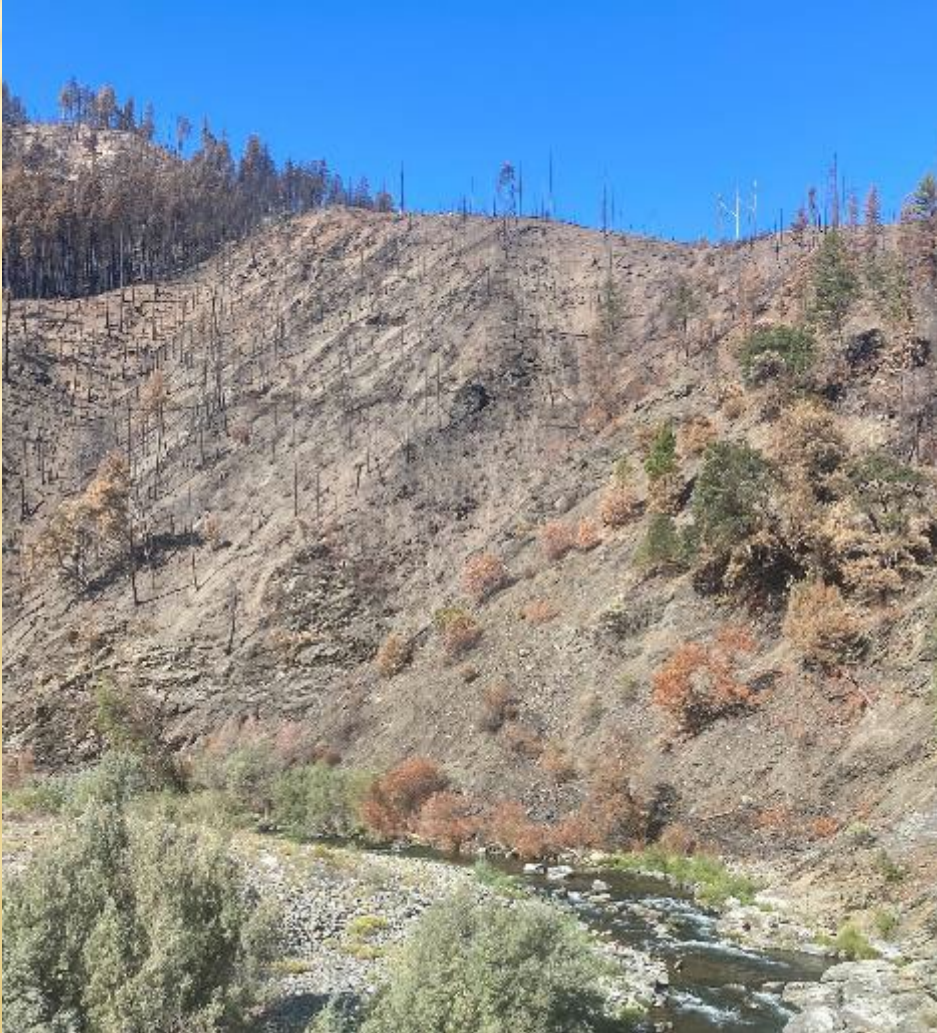
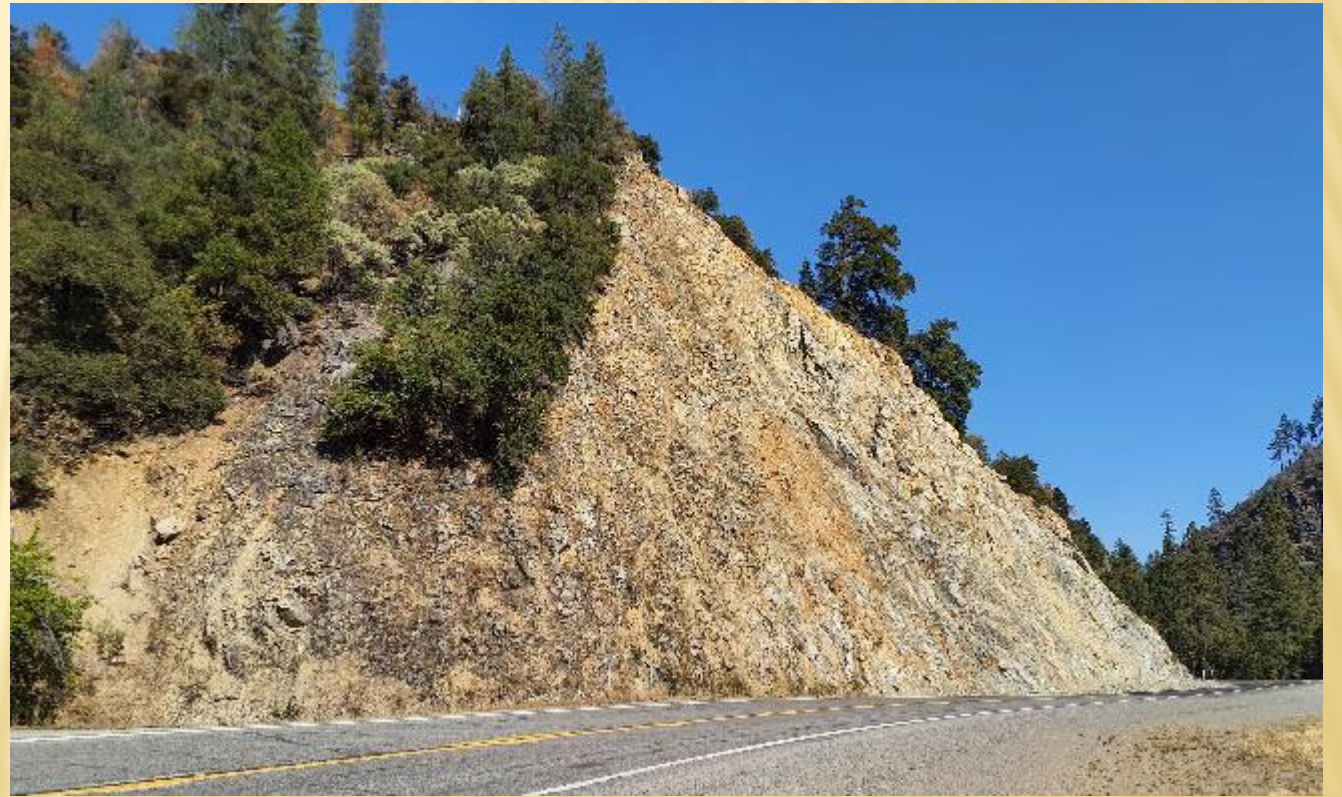
Metasedimentary and metavolcanic rock types on steep slopes are prone to landslides and erosion.

Steep, fractured, rocky terrain is naturally prone to rockfall

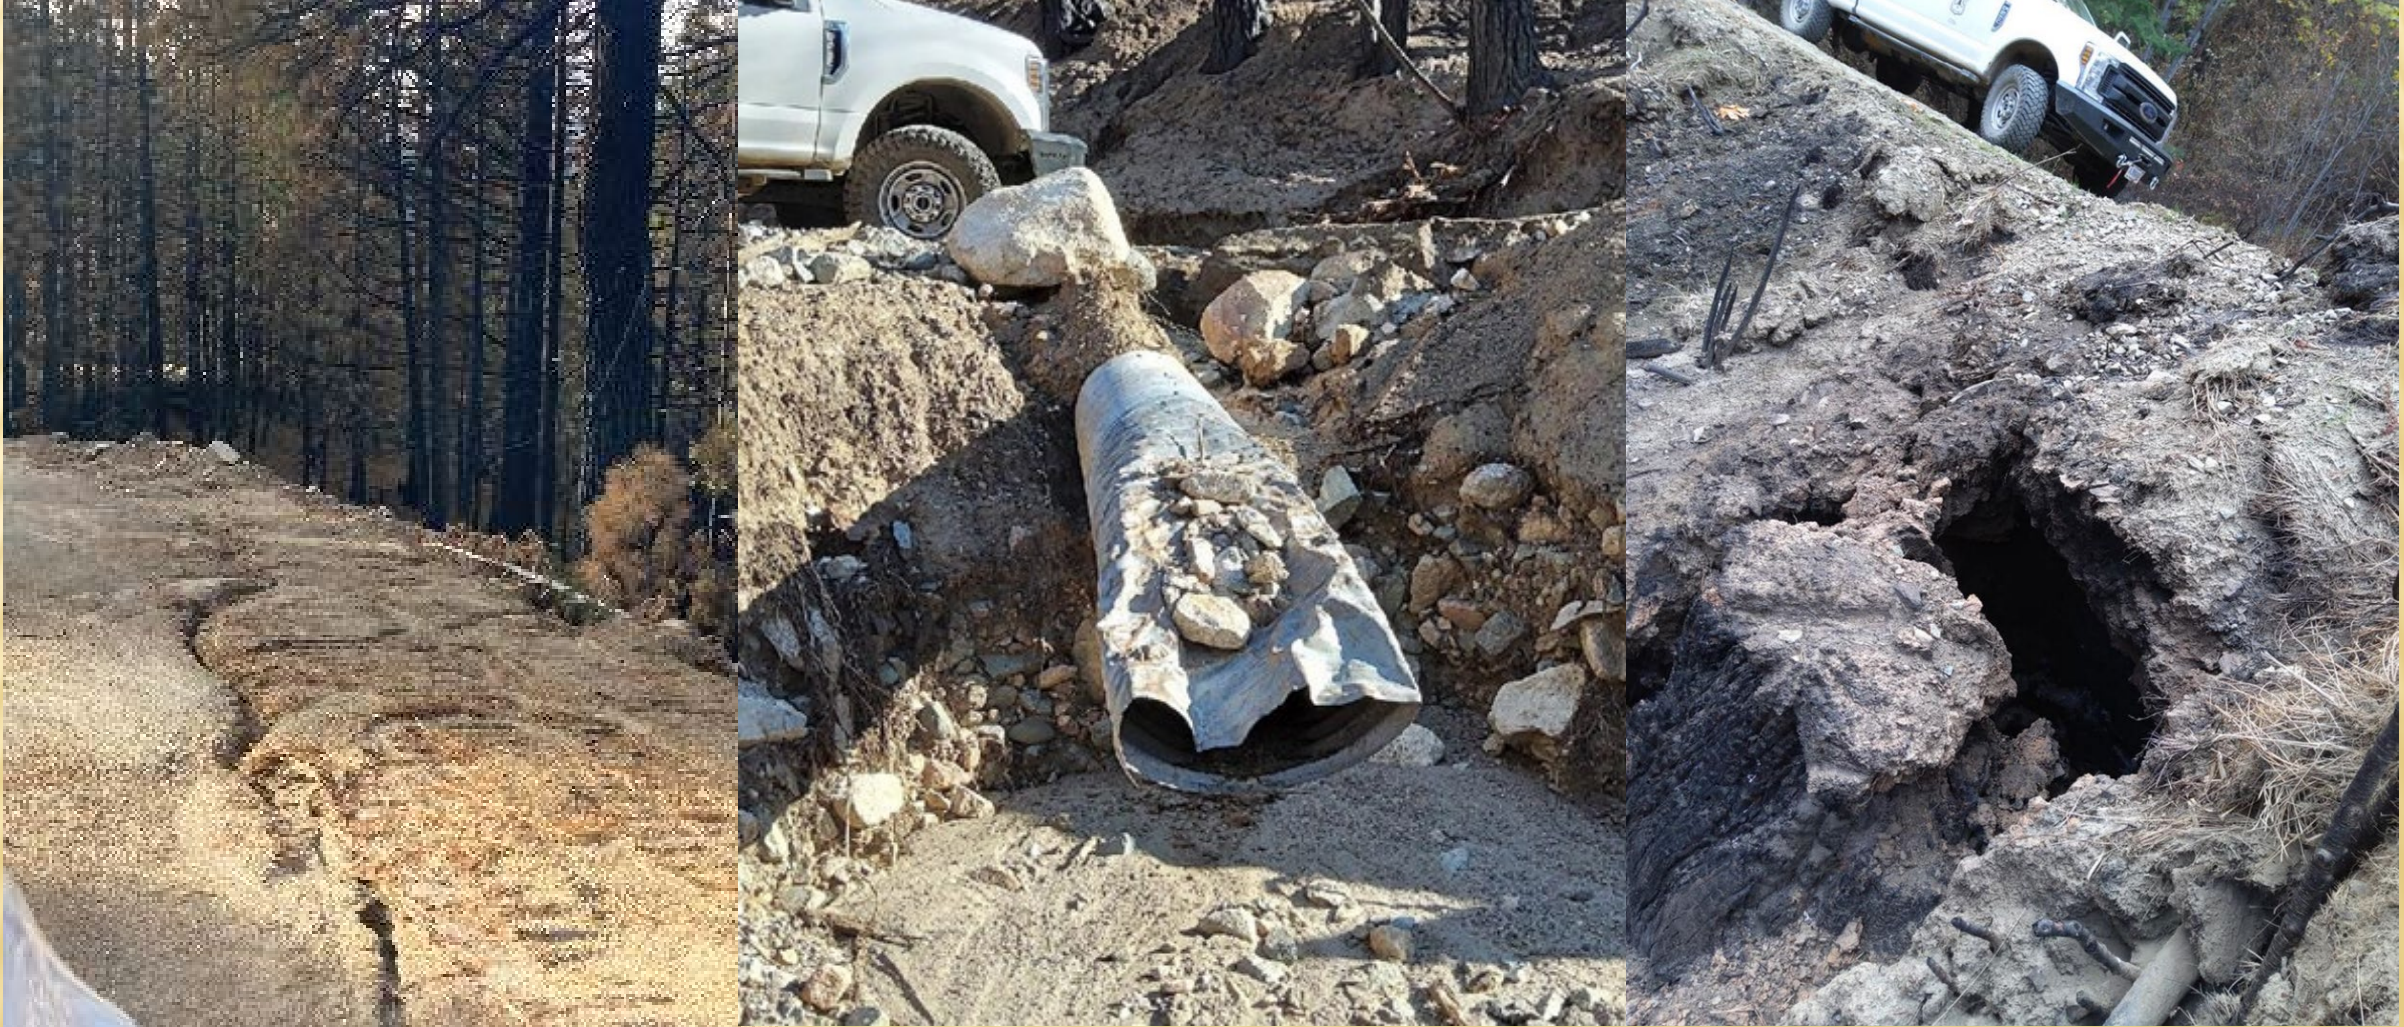
ENGINEERING – THREAT TO ROAD INFRASTRUCTURE

- National Forest System Roads
 - Road Failure or Damage Due to Increased Flow and burned stump holes
 - Rock Fall
 - Overwhelmed Drainage Crossings
- Culvert Crossings
 - Flooding and debris flow leading to drainage structure failure

Photos are NOT from the Happy Camp Complex Fires, but are examples of potential damage.

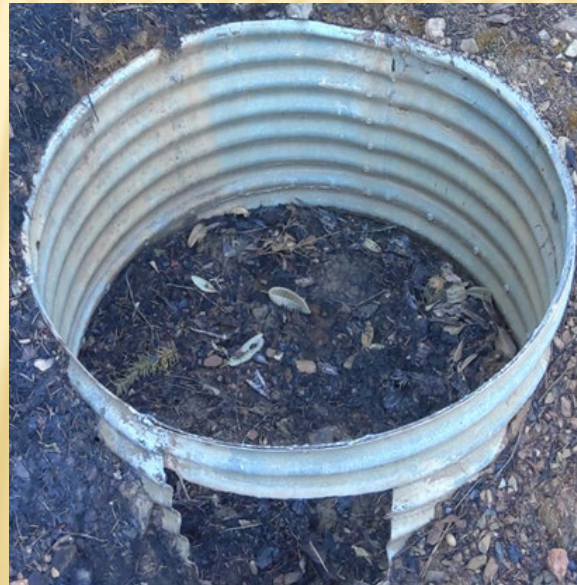
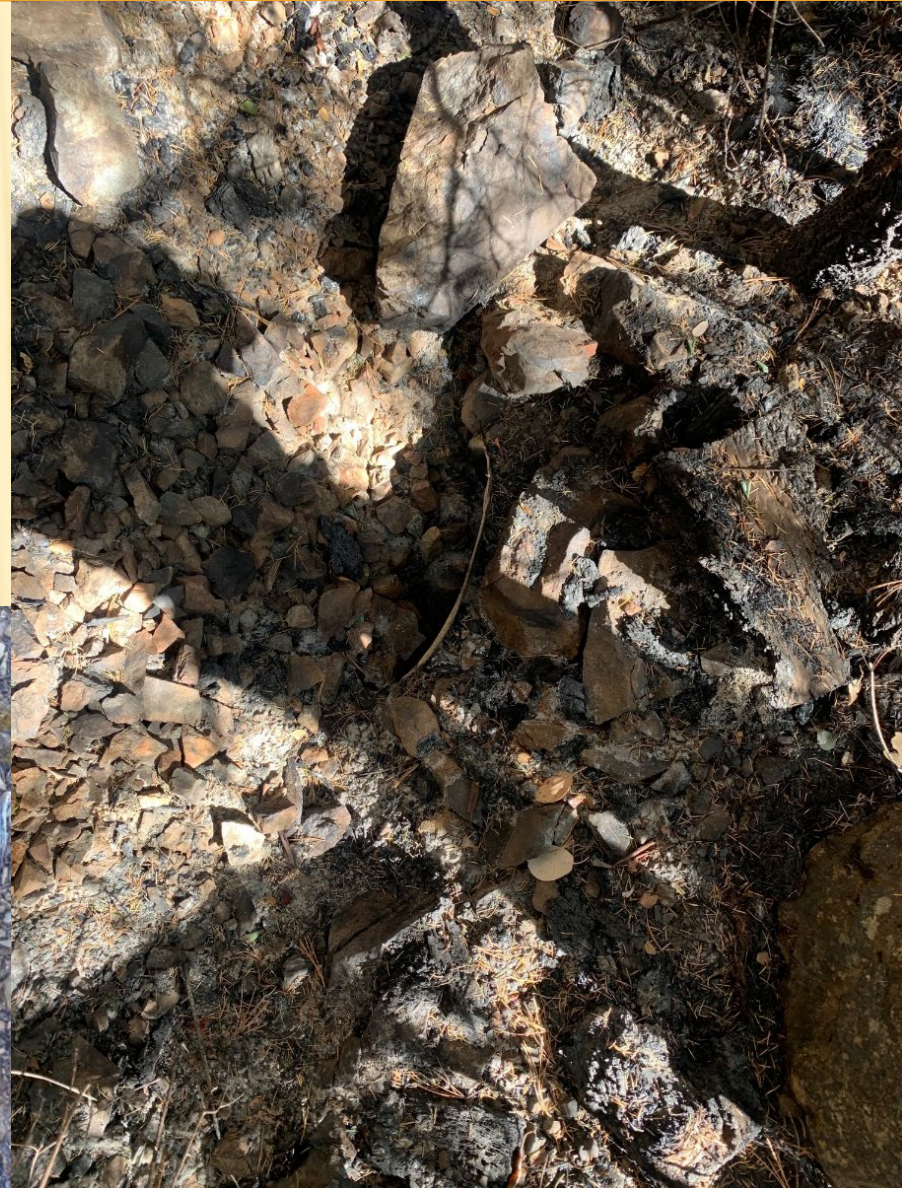
- Priority Roads

- National Forest System Roads
 - 48 miles are within the Happy Camp Complex
 - 44 were assessed to be at **Low Risk**.
 - 4 miles of road were assessed to be at **High Risk**.
 - 6 miles of non-system roads were assessed.

- Restore Drainage
- Repair Burned Stump Hole
 - Life and Safety
 - Threats Road Integrity
- Storm Inspection and Response
- Warning Signage

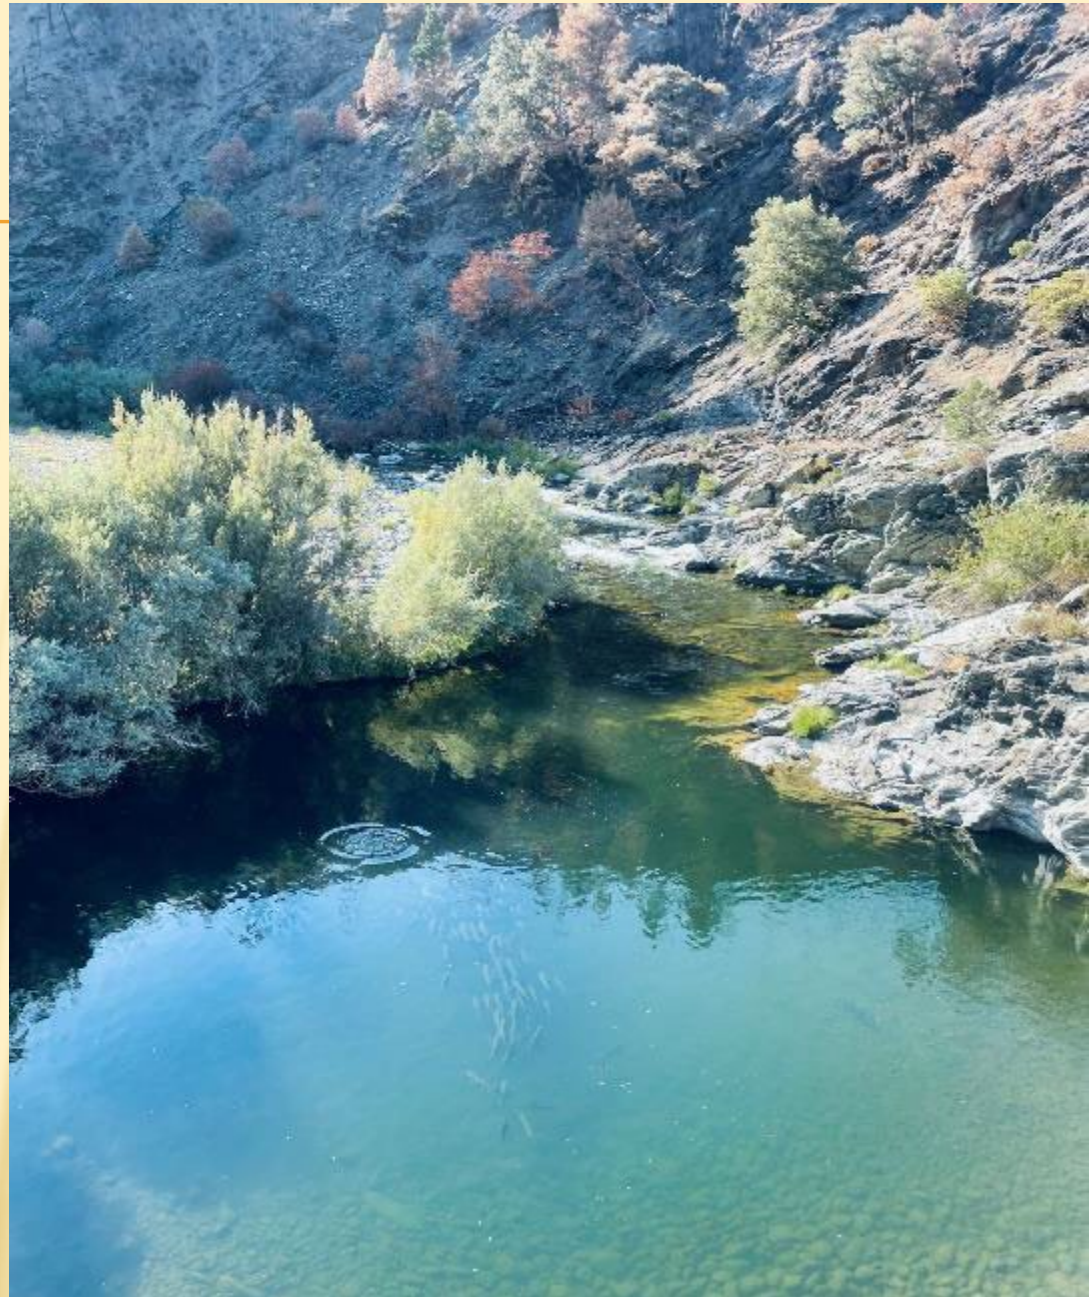
Inside the fire perimeter threatened coho populations occur on:

- Klamath River (Head Fire)
- Scott River (Head Fire)
- Elk Creek (UFISH Fire)
- Dillon Creek and Swillup Creek (Elliot Fire)

Inside the Head Fire approximately 250 fall-run chinook salmon observed in the Scott River on September 19, 2023.
