Smith River Complex Post Fire BAER Assessment August-September 2023

Six Rivers & Rogue River-Siskiyou National Forests

Smith River Complex BAER Assessment

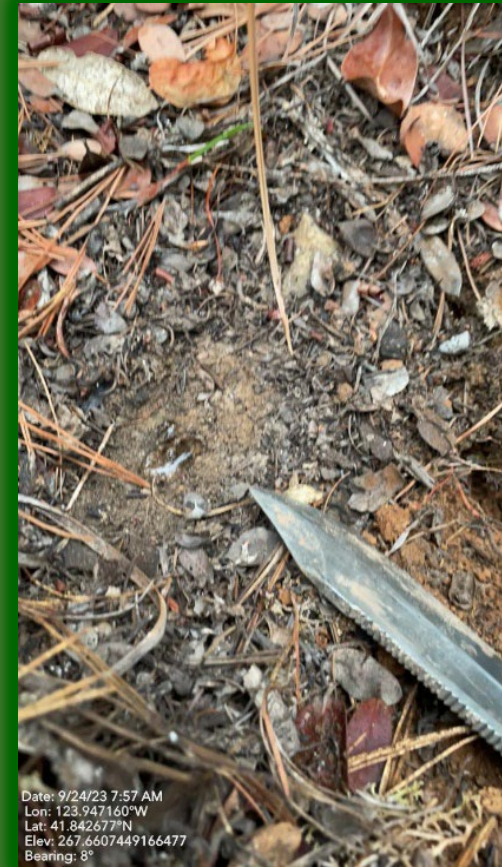
Unburned

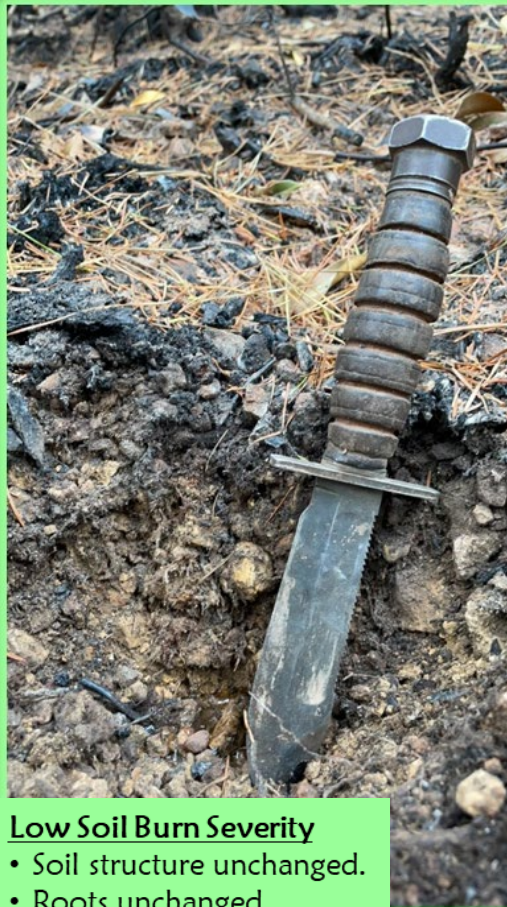
Low Soil Burn Severity

- Soil structure unchanged.
- Roots unchanged

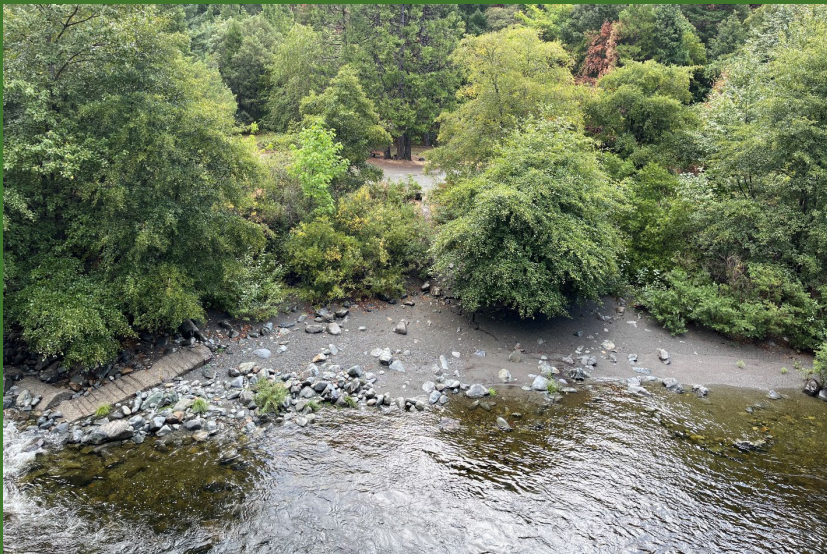
Madrona River Access Site

- Human life and safety
 - Rain events can yield flashy water and debris flows, with sudden instream flow rises in the Smith River and its tributaries.

- Warning Sign Purchase and Installation
 - River access sites, including popular dispersed camping sites

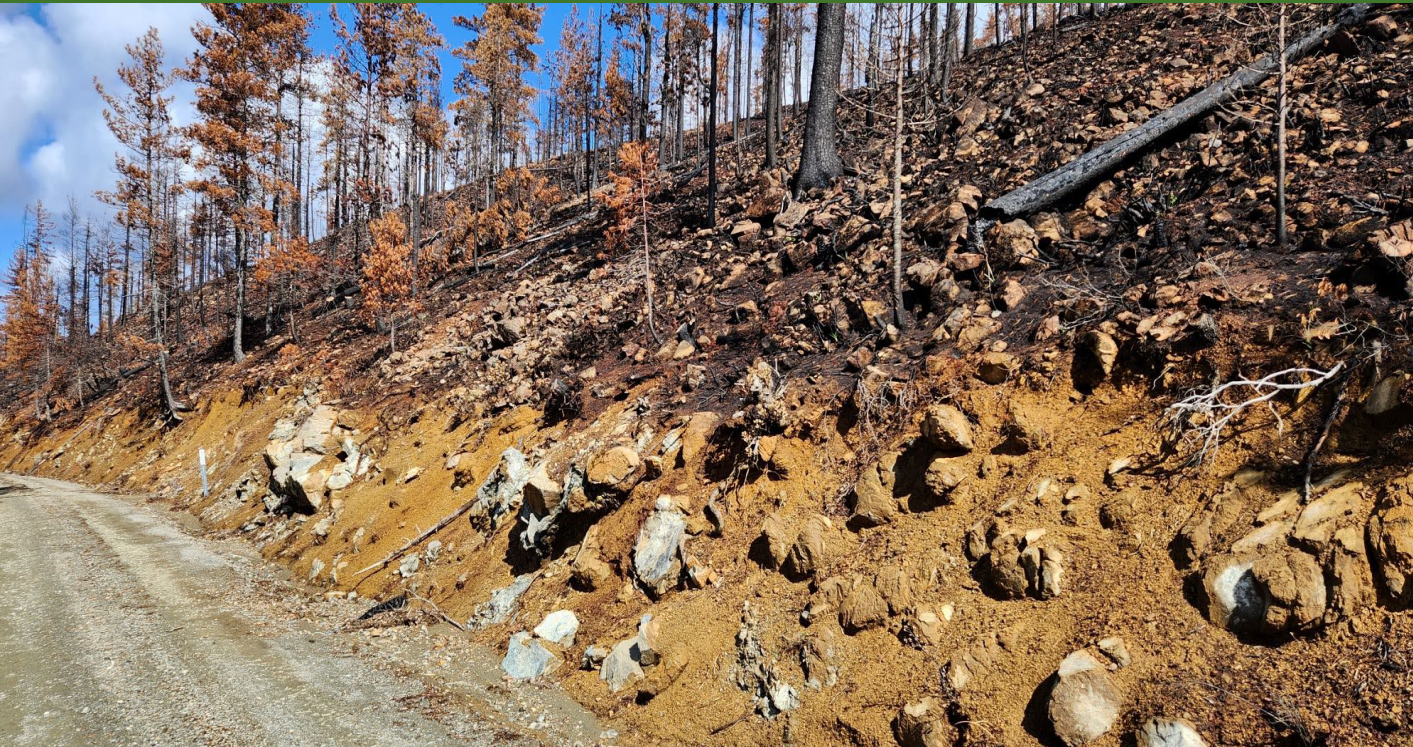
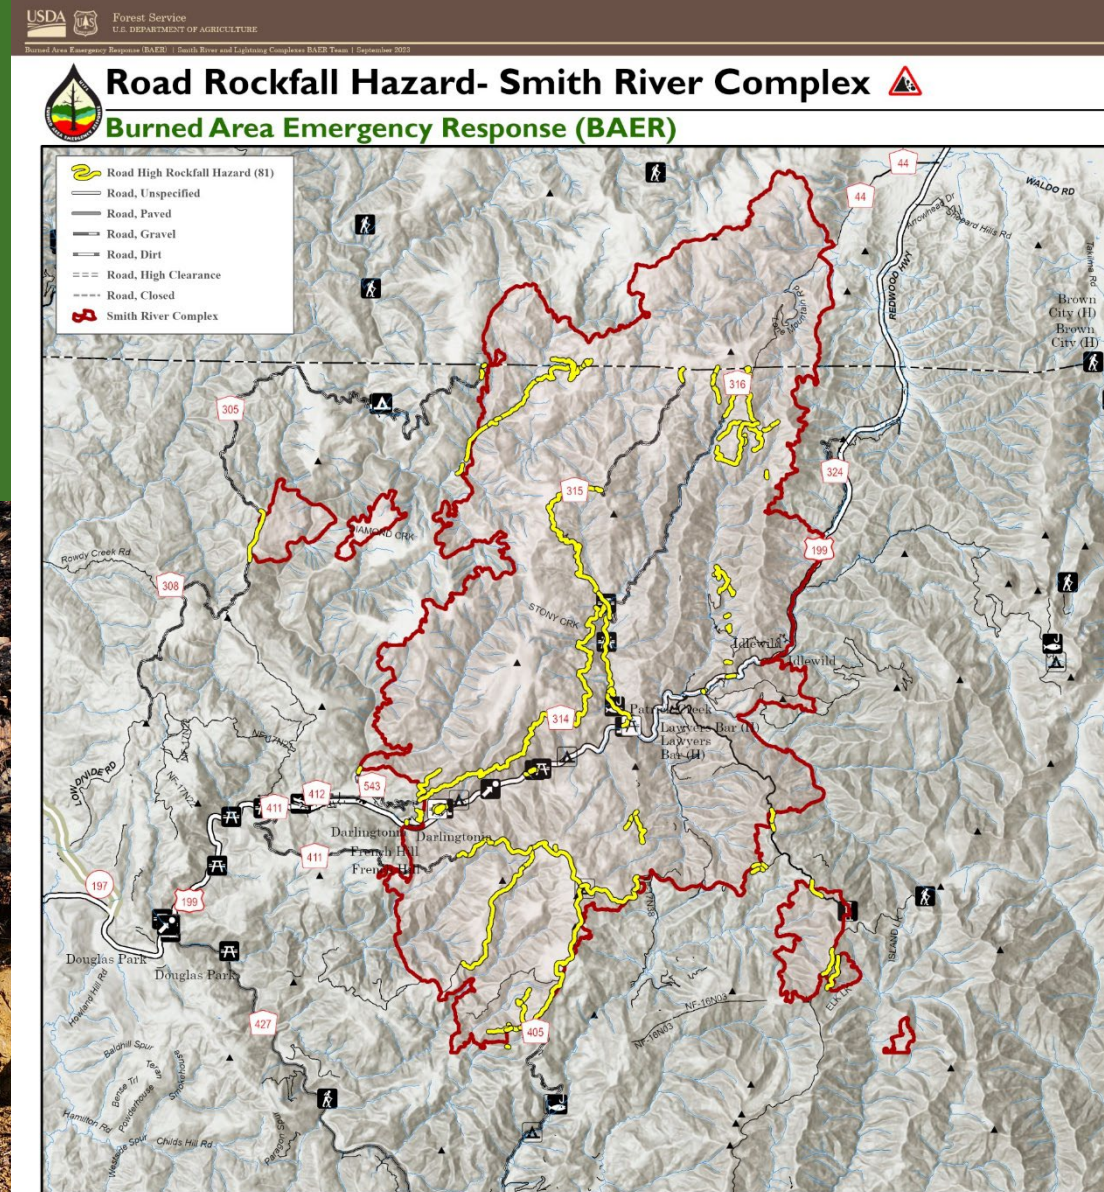
- Depending by the parent material, Some segments of roads present high potential for rockfall While other segments are void of any surface rocks.

- Coordinate warning notifications with the National Weather Service
- Post warning signs and enforce administrative closures
- Road storm proofing and storm patrols

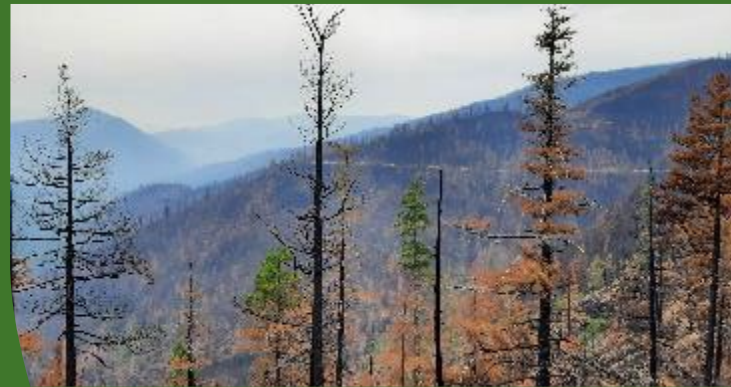
Old Gasquet Toll Road

- Road Loss
 - Rain events creating high erosion potential to block culverts leading to road failure
- Human life and safety
 - Rain events putting debris on the road leading to closures, destroyed roads, and potential for human loss
 - Hazard trees along roads

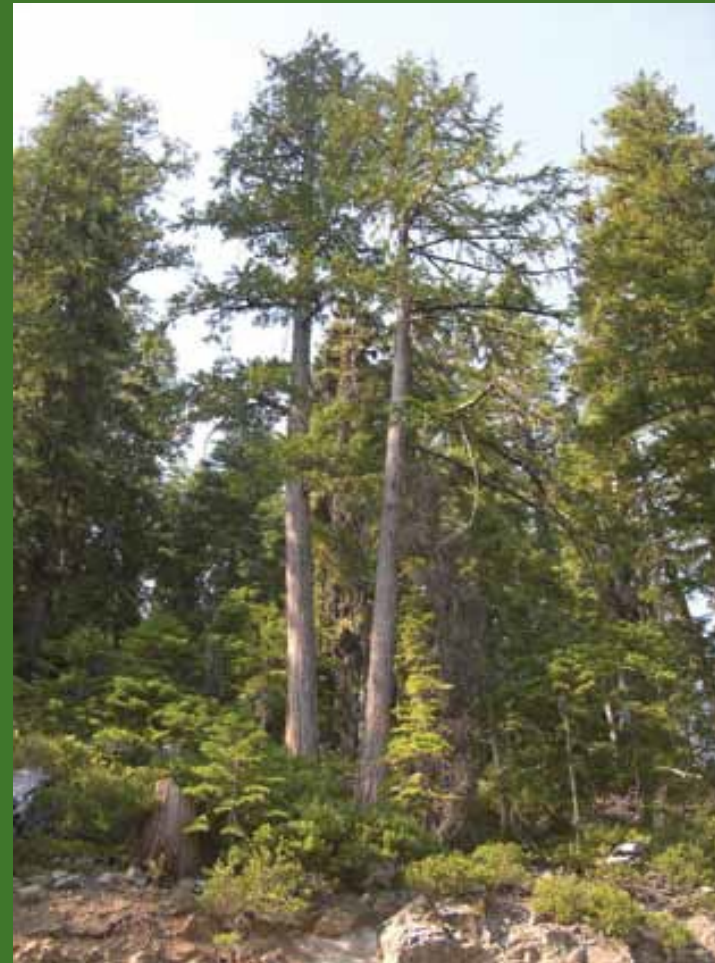
Mature healthy Port Orford cedar

- Spread of Port Orford Cedar Root Disease and Sudden Oak Death
 - Introduction of invasive plant pathogens would cause loss of the critical natural resource values associated with native plant communities
 - Plant pathogen progression can lead to loss of shade canopy and overstory of Smith River and tributaries

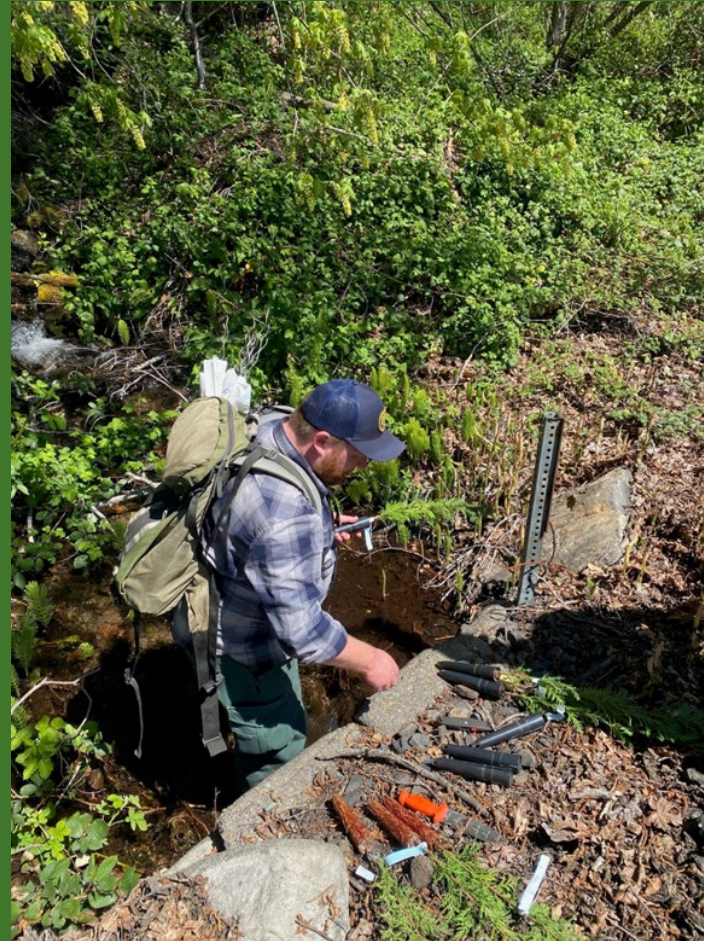
Testing using bait trees

- BAER Early Detection Rapid Response EDRR – invasive noxious weeds
- P1b Suppression Disturbance EDRR - invasive noxious weeds
- P3 Other Plant Treatments - Plant Pathogen Testing/Monitoring/Treatments

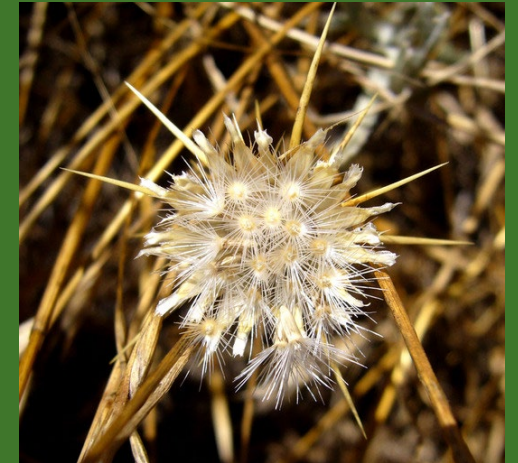
yellow star-thistle seeds

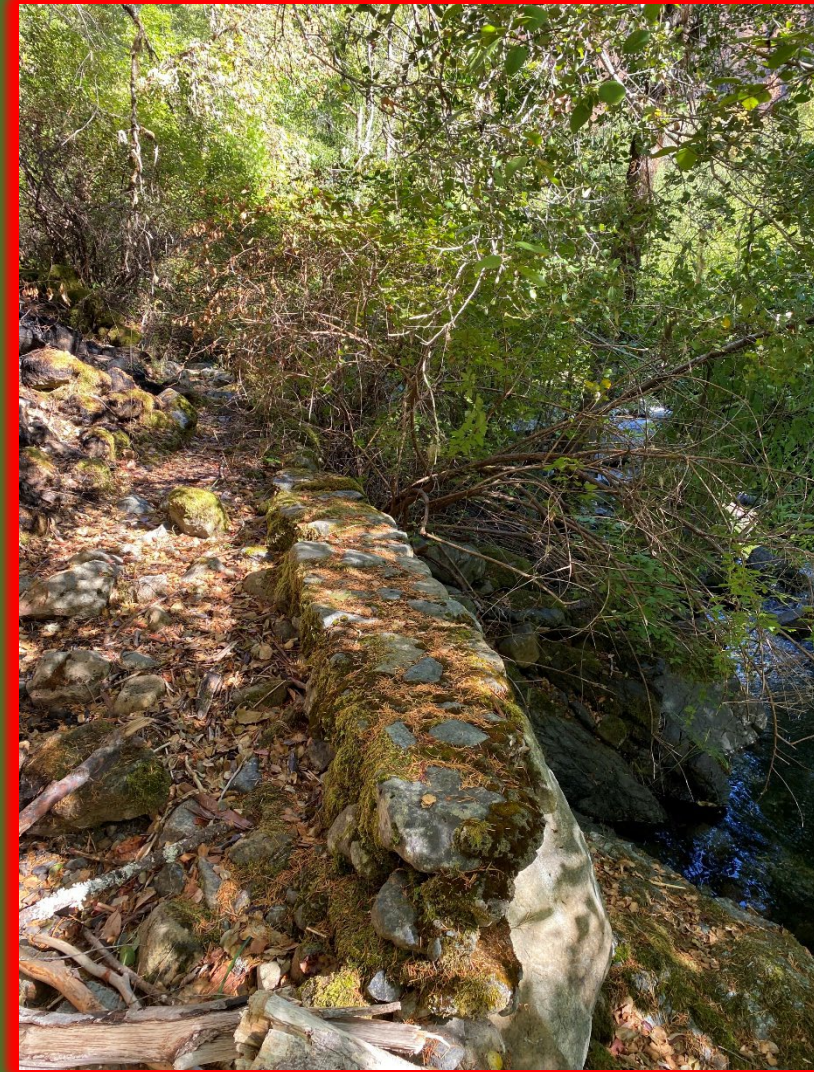
Burned
Hazard
Trees
around
historic
features

Hydrological
models
project
accelerated
erosion of
historic
masonry
along stream
(historic
swimming
area)

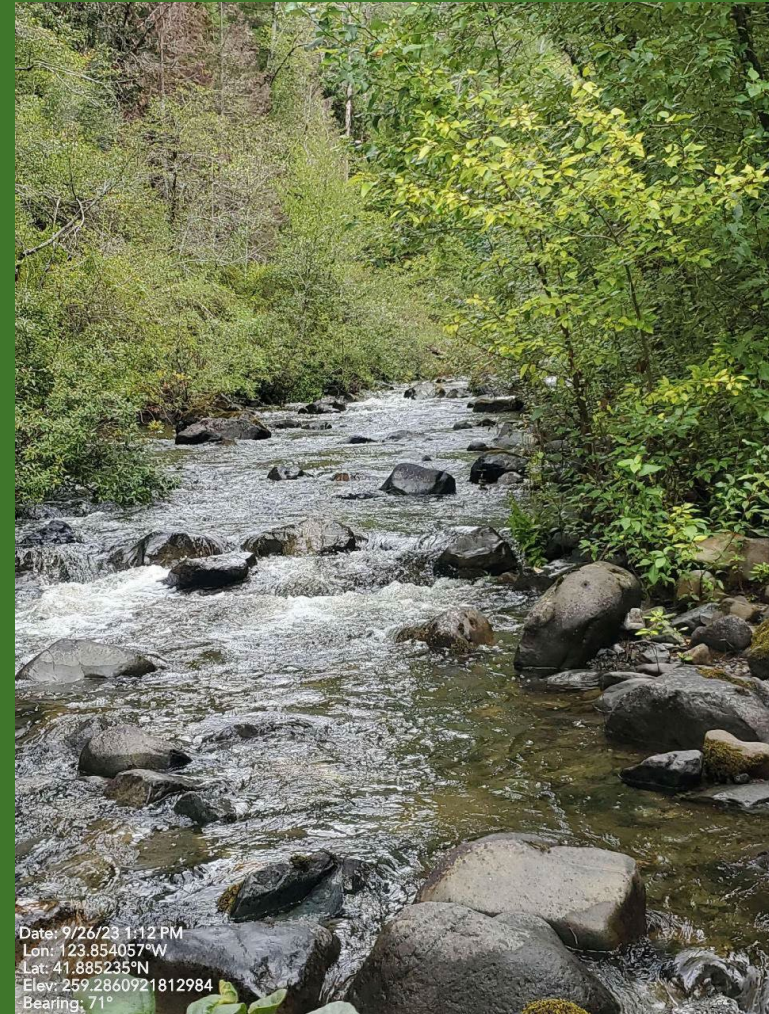
Threats to Fisheries Values

- Warming water temps and leaf litter reduction as 43% of Riparian Reserves burned had >50% basal area mortality
- Increases in expected peak flows and associated sediment delivery in some catchments
- High potential for debris flows in some areas

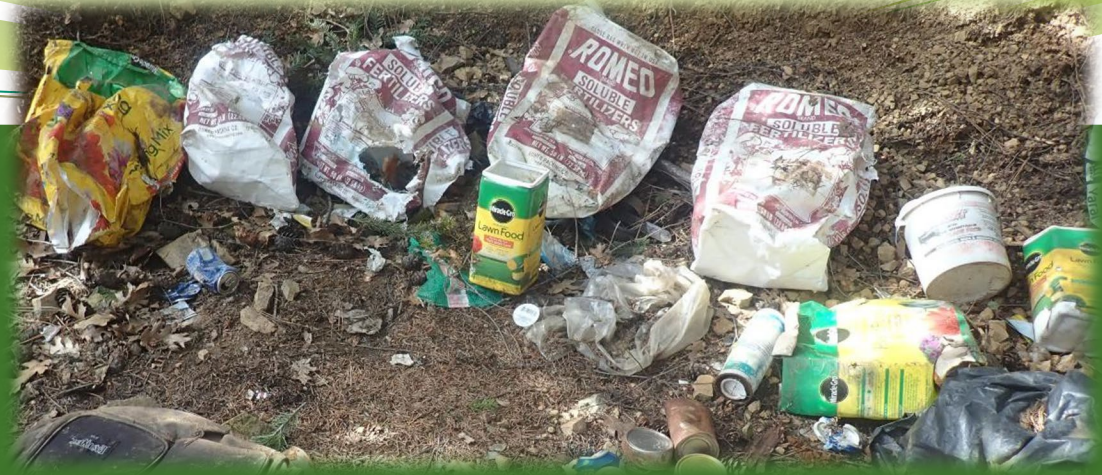
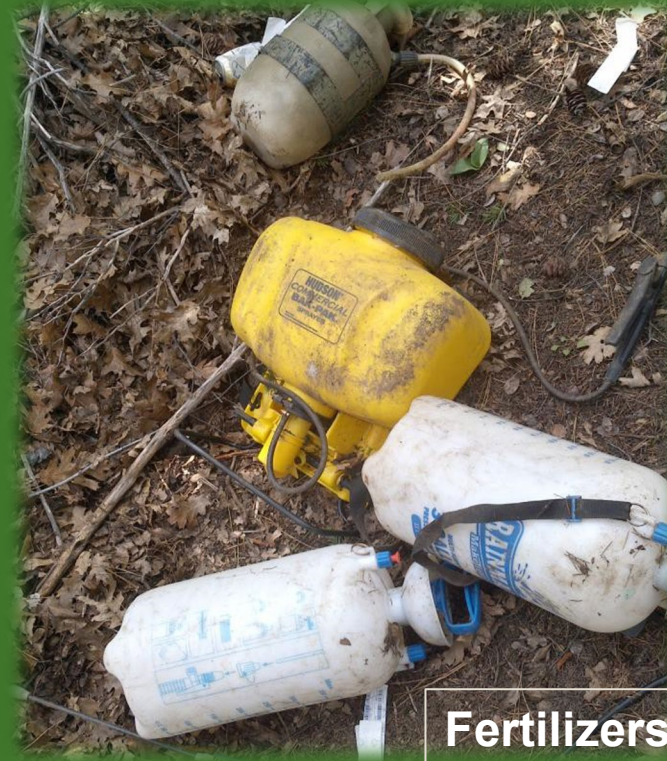
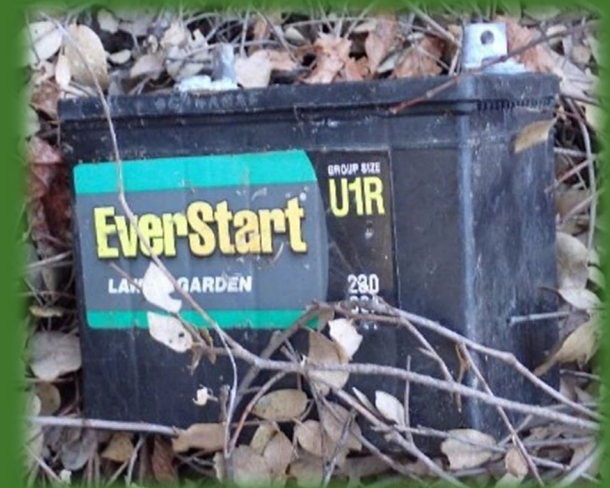
Cannabis Cultivation in Burned Areas

43 Sites Throughout

- 40 in Pacific Marten Suitable Habitat
 - 3 in Northern Spotted Owl Core Habitat
 - 24 in Coho Salmon Occupied Waters
-
- 100% Sites in R5 have Pesticides
 - 80% have Banned Pesticide
-
- Fire Exacerbates the Problem
 - Flames Compromise Containment
 - Hazmat Containment gets Liberated
-
- SBS Exposure & Transport
 - Erosion transports
 - Footprint Increases
 - Soils & Water Contaminated

Fertilizers, Batteries Pesticide Sprayers

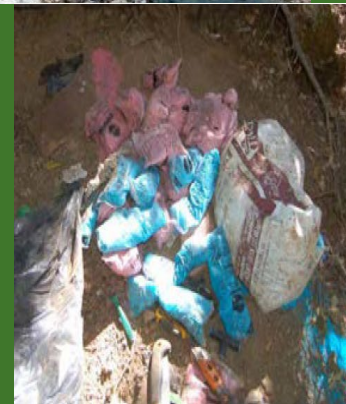
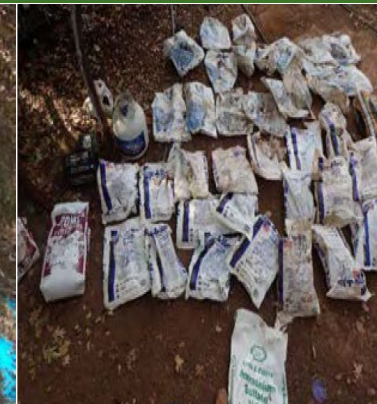
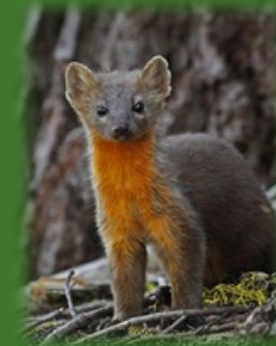
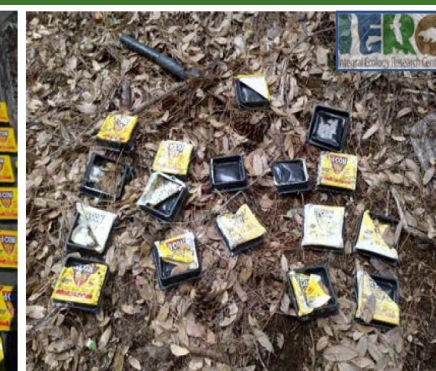
Trespass Cannabis Cultivation

Toxicants:

- ✓ Anticoagulant rodenticides (direct exposure)
- ✓ Banned Pesticides carbofuran or methamidophos (water quality & soil)
- ✓ High Gradient Fertilizers (water quality & soil)

Threats:

- Burnt packaging & containers of toxicants accessible to woodrats & deer mice, NSO primary prey
- Prey increase their exposure
- Burn area increase prey availability
- Toxicants store in soils & transport to water bodies
- Human safety from direct exposure to hunters year-round
