Post Fire Burned Area Summary

Burned Area Report

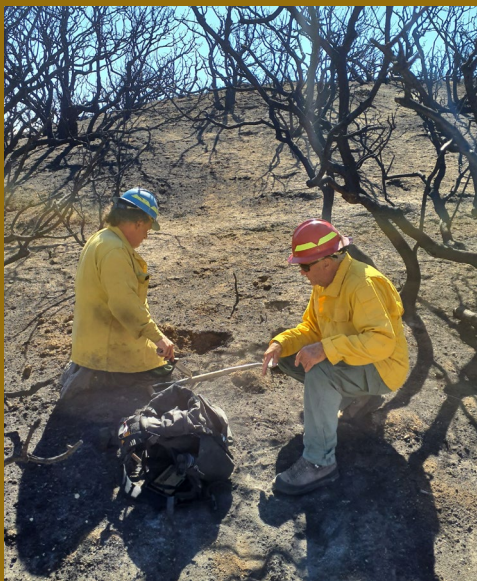
Soil scientist and Hydrologist evaluating soil burn severity.

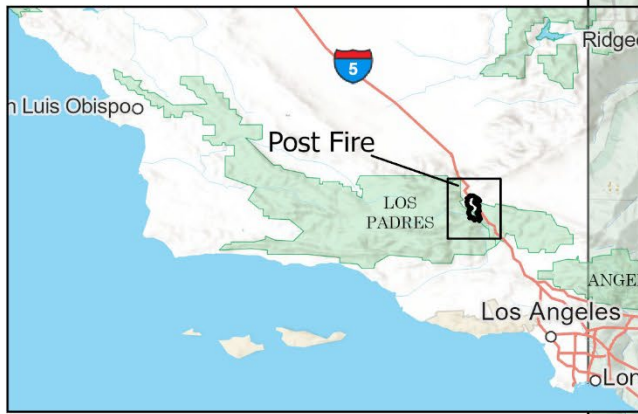
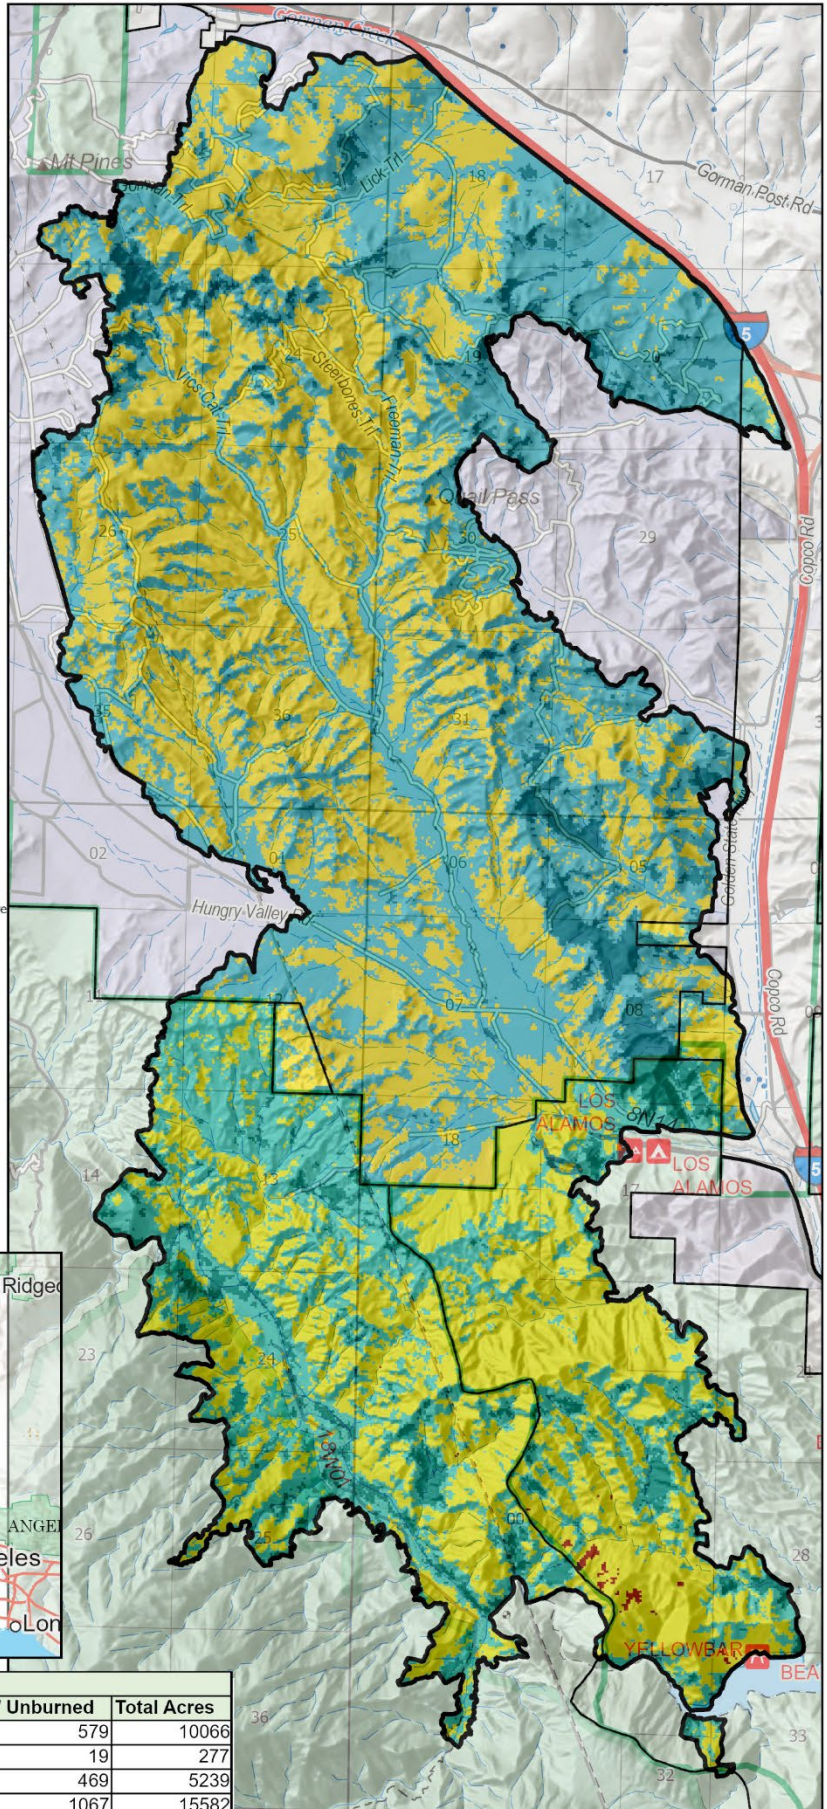
Soil Burn Severity 2024 Post Fire BAER Assessment Los Padres and Angeles National Forest

Mapped and validated SBS for the burned area is High (<1%), Moderate (48%), Low (45%), and Very Low/Unburned (7%) see map on page 1. The more severe a fire's effects are on the soil, the more likely those soils will erode in subsequent rainstorms – especially in locations with steep slopes. Erosion after fires can cause tremendous damage to homes and other structures in the years after a fire. The Post Fire had very little high soil burn severity; therefore, there should be minimal long-term damage to soils that would slow vegetative recovery.
