Park Fire Burned Area Summary

Burned Area Report

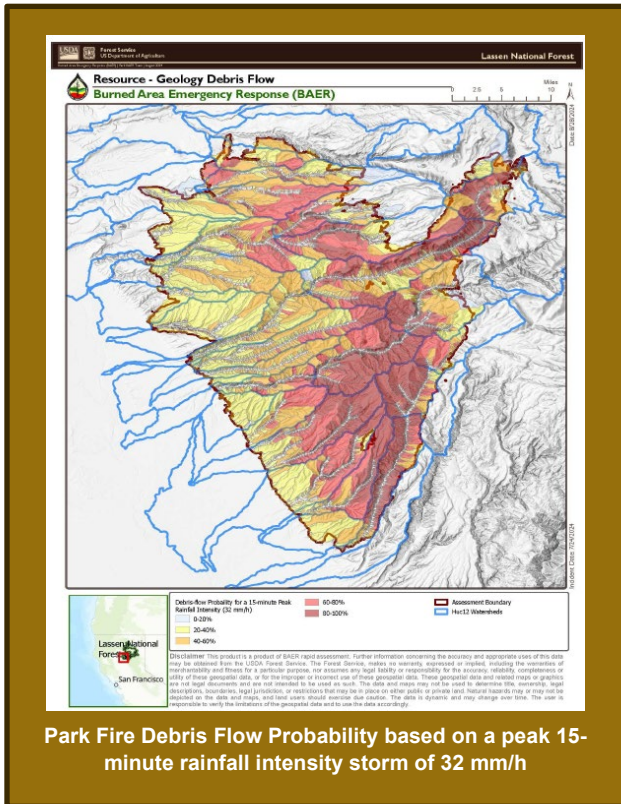
The tuff beds in a high soil burn severity have a significant decrease in infiltration. Re-initiation of mass wasting features can contribute to debris flows concentrating in channel networks. Debris flow footprints and deposits were observed in many parts of the fire area including tributaries to Mill Creek, tributaries to Deer Creek, and tributaries to Antelope Creek.
