EATON & HURST FIRES BURNED AREA EMERGENCY RESPONSE (BAER)

BAER Team
Assessment
January 27, 2025

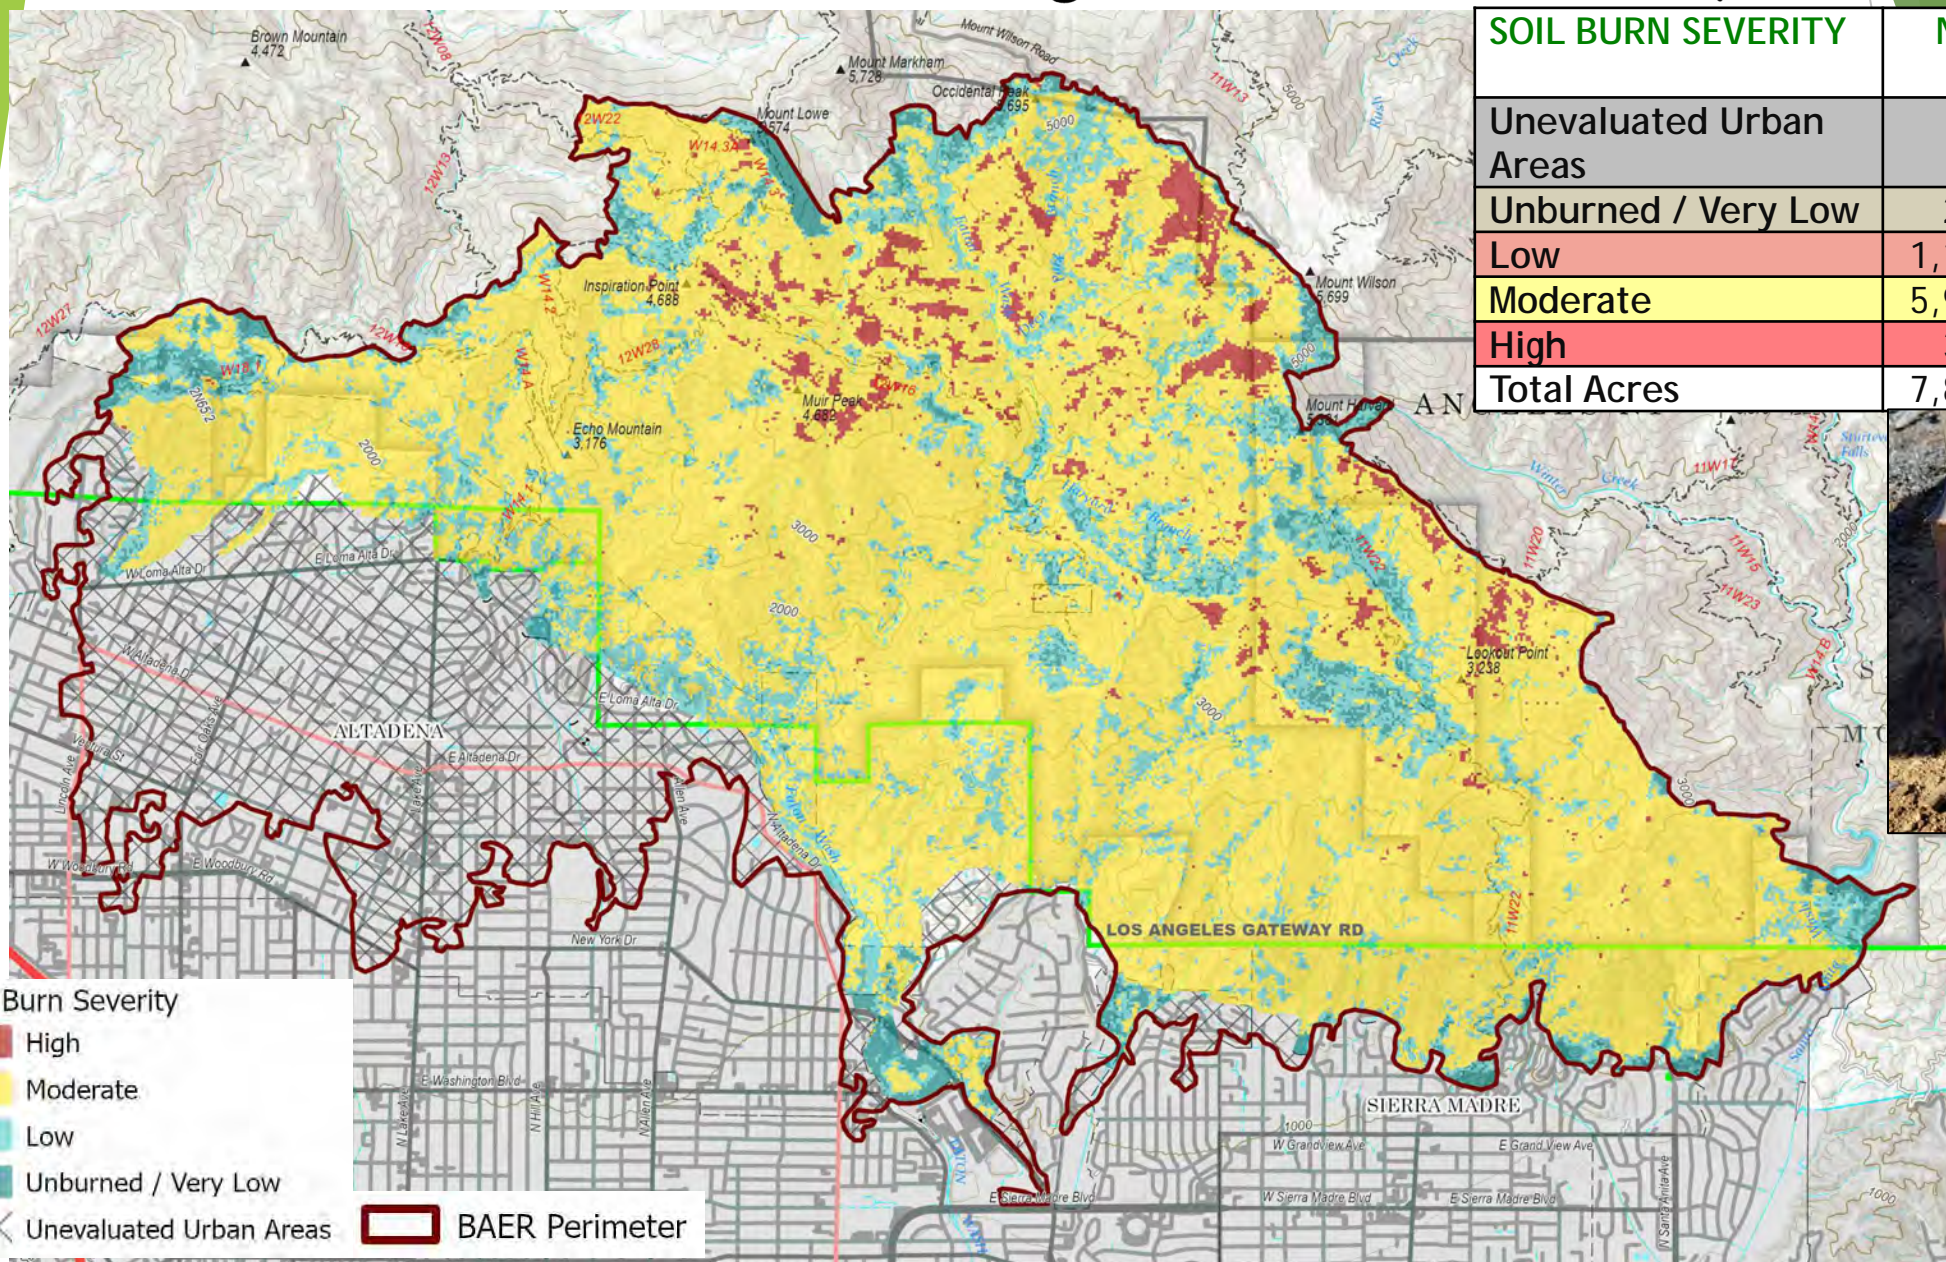
SOIL BURN SEVERITY	NFS	NON-NFS	TOTAL ACRES
Unevaluated Urban Areas	3	2,795	2,798
Unburned / Very Low	282	253	535
Low	1,184	775	1,959
Moderate	5,985	2,506	8,490
High	364	85	448
Total Acres	7,817	6,414	14,231

Soil Burn Severity was not evaluated in the urban portion of the fire

78% of the evaluated fire area was in Moderate + High

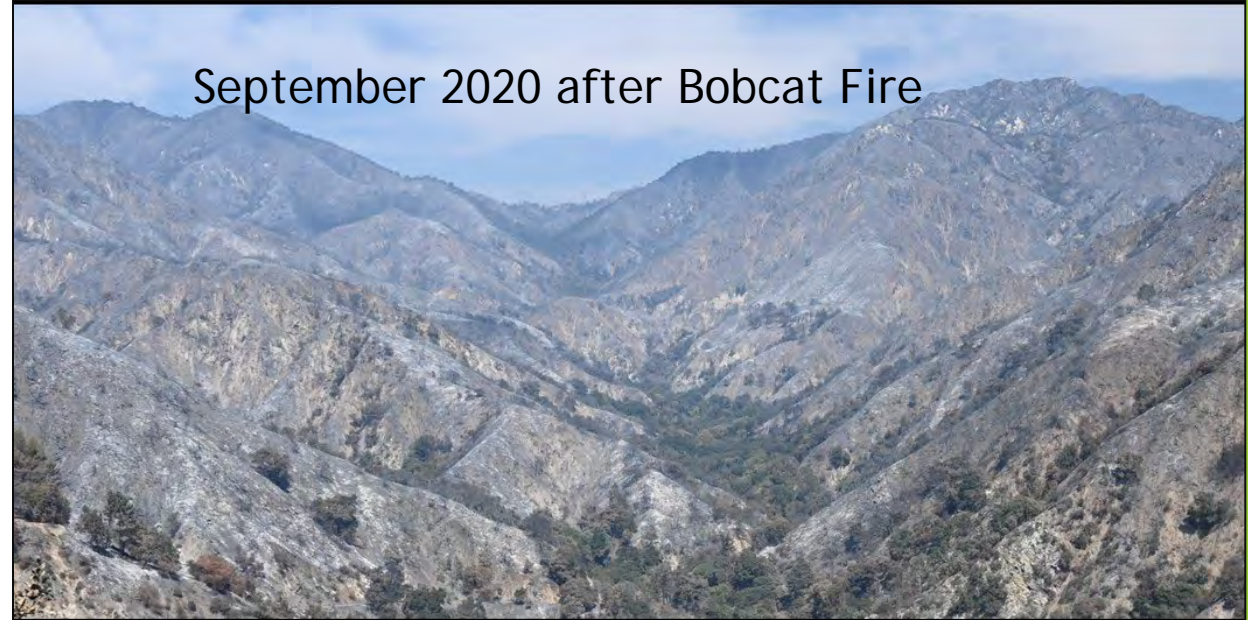
September 2020 after Bobcat Fire

Although the lower elevation areas of the fire may have delayed recovery or site conversion (some plants will not grow back), the headwaters of the drainages will likely recover similarly to the 2020 Bobcat Fire in Santa Anita Canyon.

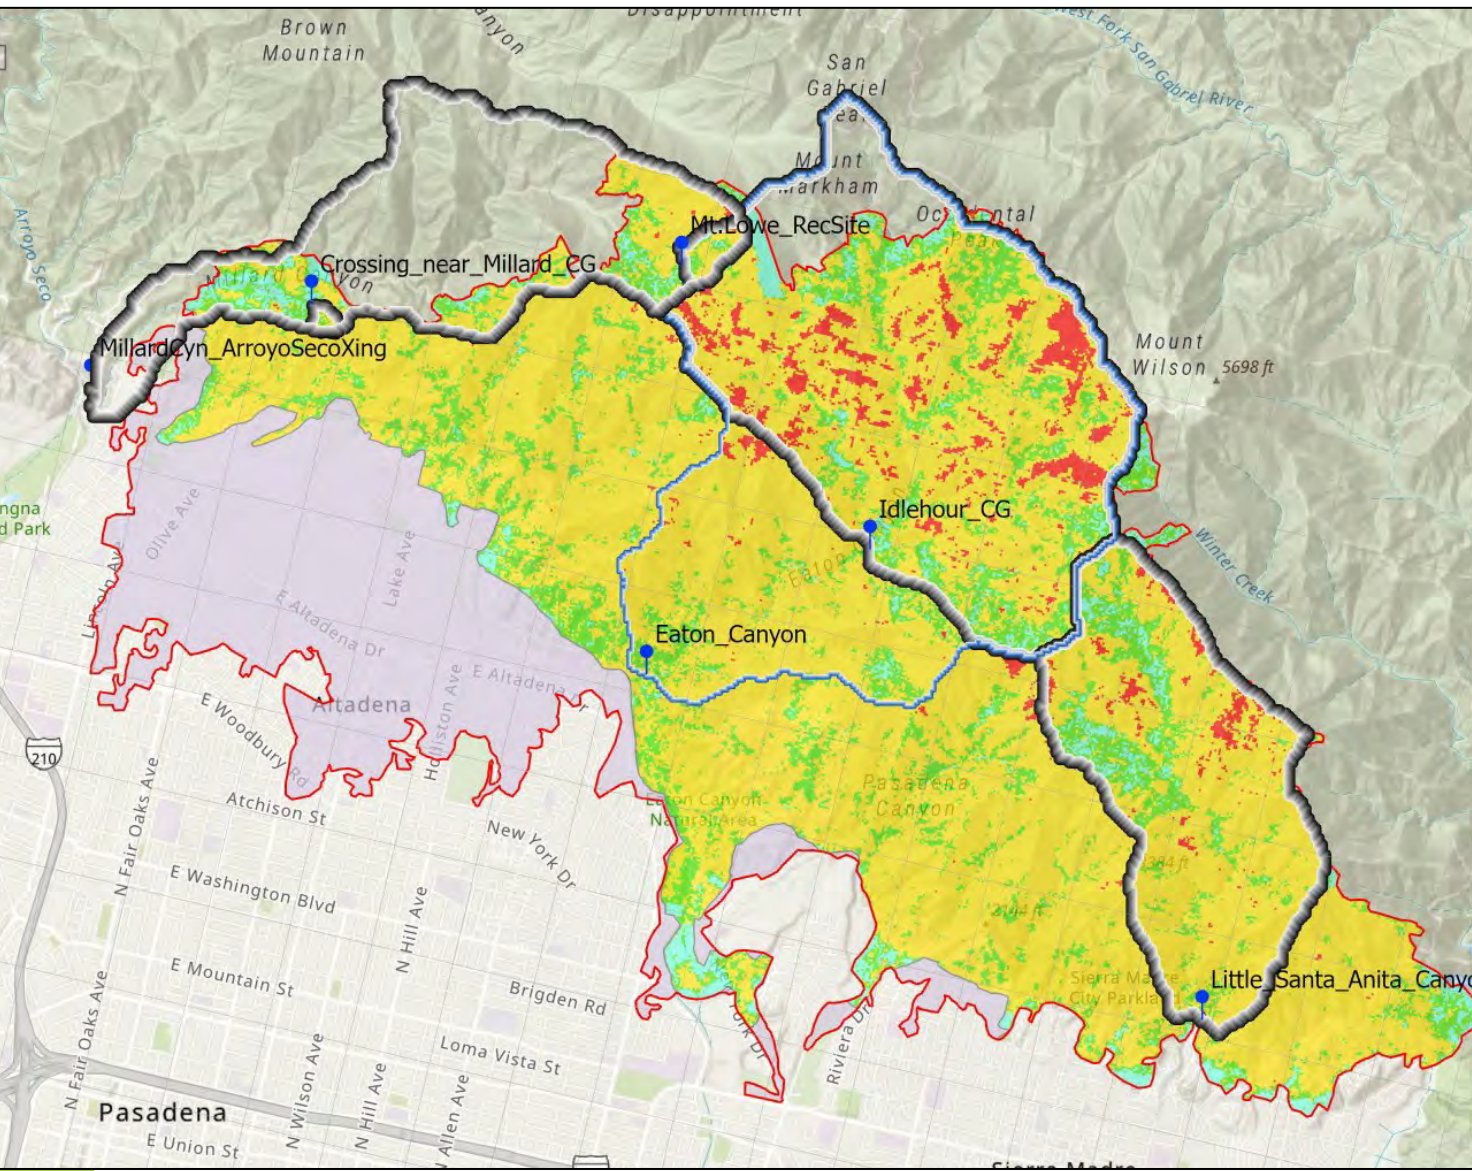
Critical Values Pour Point Watersheds	Drainage size (acres)	% Mod + High SBS	Pre-Fire Discharge (cfs) Q2	Post-Fire Discharge, Bulk (cfs)	Magnitude of Post-Fire streamflow increase w/bulking
Eaton Canyon near Falls	4,133	74%	187	2346	12.52
Idlehour CG	2,925	68%	155	1857	12.01
Crossing near Millard CG	14	71%	3	17	5.04
Mt.Lowe Rec Site	53	70%	10	70	6.87
Little Santa Anita Canyon	1,583	79%	92	986	10.71
Millard Crossing at Arroyo Seco	1,768	19%	95	426	4.51

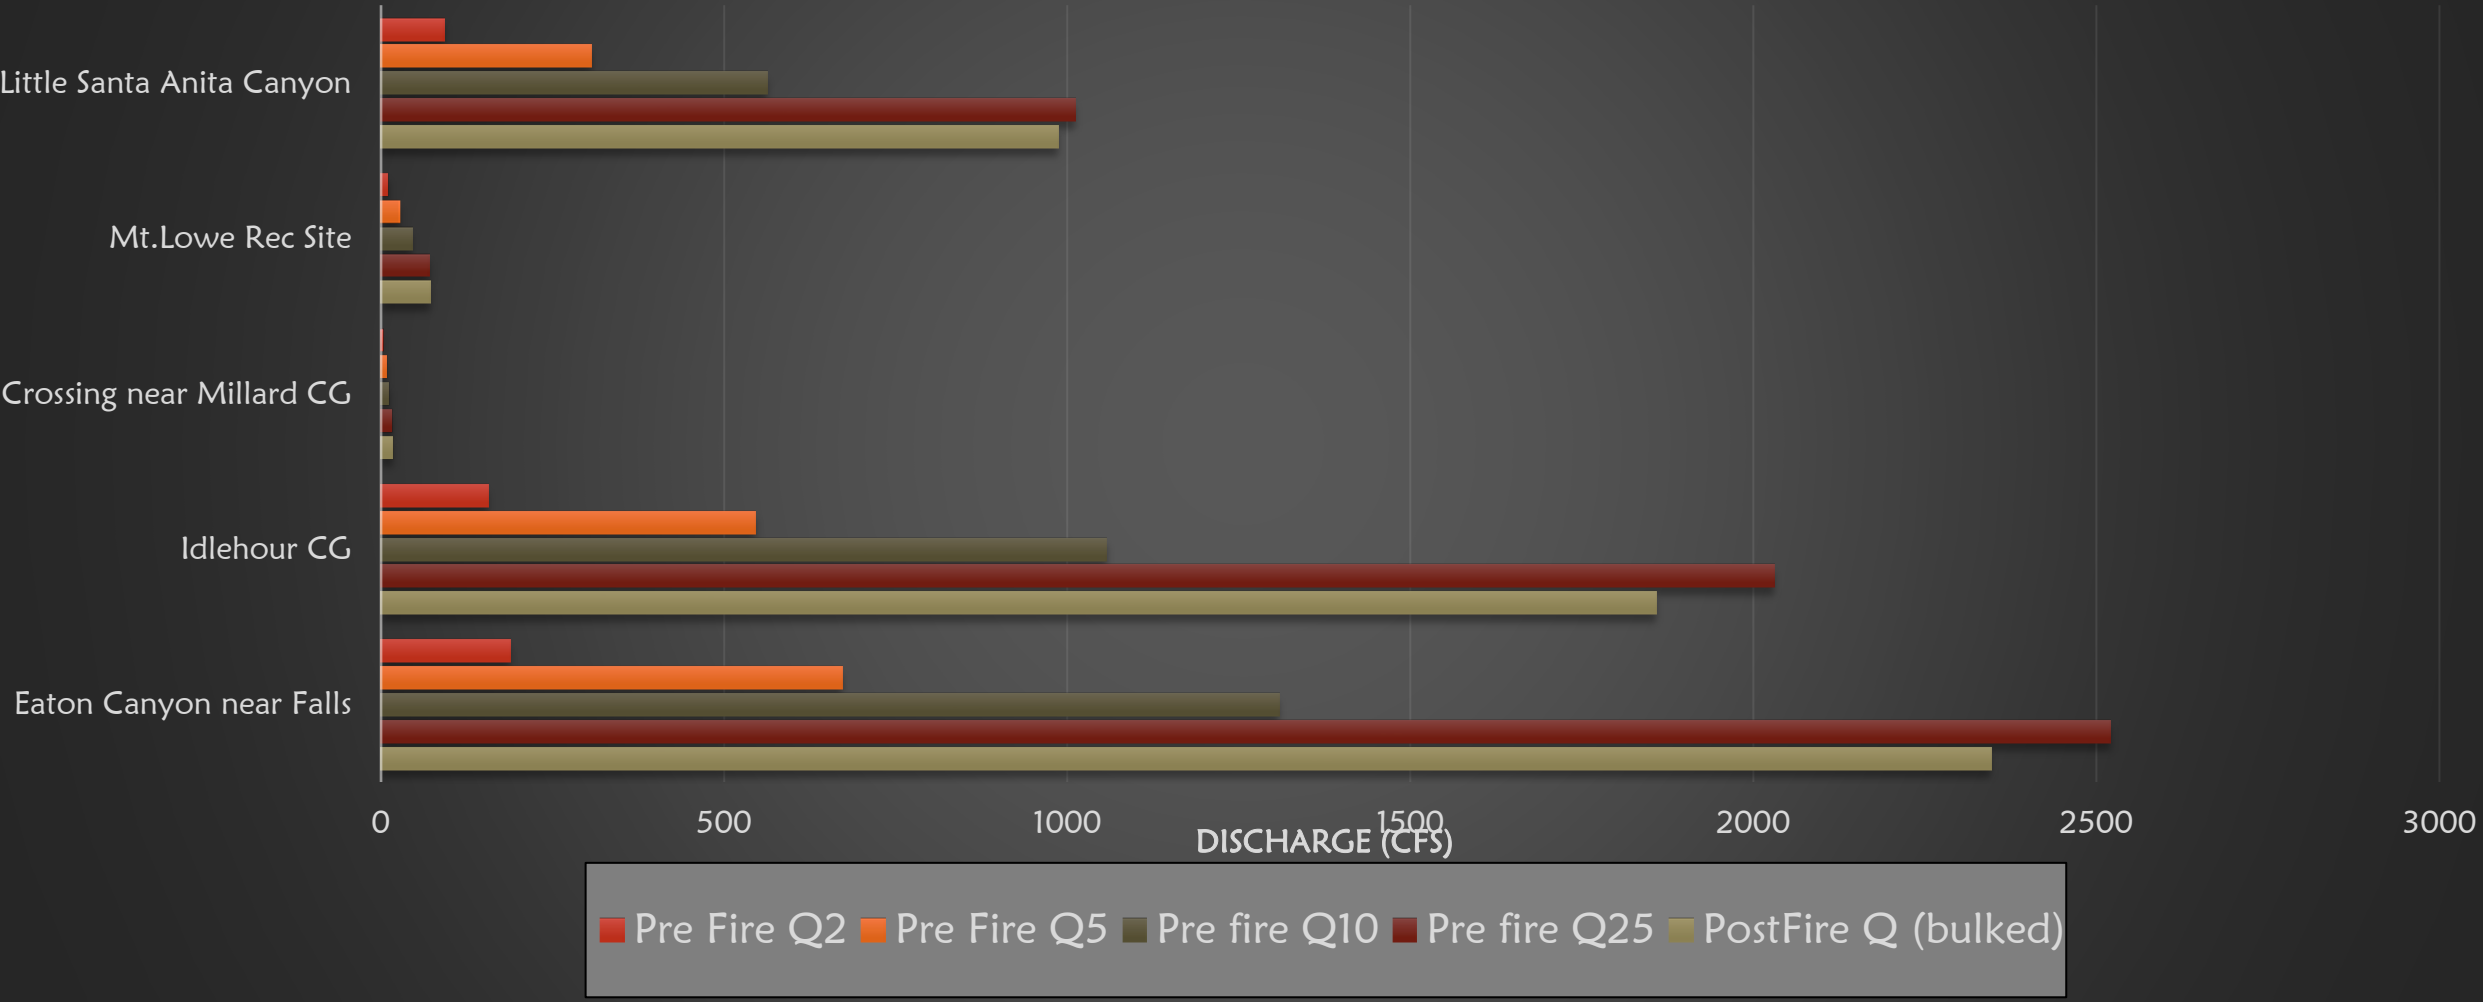
Comparison of Pre- and Post-Fire Discharges

➤ **TAKE-HOME MESSAGE:** Results show that a 2-year storm indicate flows may reach the equivalent of around or below a 25-year flood event (meaning there will be an increase of flow amounts for a less often storm event).

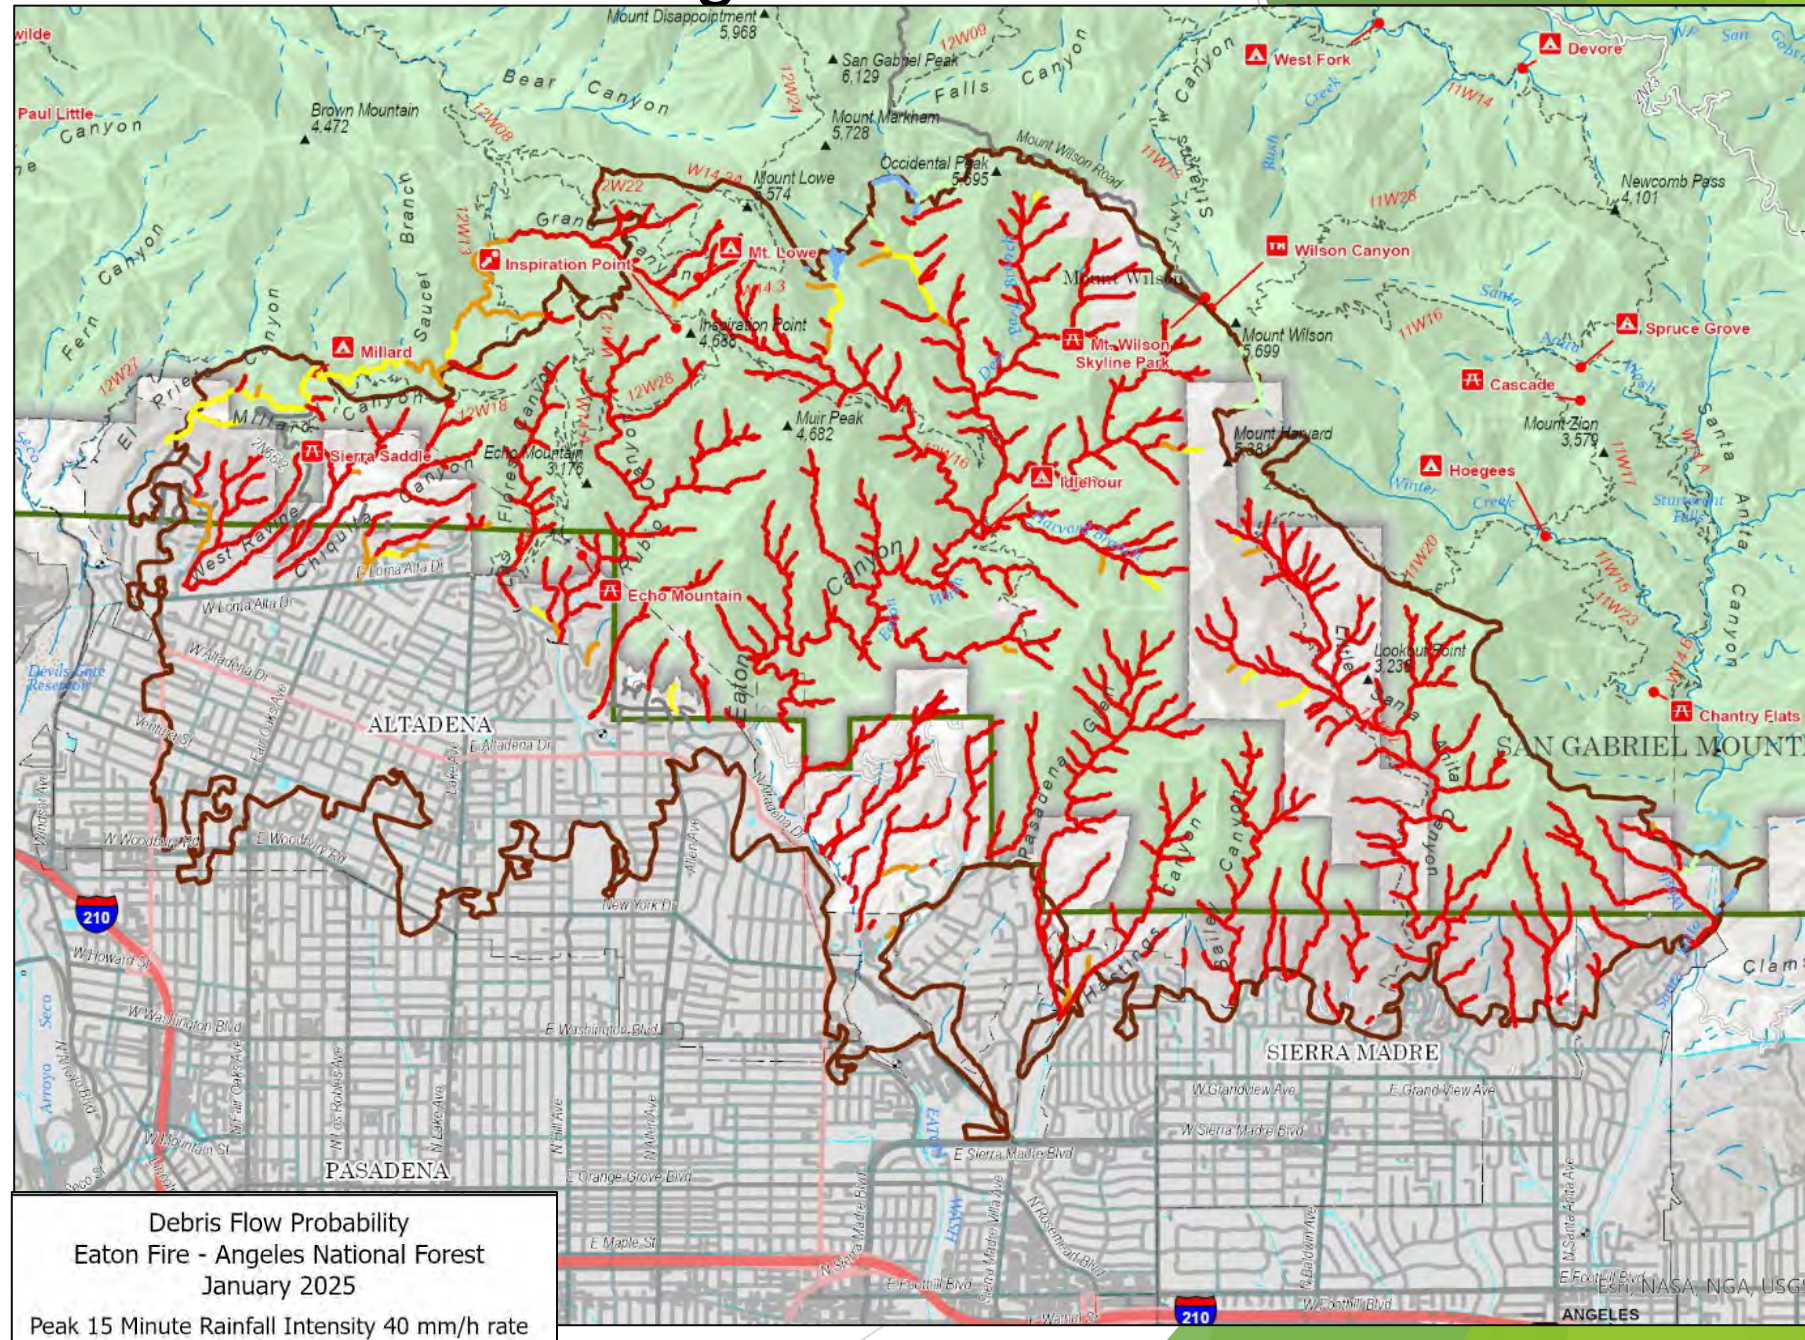
USGS Debris Flow Model Findings:

- ▶ High to Very High probabilities of debris flows.
- ▶ Predicted volumes of debris flows range from 1K to over 100K cubic meters.
- ▶ High combined hazard for nearly all drainages in the burn scar.
- ▶ Magnitude of storms ranging from 12 to 20 mm/hour (0.5-0.8"/hour) have 50% probabilities of initiation of debris flows in most drainages in the burn scar.

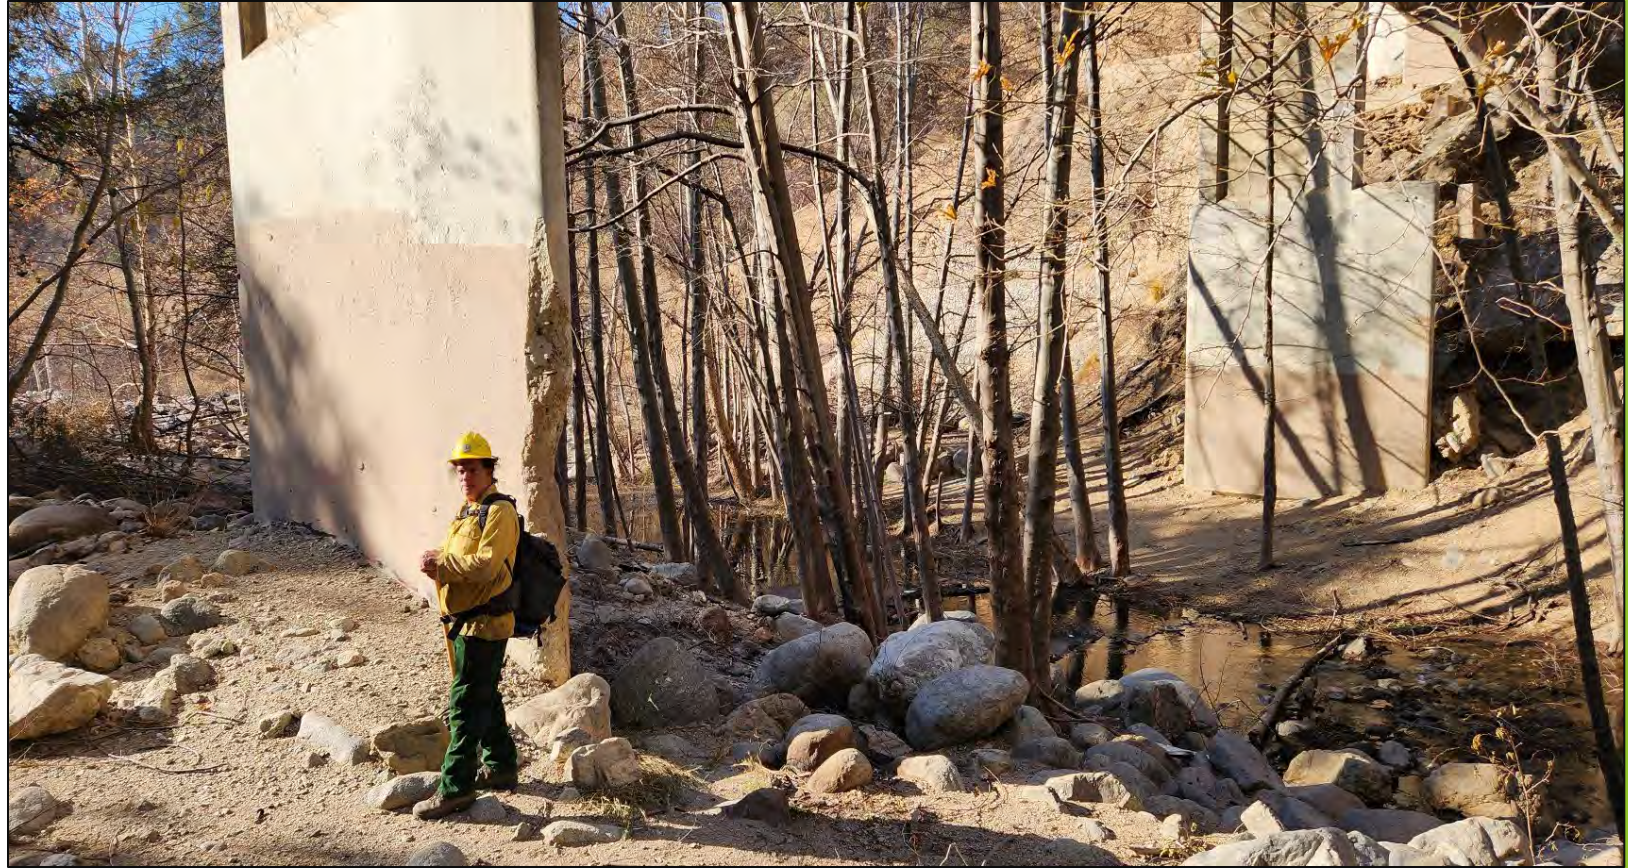
- Post-fire geological hazards in the burn scar present *high* threats to human life and safety and to some properties.

- Implement a one-year closure of the whole burn scar.
- Re-evaluate the closure before the next rainy season for specific adjustments.
- Post warning & closure signs at trailheads, road ingress/entries, and campgrounds.

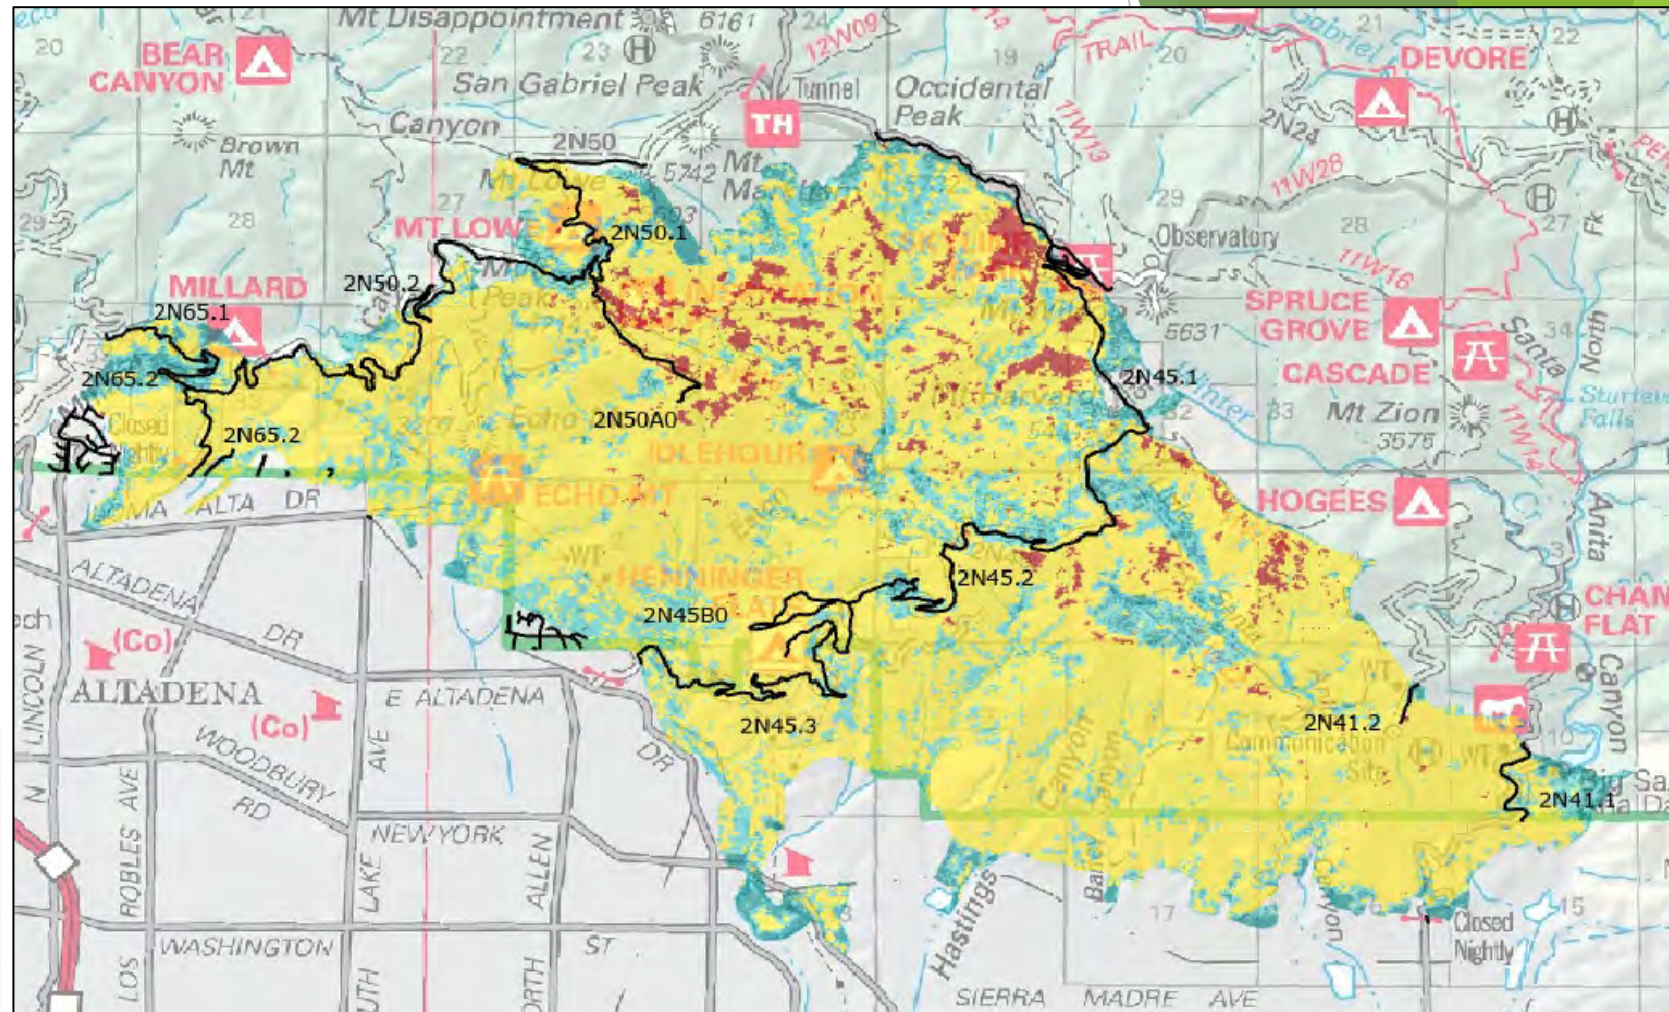
Soil Burn Severity & National Forest Service Roads

A total of 22.76 miles are within the Eaton Fire

- 11.89 miles of roads were determined to have Likely Probability of Damage and will have a Major Magnitude of Consequence leading to a High Risk.
- These are roads located on Moderate/High burn severity upslope, steep drainages, and roads with steep grades.

- 12.46 miles of roads were assessed to have Unlikely Probability of Damage but will have a Moderate Magnitude of Consequence leading to a Low Risk.
- These are roads located on ridgetops, in locations with Low to Unburned upslope, or in flat terrain.

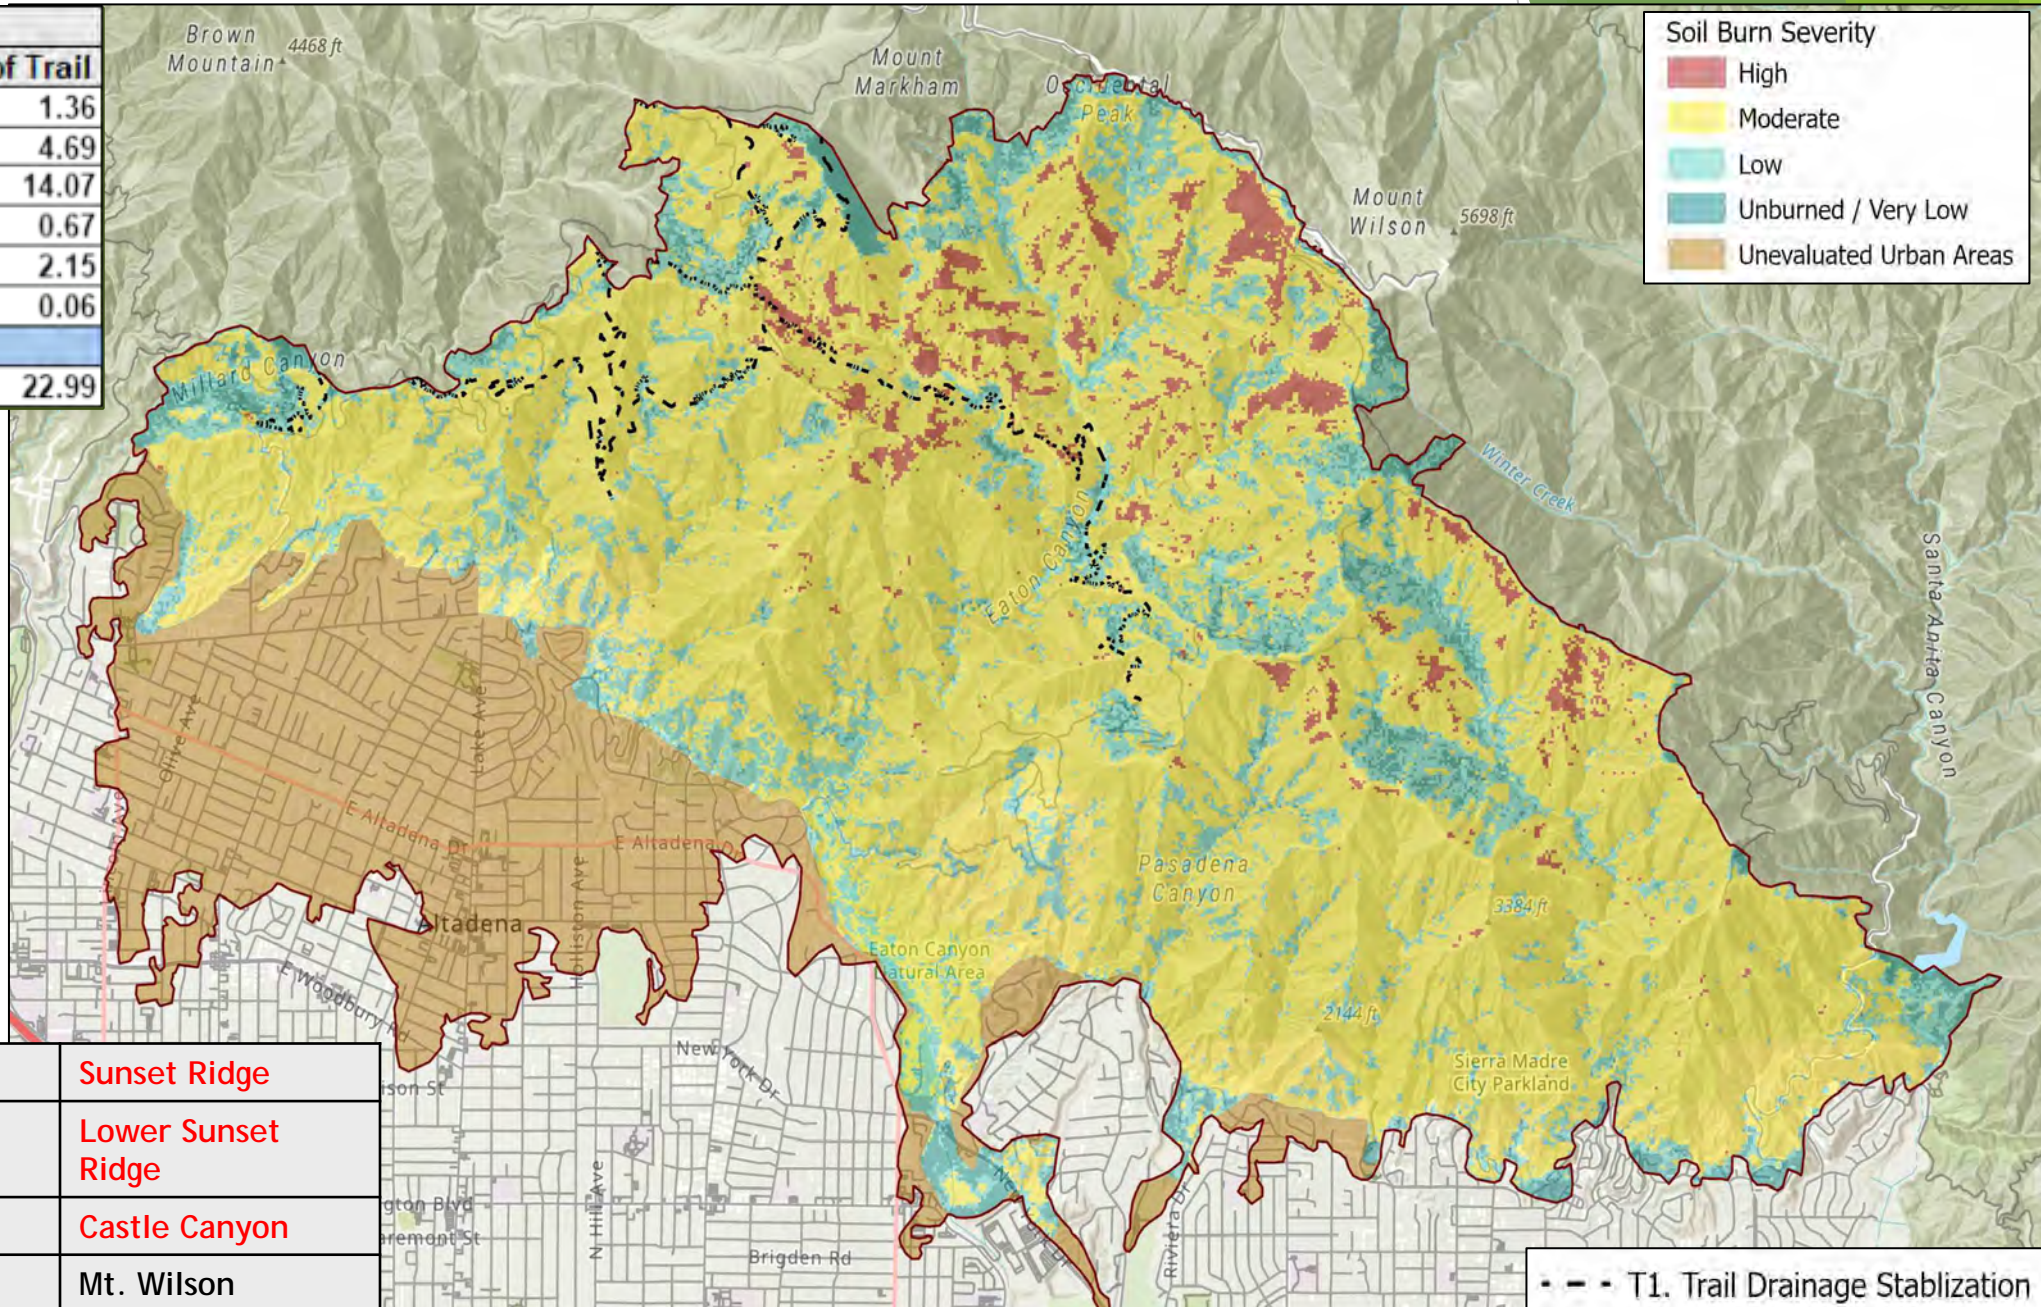
Trails	
Soil Burn Severity	Miles of Trail
Unburned / Very Low	1.36
Low	4.69
Moderate	14.07
High	0.67
Outside the Fire	2.15
Unevaluated Urban Areas	0.06
Grand Total	22.99

- - - T1. Trail Drainage Stabilization

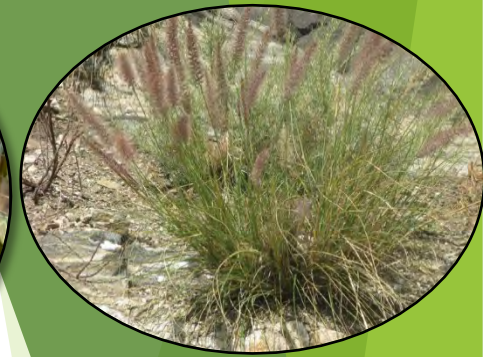
Crimson Fountaingrass

- Much of the fire area was relatively weed-free and is mainly composed of mixed chaparral types and conifer forest.
- Many weed occurrences at the Incident Command Post (ICP) and along the access road corridors are potential vectors to spread into the fire.
- Dozer and hand lines are most likely introduction sites.

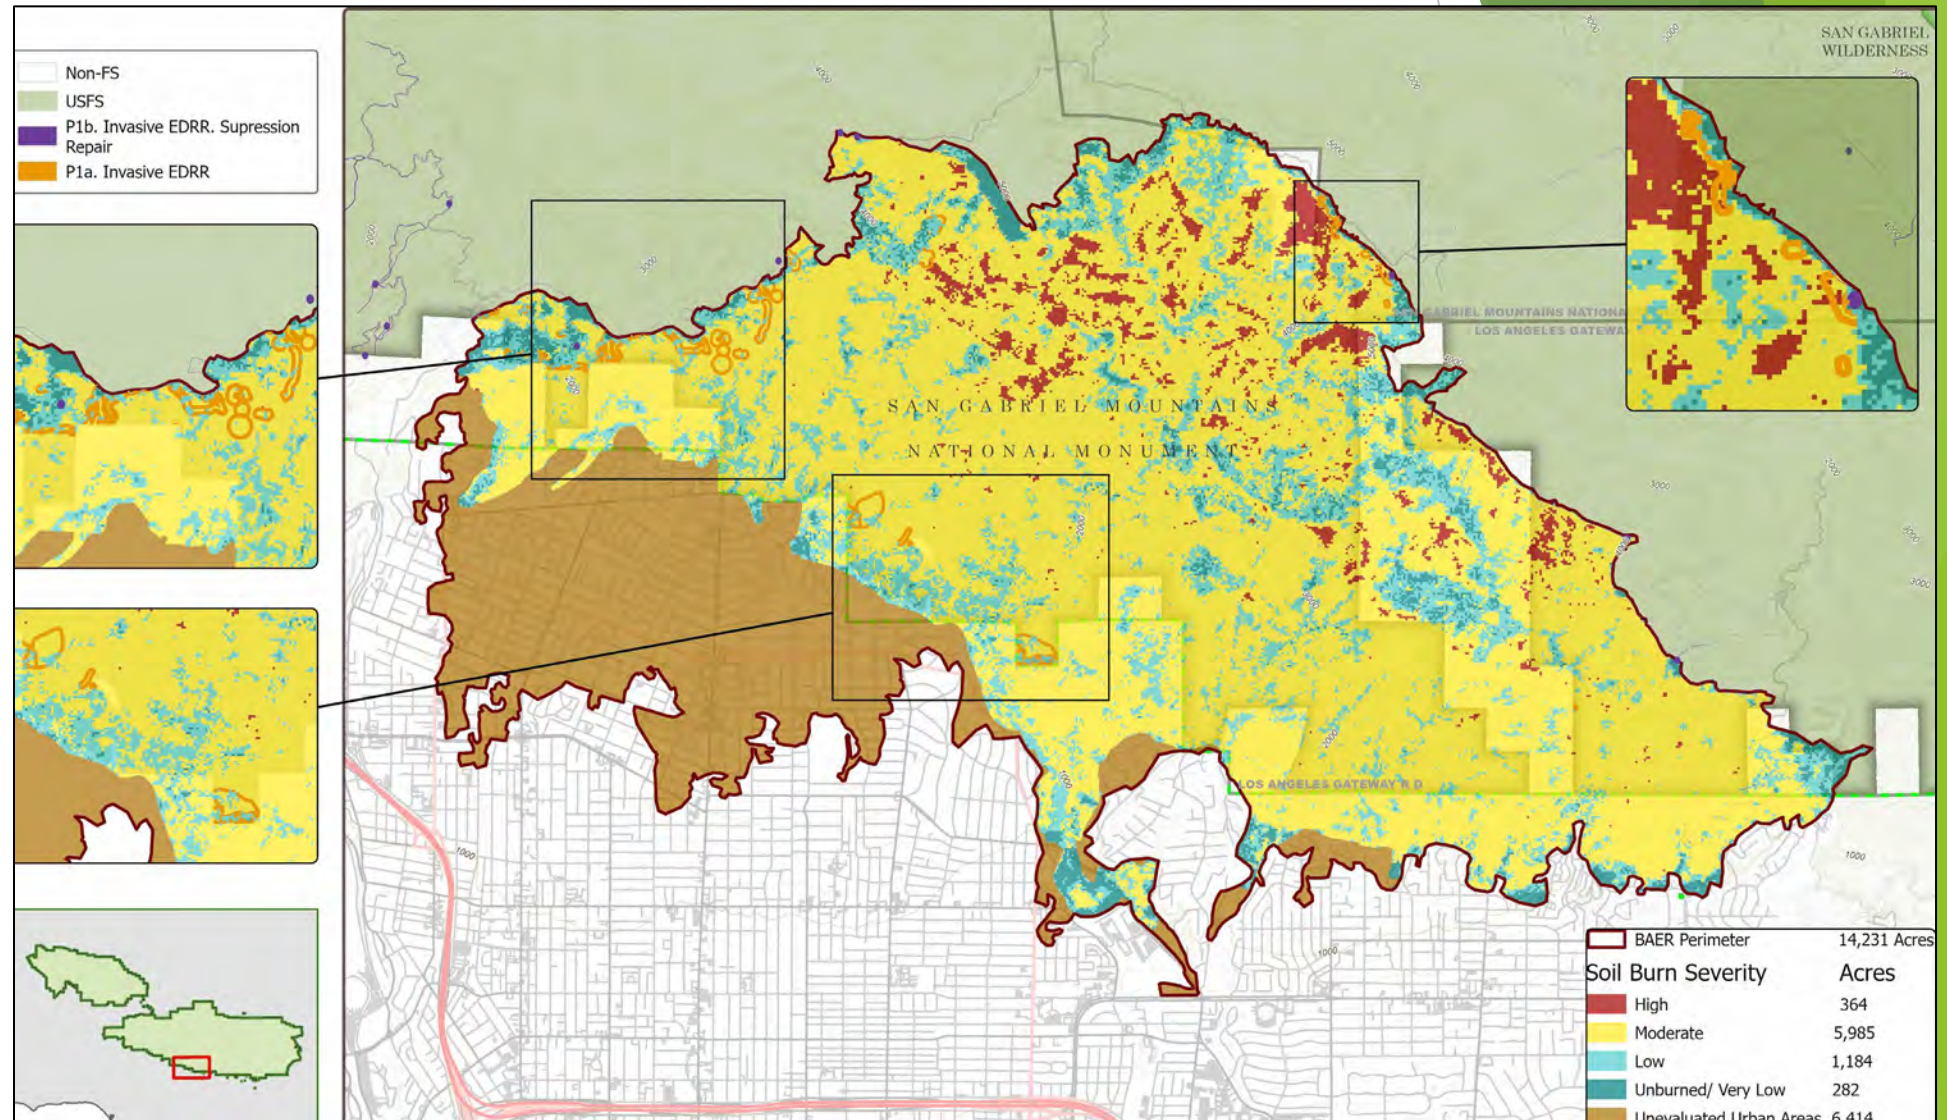
- **Suppression Sites – 72 acres including:**
 - Dozer line: 23 miles
 - Widened road: 8 miles
 - Handline: 7 miles
 - 4 Helispots
 - 6 Drop points
 - 5 Dozer pushes
- **Burned Slopes Away From Suppression Sites**
 - 135 acres of high priority and high-risk areas

BAER Standard Treatment: Early Detection/Rapid Response (EDRR)

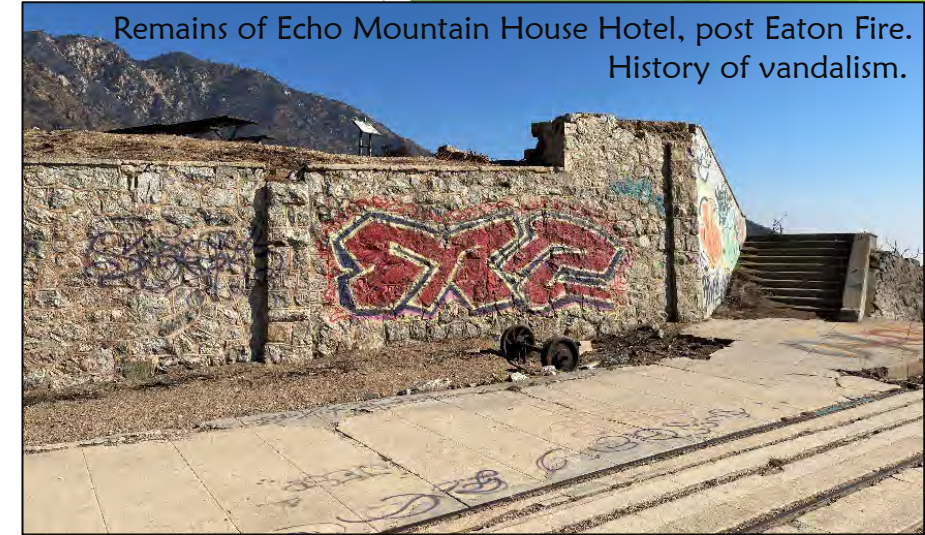
- 18 previously-identified archaeological sites in/close to the burn.
- 12 of the 18 were identified as having high or very high risk (11 of 12 are roads and trails).

Echo Mtn Trail one week after Eaton Fire and almost impassable. Railway bridge abutments visible.

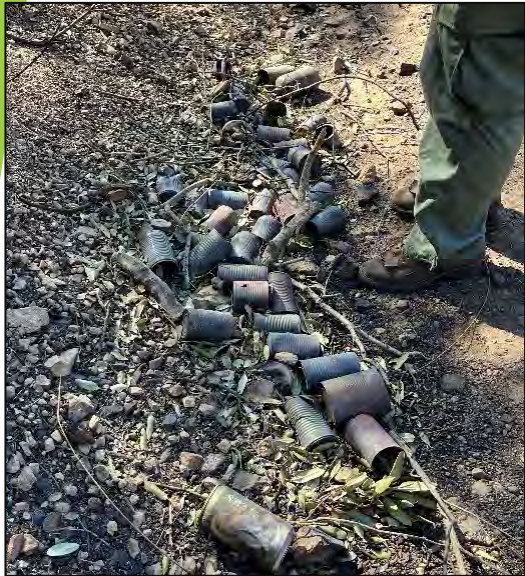
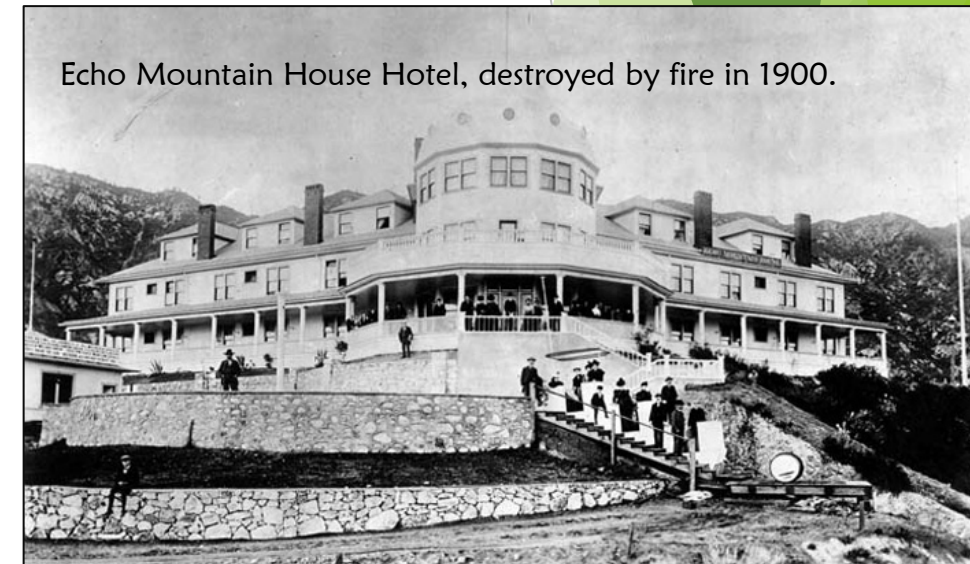
Echo Mountain House Hotel, destroyed by fire in 1900.

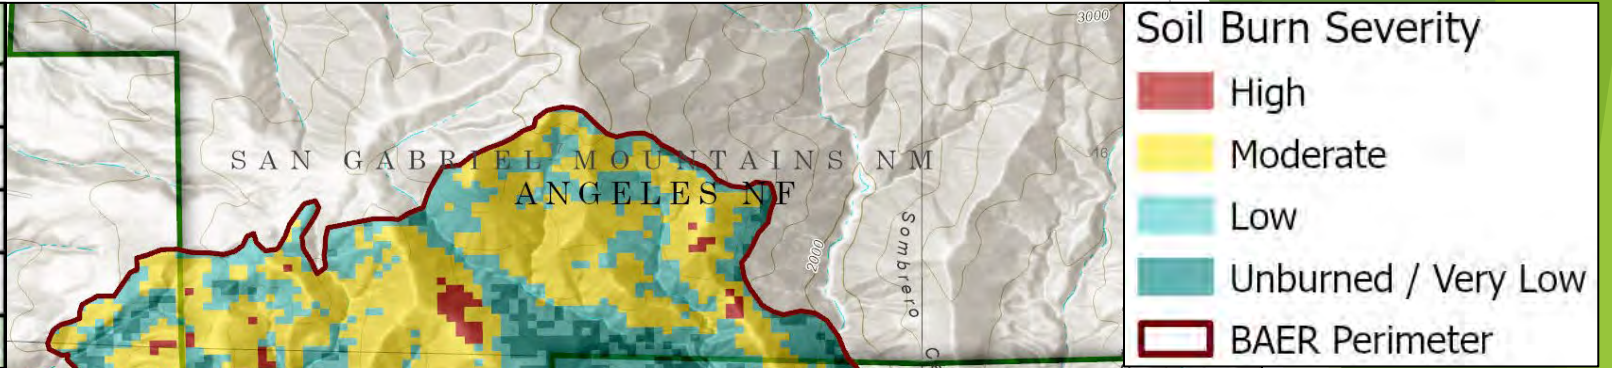
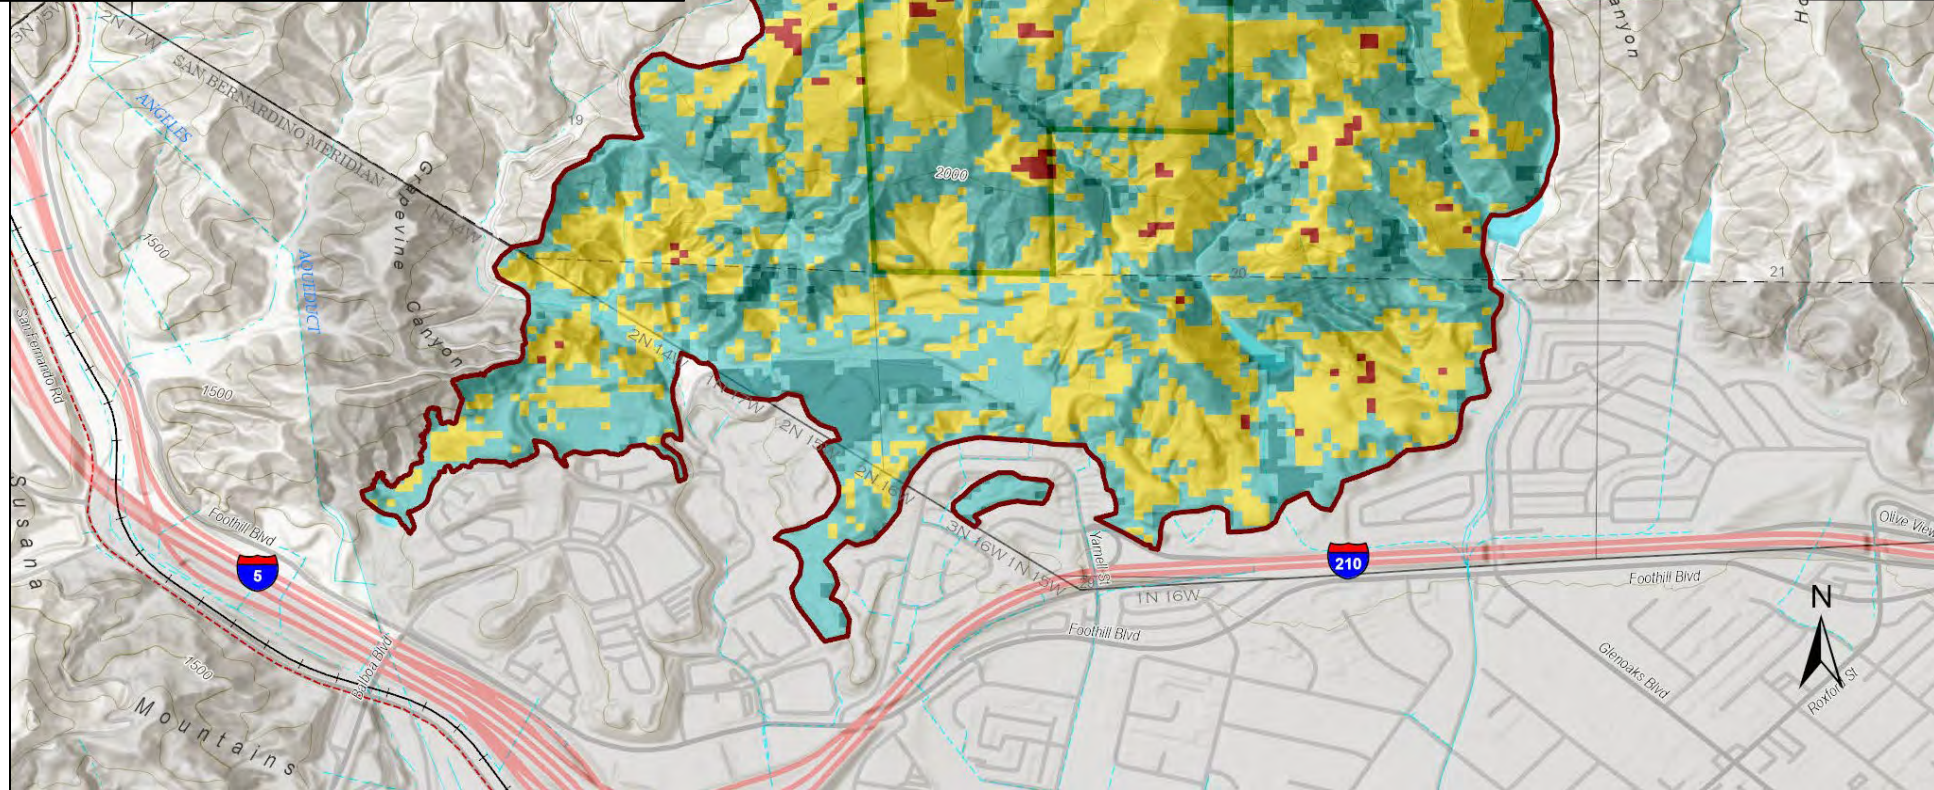
Hurst Post-Fire Watershed Assessment Findings - Soil Burn Severity

Soil Burn Severity	GIS Acres
High	13
Moderate	384
Low	386
Unburned / Very Low	61
Total Acres	844
