Moon Complex Fire Burned Area Summary

Burned Area Report

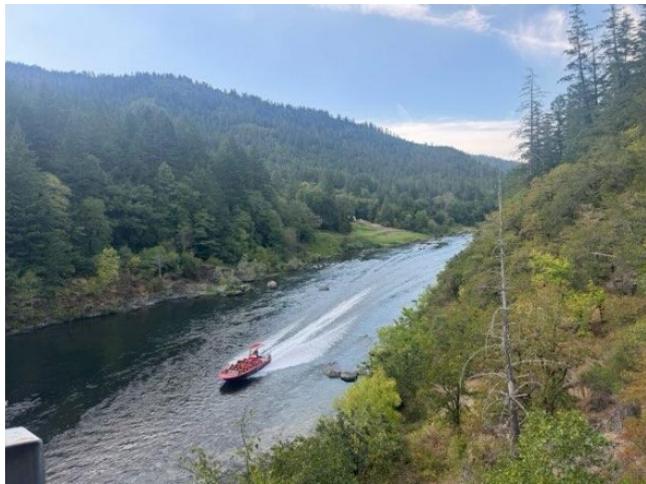
Figure 3. Recreationists, private landowners, and Outfitters and Guides use the river year-round. A jet boat travels up the Rogue River in this photo providing an example of the river use and business occurring on the Rogue River.
