PHASE 2 HERMITS PEAK-CALF CANYON POST-FIRE BAER SOIL BURN SEVERITY MAP RELEASED

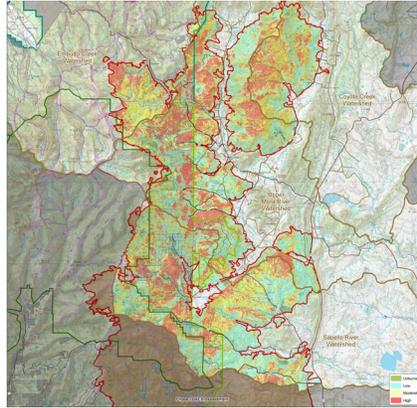
BAER team specialists completed data gathering and analysis for Phase 2 of the Hermits Peak-Calf Canyon burned area on June 8, 2022. The soil burn severity (SBS) map analyzes 190,026 acres for the *Sapello River*, *Upper Mora River*, *Coyote Creek* and portions of *Embudo Creek* watersheds. The map and the data display soil burn severity (SBS) categories of unburned/very low, low, moderate and high.

Approximately 43% of the Phase 2 acres are either unburned/very low or low SBS, while 33% are moderate SBS and 24% are high SBS. Areas within the watersheds that were assessed continue to burn, and the potential for reburn exists in areas with unburned, very low and low SBS.

The Phase 2 SBS map also shows the acreage for land ownership for the 190,026 acres in the Phase 2 assessment:

- 42,124 acres for the Santa Fe National Forest (NF),
- 14,969 acres for the Carson NF, and
- 132,933 acres of private land.

The BAER assessment team used preliminary remote sensing data based on satellite imagery from May 30, 2022, with field-validated data collected over several days to produce the Phase 2 SBS map. Field-validated data was only collected on National Forest System (NFS) lands. This information was then used to extrapolate SBS off NFS lands.
